Re: River Intake, RI4

CITY OF AURORA RIVER INTAKE BOOSTER #4 INSPECTION REPORT

| JOB NAME | AURORA RIVER INTAKE | | BOOSTER | 4 | DATE | 4/11/2024 |

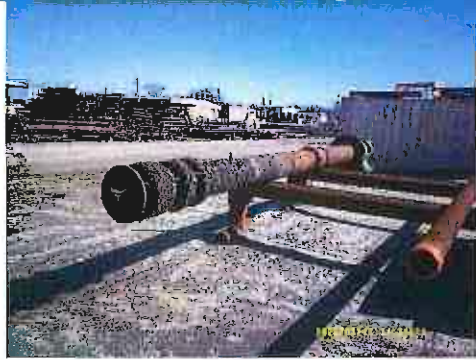
RI 4 booster on Layne's blast rack

Replace bowl assembly.

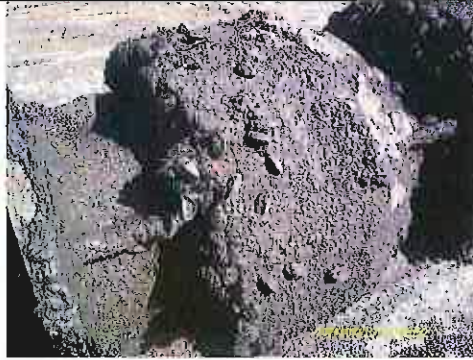
Heavy encrustation on bowl OD

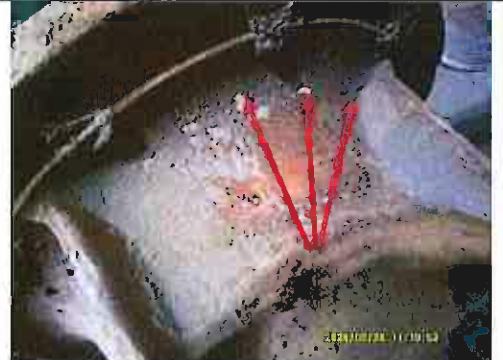
Pin holes in intermediate casting

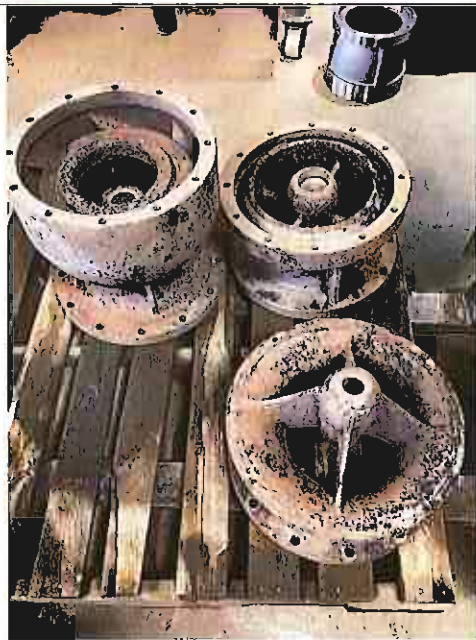
Castings after disassembly

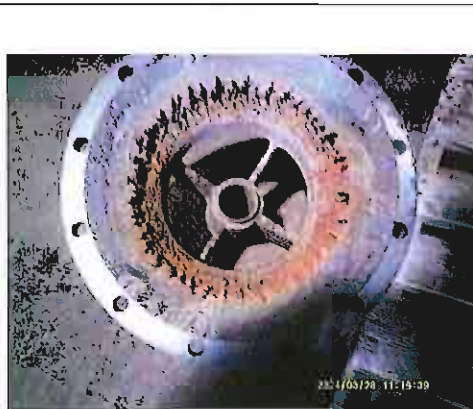
Heavy cavitation erosion in suction bell

Holes and major cavitation to suction bell. Pitting throughout impeller shaft. Nicks on impeller flutes. Suction screen is stainless and in good condition.

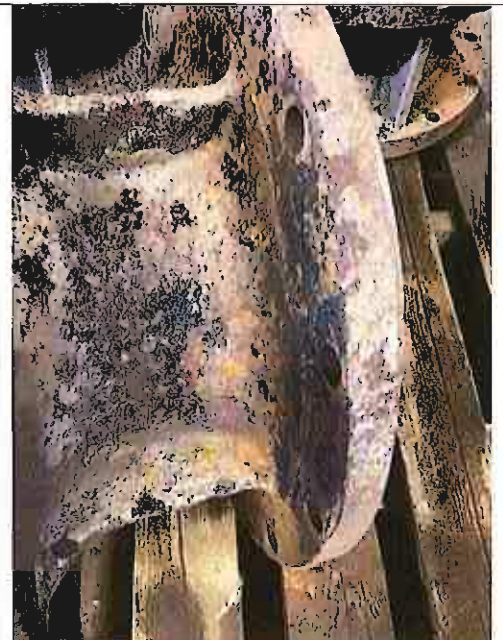
Pin holes in casting

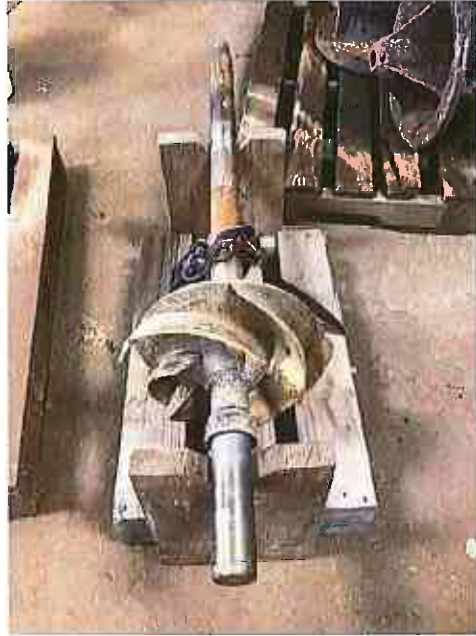
Impeller and impeller shaft

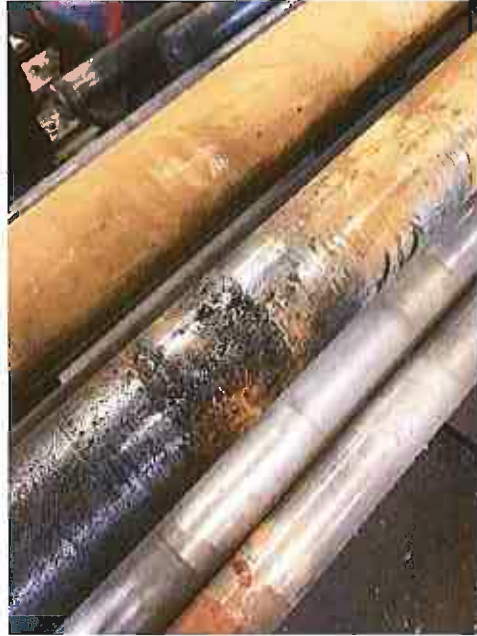
Heavy pitting on impeller shaft

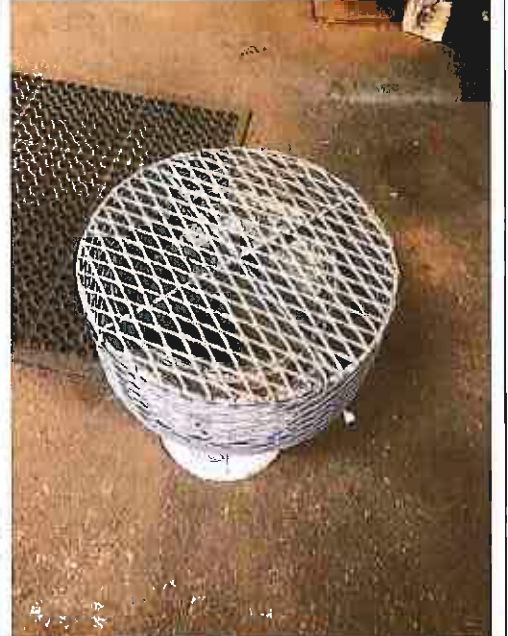
Basket suction strainer

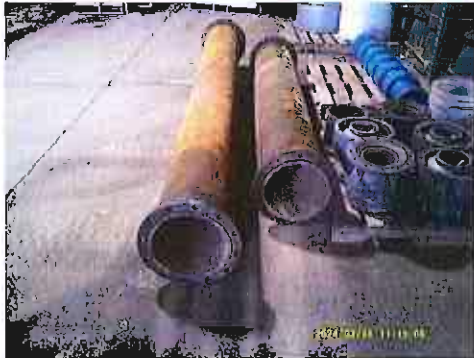
12" flanged column

The column assembly components are in poor condition.

Replace column assembly.

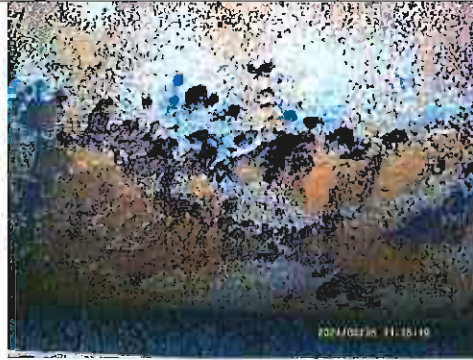
Heavy pitting to OD of column (typ.)

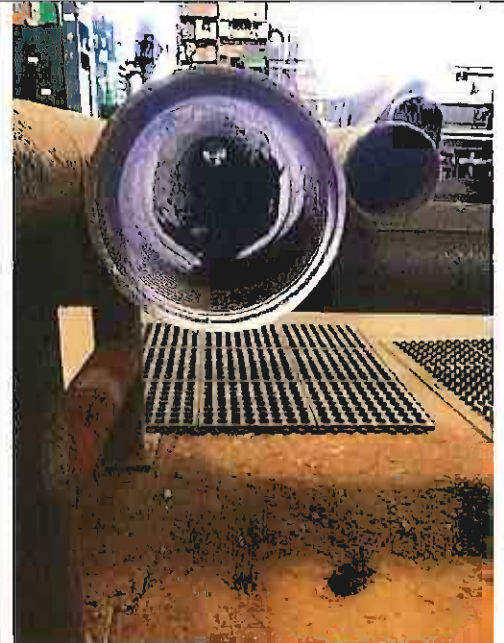
Heavy encrustation on ID of column (typ.)

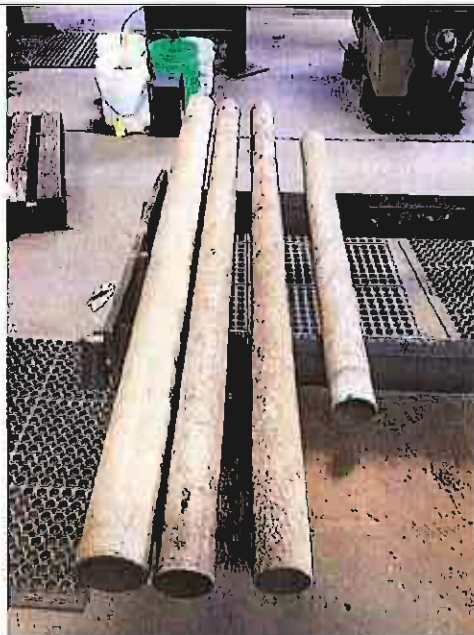
3" tubing

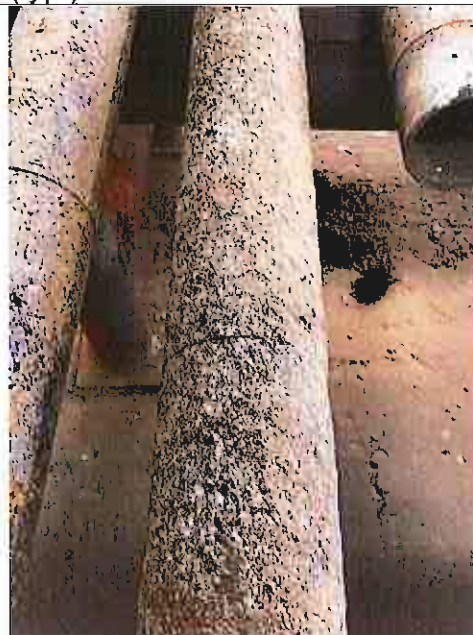
Heavy pitting to OD of tubing (typ.)

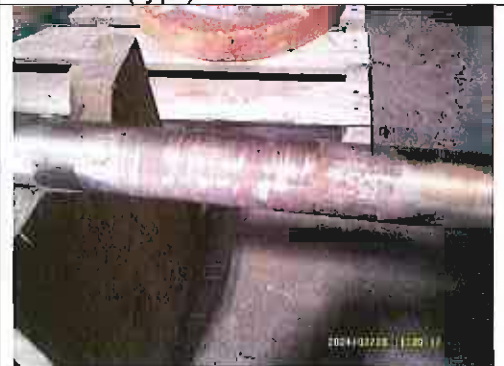
Heavy wear at bushing locations on 1 11/16" shaft (typ.)

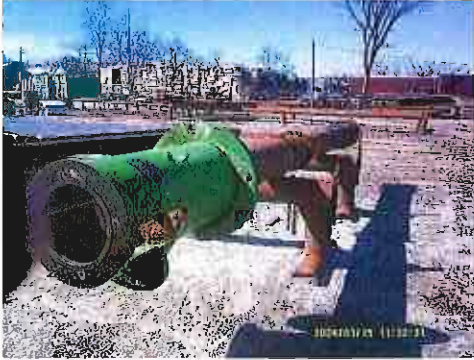
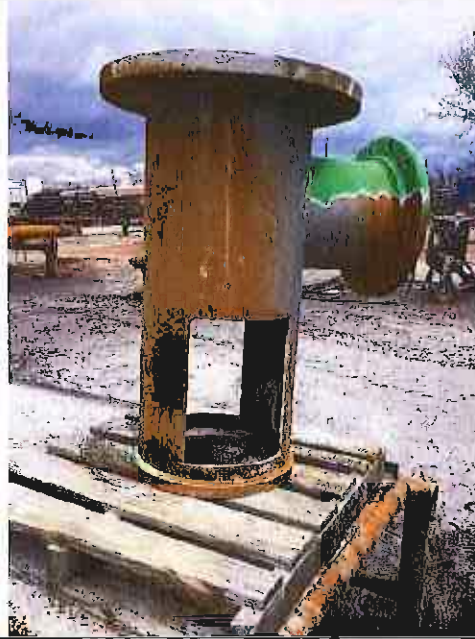
Fabricated 12" discharge head

Overall, the discharge head is in good condition. The mechanical seal and tension assembly are damaged.

Replace mechanical seal and tension assembly. Epoxy coat.
