Condition Assessment

## AURORA POLICE DEPARTMENT PARKING STRUCTURE

Aurora, Illinois

April 29, 2022

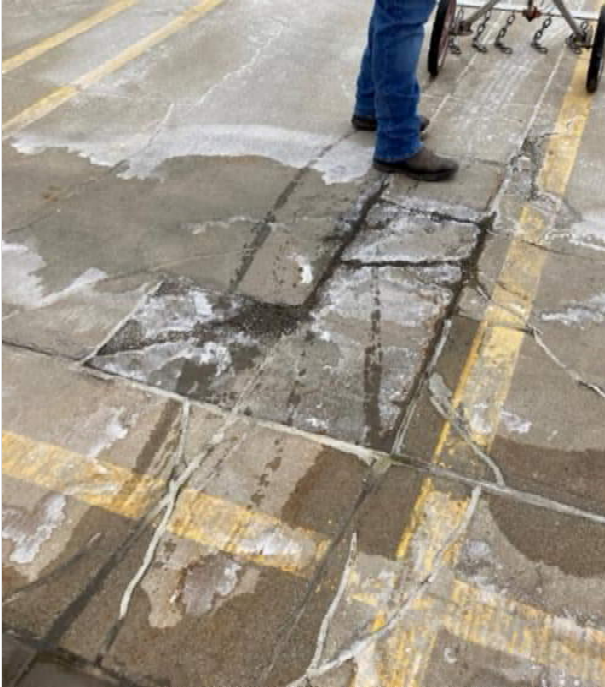
- Small concrete delamination/spalling was observed along the tee-to-tee joints and within concrete washes at isolated locations throughout the parking structure. (Photos 1 & 2)
- Delaminated concrete at lifting loop pockets on the floor surface throughout the parking structure were identified during our chain drag survey. (Photos 3 & 4)
- Isolated random cracking was noted in the precast double tees. Cracking was observed to be narrow ranging from 0.010" – 0.015".

Photo 1 – Typical spalled and delaminated concrete.

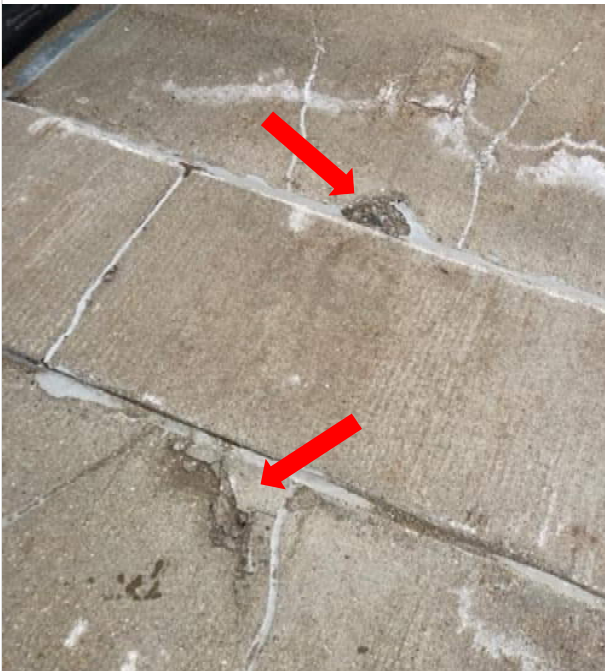
Photo 2 – Typical spalled and delaminated concrete.

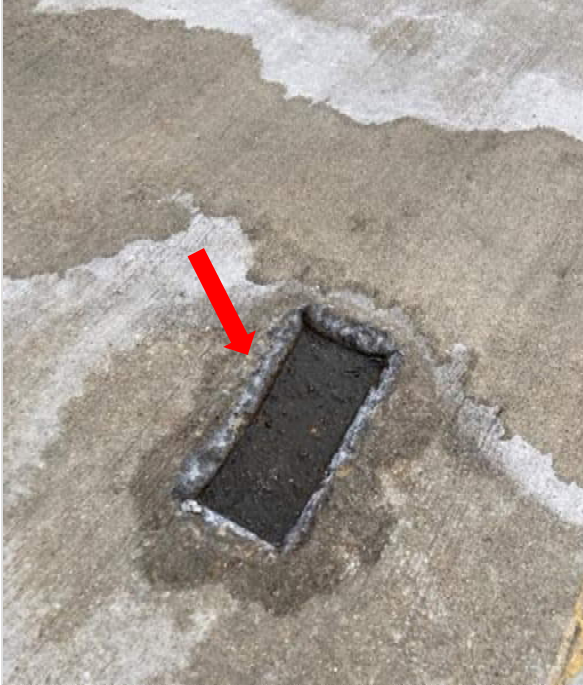
Photo 3 – Typical delaminated concrete at lifting loop pockets.

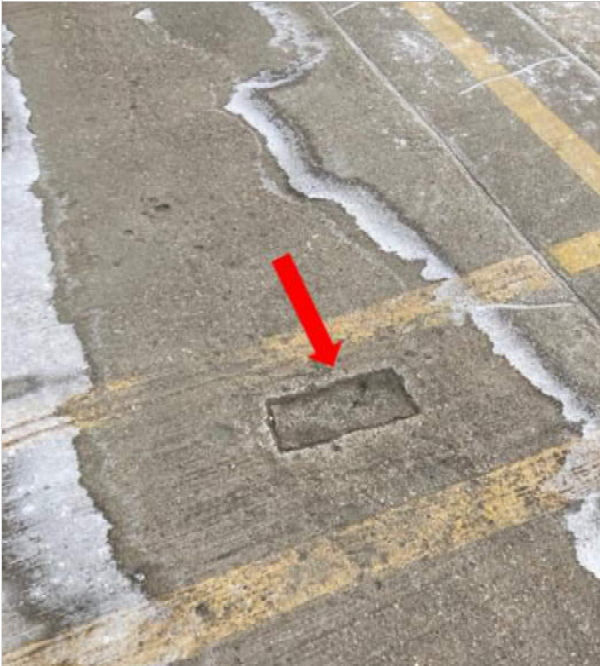
Photo 4 – Deteriorated concrete at a curb on the top level.

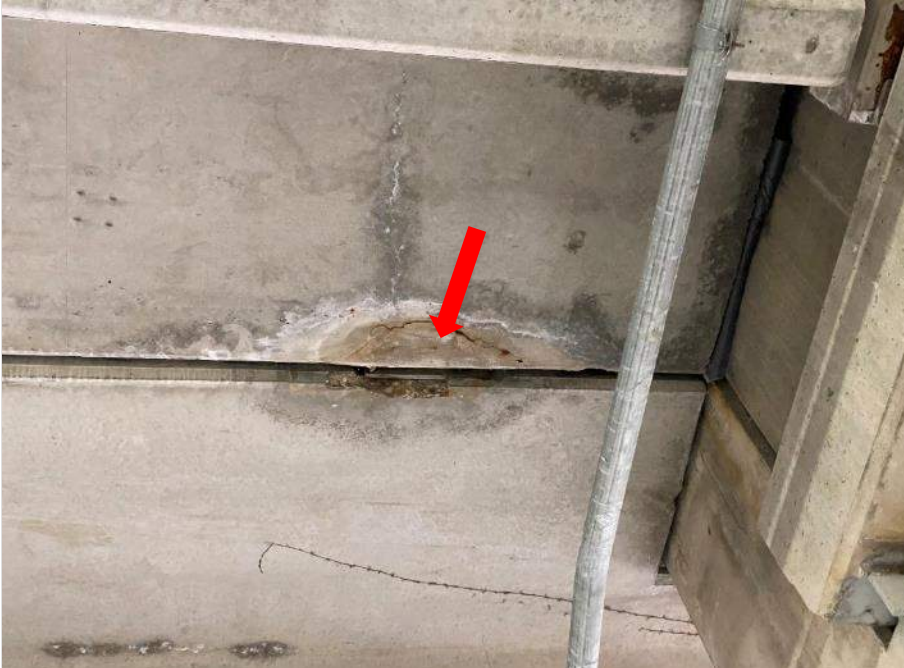
Additionally, we observed a few localized areas of overhead concrete deterioration. Further deterioration may cause the concrete to become loose, potentially falling on garage occupants. Therefore, we recommend engaging a contractor to survey all overhead surfaces and removing loose and/or deteriorated concrete.

- Spalled/delaminated concrete was observed overhead on the underside of the double-tee flanges at numerous locations throughout the structure. (Photo 5)
- Full-depth cracking and water infiltration was observed at double-tee flanges that were previously repaired. (Photos 6 & 7)
- Isolated spalled concrete and precast wall panels was observed on the top level. (Photo 8)
- Isolated delaminated grout pockets at the top of precast wall panels were identified. (Photo 9)

Photo 5 – Typical delaminated/spalled concrete on the underside of a tee flange.

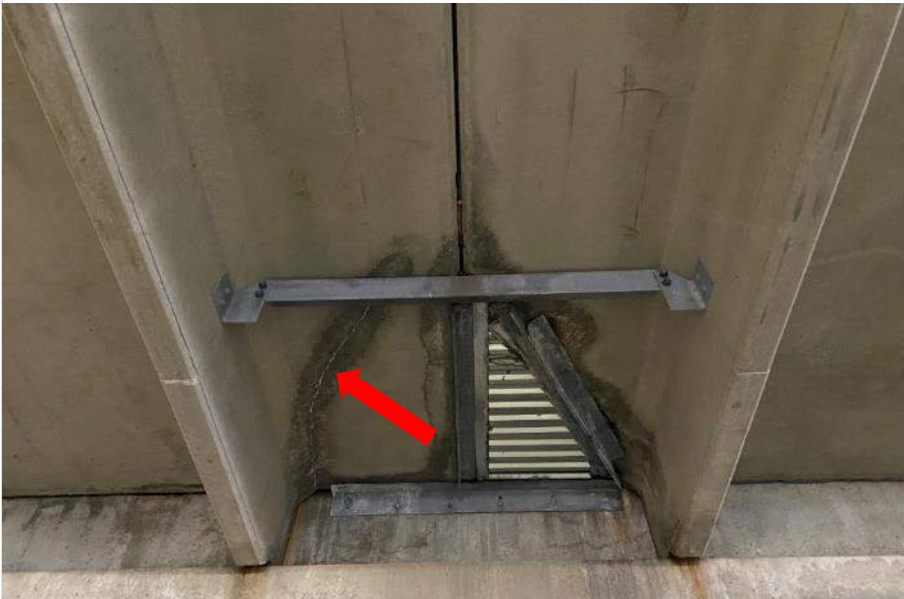
During our assessment, we observed through-depth cracking and water infiltration at double-tee flanges that were previously repaired. The cracked tee flanges are supported by a steel angle that spans between adjacent tee stems. However, cracking extends beyond the support of the supplemental steel angle. At one location, a portion of the double-tee flange that previously failed was replaced with concrete-filled metal decking. However, cracking in the tee flange adjacent to this area was still noted. Walker recommends performing full-depth tee flange repairs to replace the damaged tee flange sections and properly anchor the new sections to the existing double-tees.

Photo 6 – Full-depth cracking and water infiltration observed at double-tee flanges that were previously repaired.

1. Perform full-depth double-tee flange repairs at locations that were previously repaired but currently exhibiting through-depth cracking and water infiltration.
2. Survey and remove loose and/or delaminated overhead concrete that may be a potential falling hazard throughout the structure. This recommendation should be performed on a continuous basis.

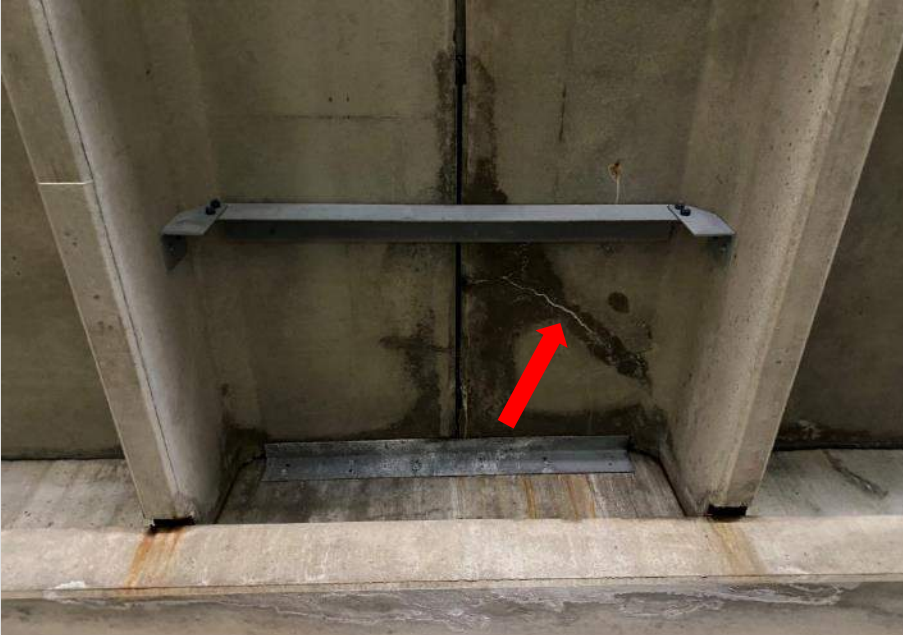
Photo 7 – Full-depth cracking and water infiltration observed at double-tee flanges that were previously repaired.

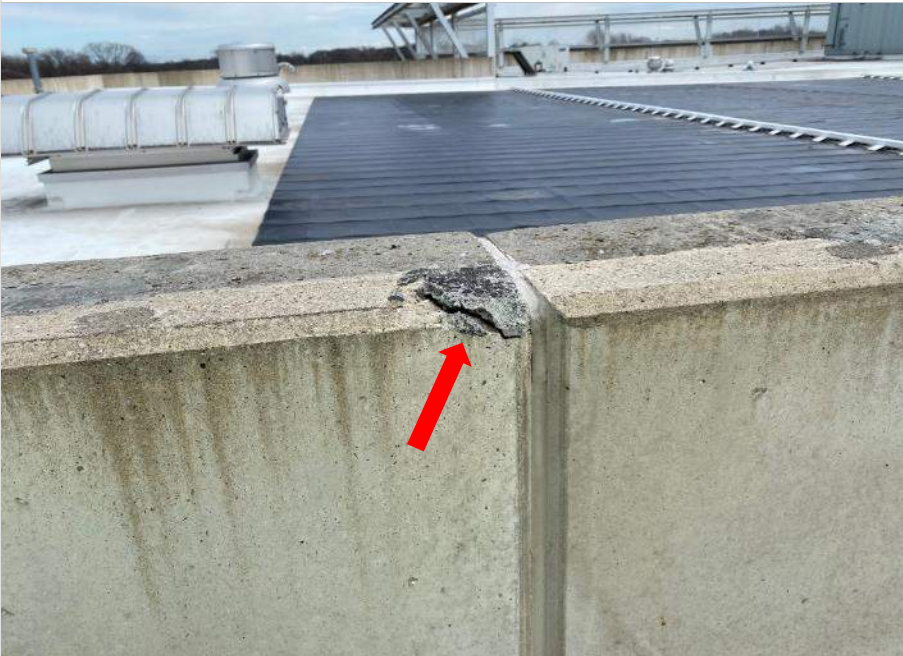
Photo 8 – Isolated spall concrete at precast wall panels observed.

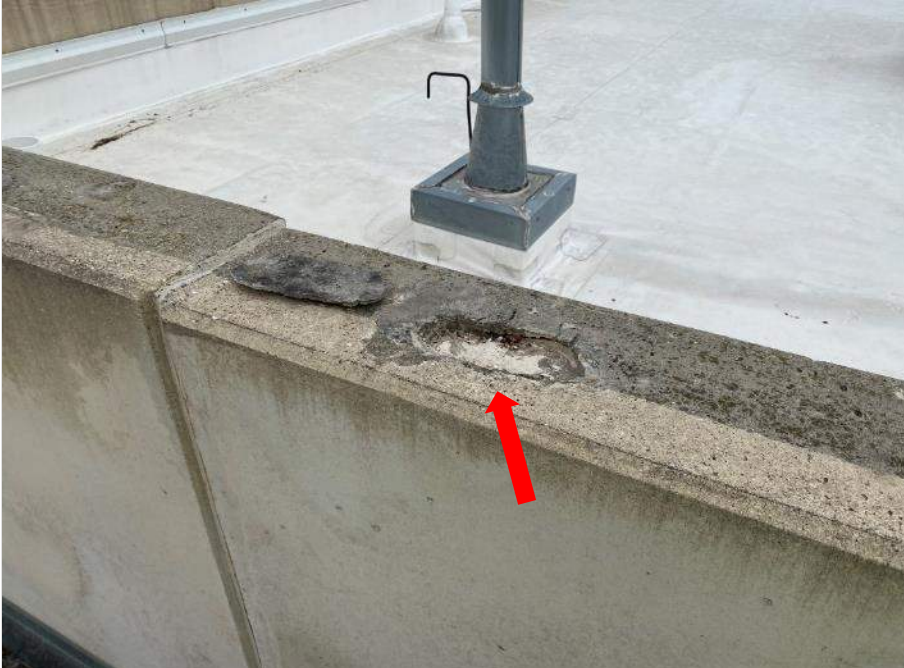
Photo 9 – Typical delaminated concrete observed at a precast wall.

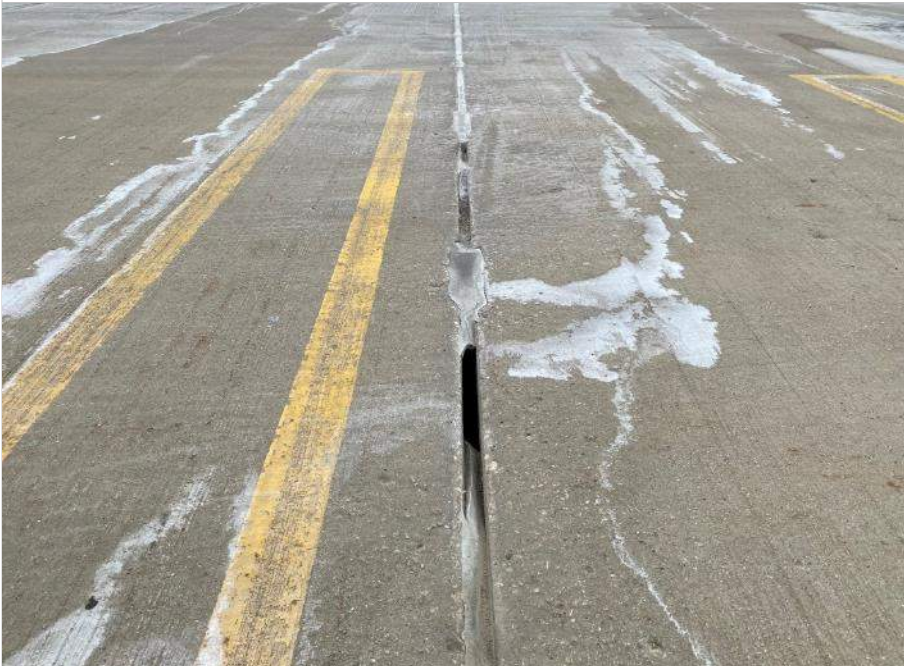
- Widespread failed tee-to-tee joint sealant was observed on the top level throughout the parking structure. (Photos 10 - 14)

Photo 10 – Widespread failed tee-to-tee joint sealant observed.

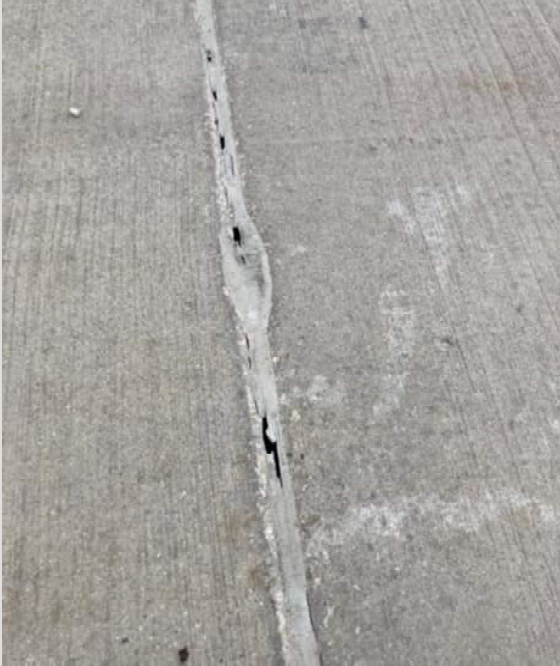
Photo 11 – Widespread failed tee-to-tee joint sealant observed.

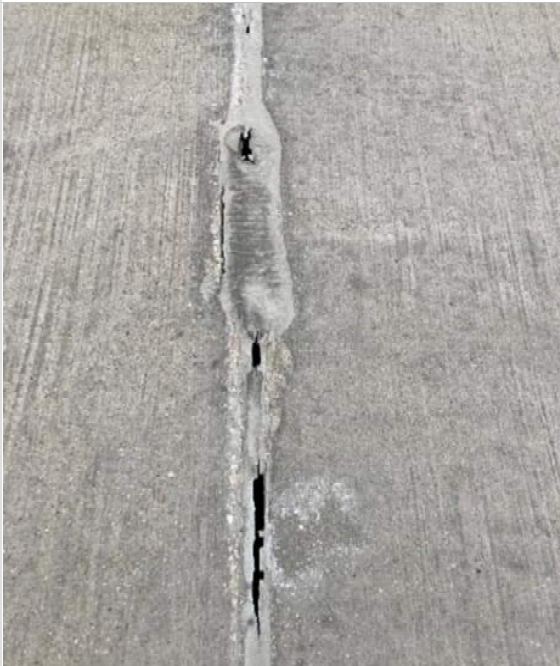
Photo 12 – Widespread failed tee-to-tee joint sealant observed.

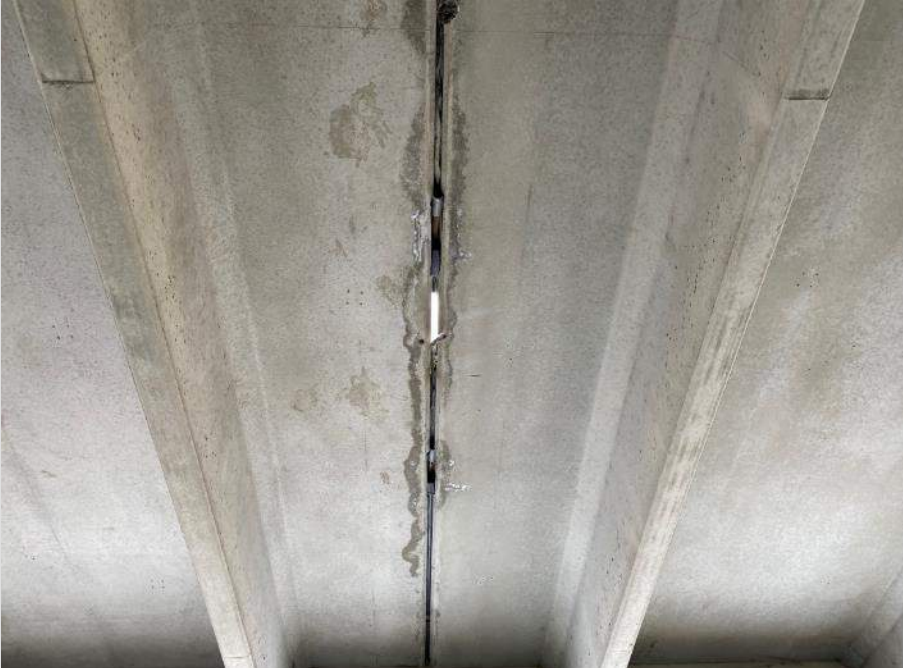
Photo 13 – Widespread failed tee-to-tee joint sealant observed.

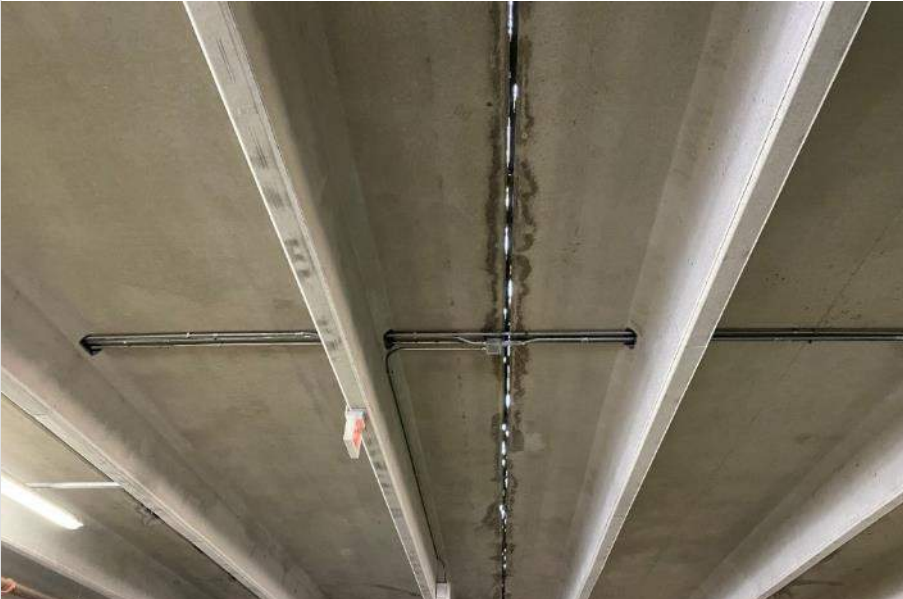
Photo 14 – Typical failed tee-to-tee joint sealant as observed from the underside at isolated locations throughout the structure. Note daylight at failed sealant.

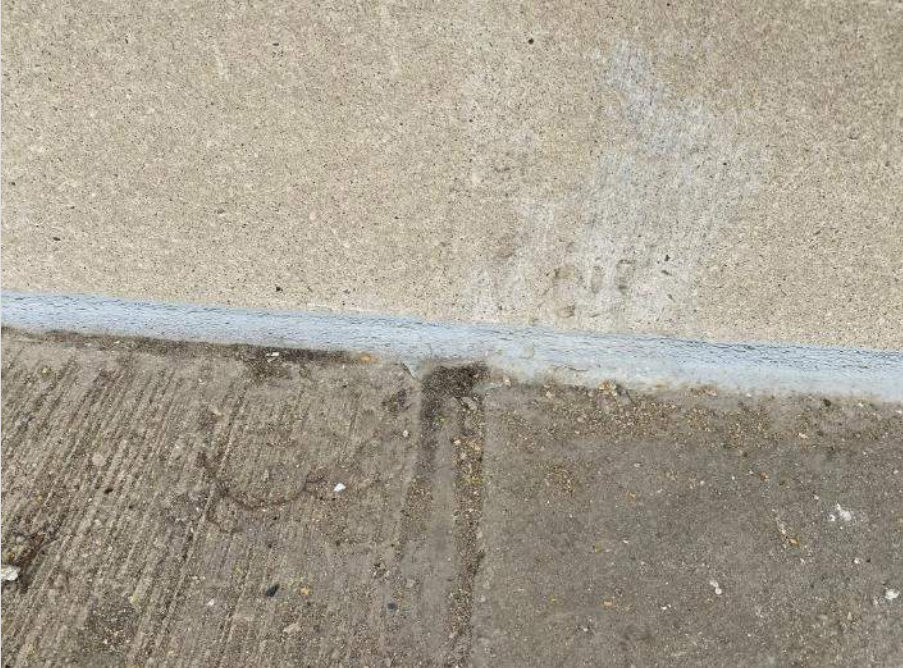
- Drying and shrinkage cracks noted on vertical joint sealant and cove sealant. (Photo 15)
- Isolated damaged cove sealant was observed throughout the parking structure. (Photo 16)

Photo 15 – Drying and shrinkage cracks noted in cove sealant.

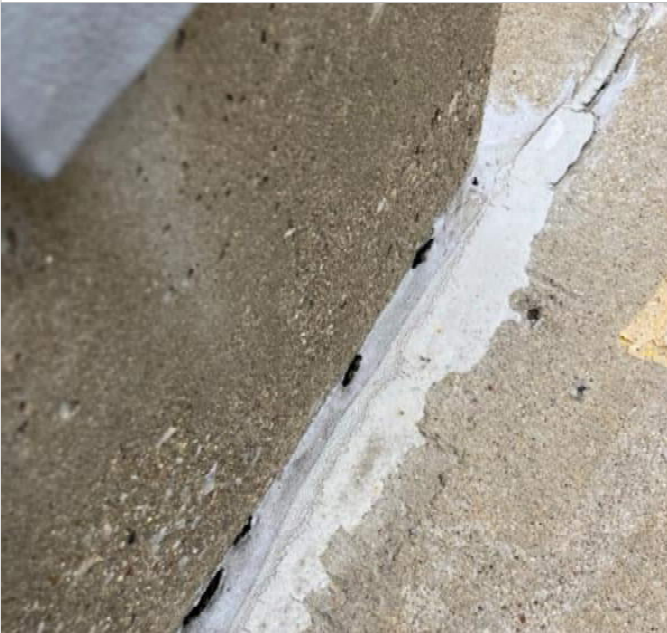
Photo 16 – Adhesion failure to cove joint sealant.

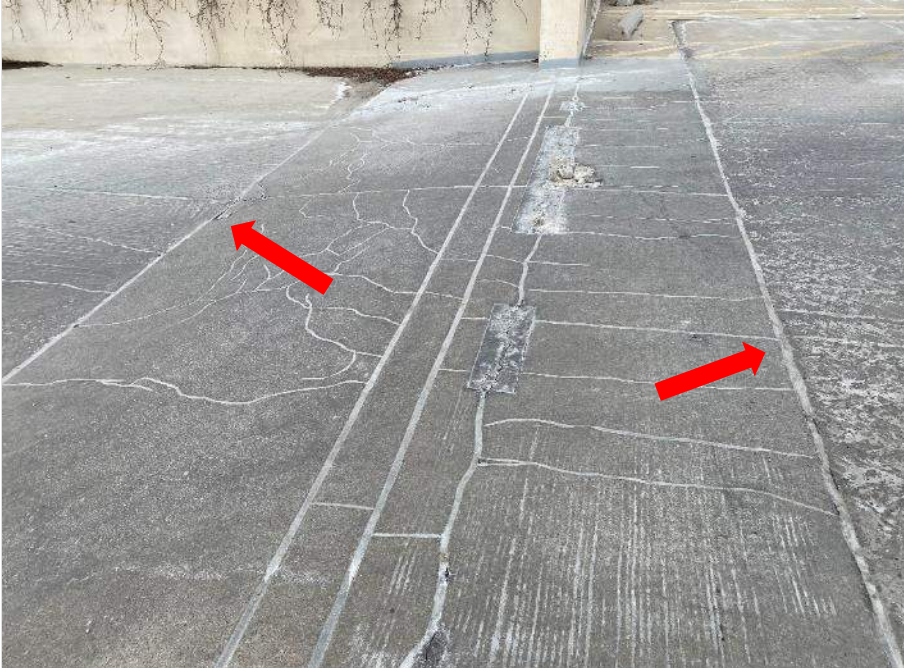
In general, construction joint sealants appeared to be in poor condition throughout the structure due to adhesion failure at multiple locations along the length of the joint. Based on the observed deterioration, we recommend that all construction joint sealants are replaced in the year 2022. Isolated damaged cove sealant was also observed. We recommend that damaged cove sealants are replaced in the year 2022.

Photo 17 – Failed construction joint sealant noted throughout parking structure.

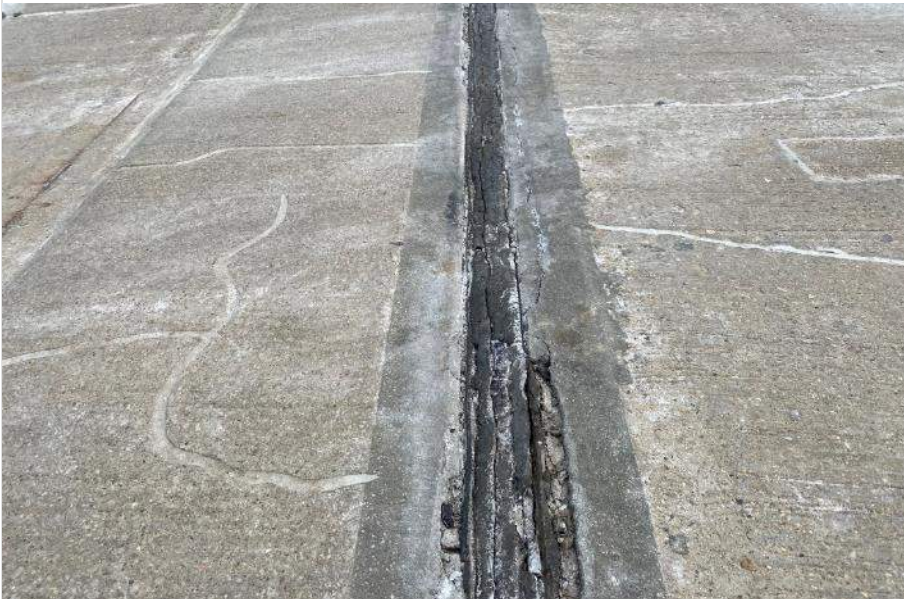
An elastomeric concrete-edged expansion joint runs east-west along the parking structure's length. The expansion joint serves to limit the stresses induced in the parking structure's concrete framing due to volume change effects from temperature fluctuations. The condition of the expansion joint is poor along most of its length. Cracking, tears, and hardening of the expansion joint gland were observed. Spalls, delamination, and cracking in the elastomeric concrete headers on each side of the joint were also observed. Deterioration of the expansion joint allows water infiltration that may cause additional damage to the adjacent concrete framing. We recommend replacing the elastomeric concrete-edged expansion joint, rubber gland and headers, in the year 2022. When properly installed and maintained, these joint systems typically have a life expectancy of approximately 7 to 10 years. A silicone expansion joint runs around the stair/elevator tower on the south elevation of the parking structure. Adhesion and cohesion failure of the silicone sealant was observed. Similar to urethane joint sealants, surface preparation of the concrete to receive the sealant is essential to achieve a full life expectancy of the sealant. We recommend that the silicone expansion joint is replaced in the year 2022.

Photo 18 – The parking structure expansion joint has failed. Delamination/spalling in the elastomeric concrete headers was also observed.

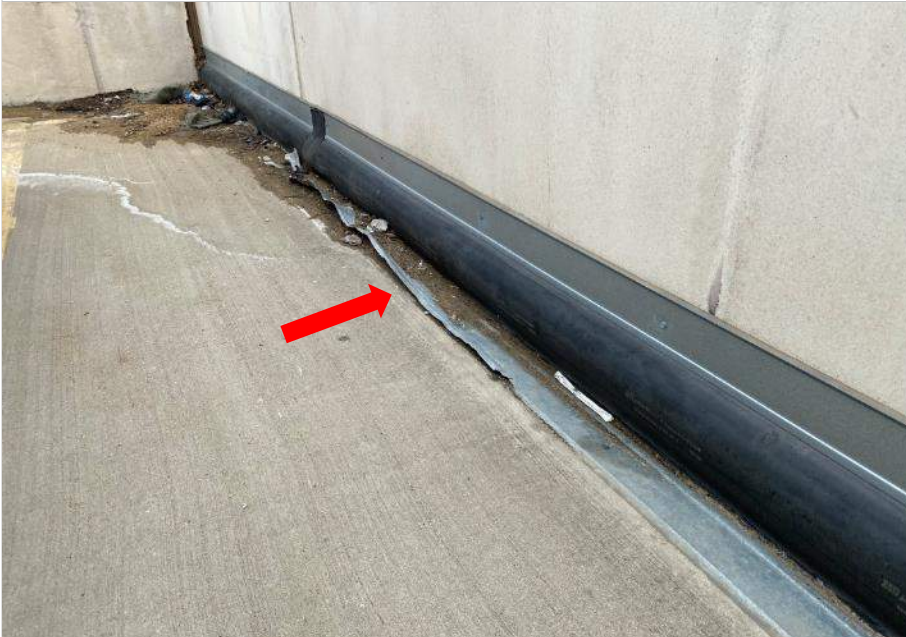
An expansion joint with counter flashing runs along the east elevation of the parking structure and separates the structure from the adjacent building. Punctures within the expansion joint, especially at splices of expansion joint material, bent or unattached metal flashing, and failed sealant above and below the expansion joint were all observed. We recommend repairing this expansion joint to maintain watertightness between the parking structure and the adjacent building in the year 2022. Careful attention to the detailing should be exercised at the intersection of the parking structure elastomeric concrete-edged expansion joint and the expansion joint separating the parking structure from the adjacent building to maintain watertightness.

Photo 19 – Counter flashing bent and allowing water intrusion. Sealant at floor line failed.

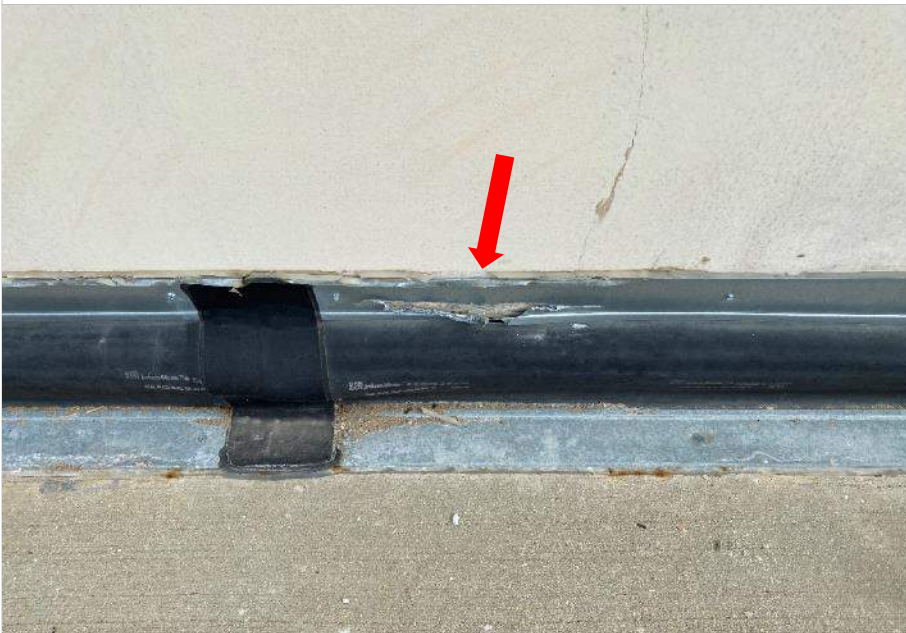
Photo 20 – Sealant at precast wall panel failed.

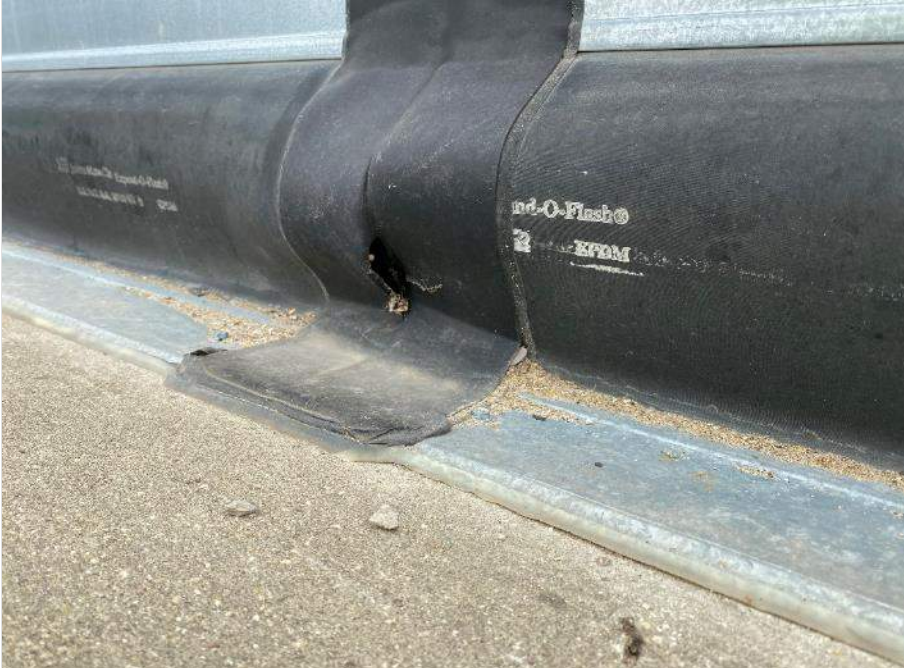
Photo 21 – Joint boot in expansion joint punctured.

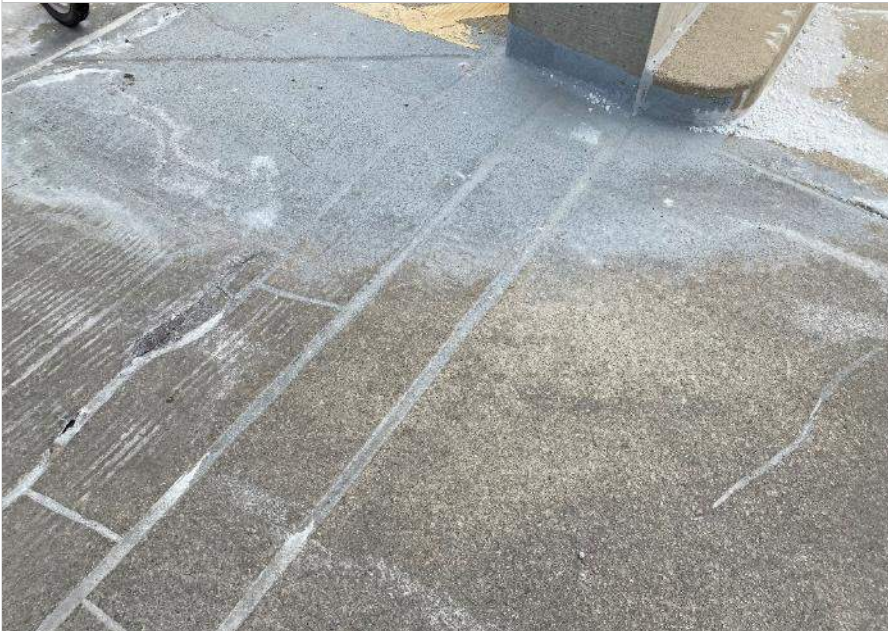
Photo 22 – Traffic bearing membrane on top level worn.

- Traffic bearing waterproofing membranes were observed to be damaged or worn throughout the Upper Level of the parking structure. Recoating and/or new application of heavy-duty traffic bearing waterproofing membrane is recommended to reduce water infiltration.

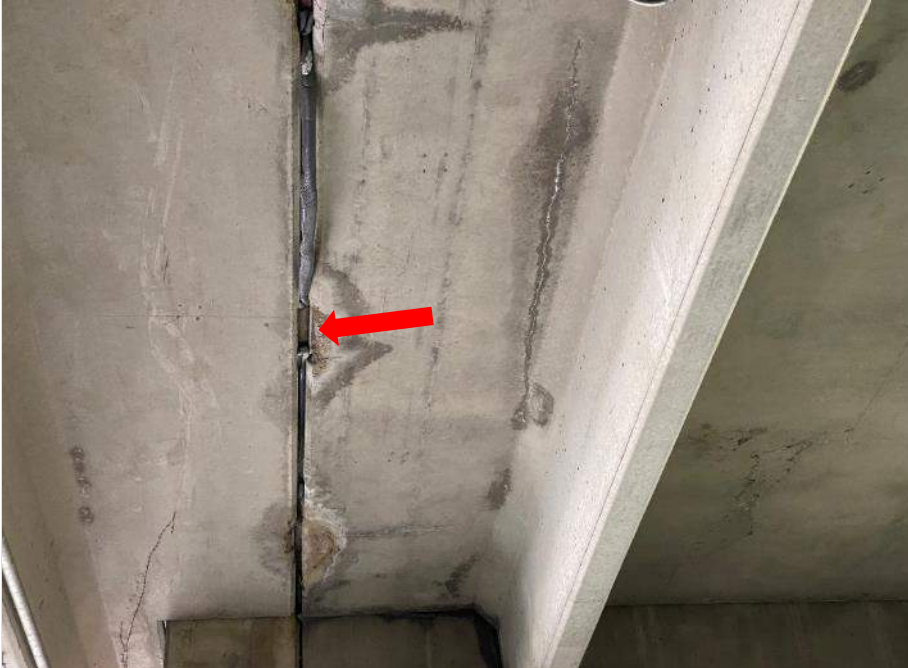
Photo 23 – Broken double-tee shear connector observed (welds broken).

1. Replace or supplement precast double-tee shear connectors throughout the parking structure.
2. Repair broken connections between precast double-tees and precast walls.

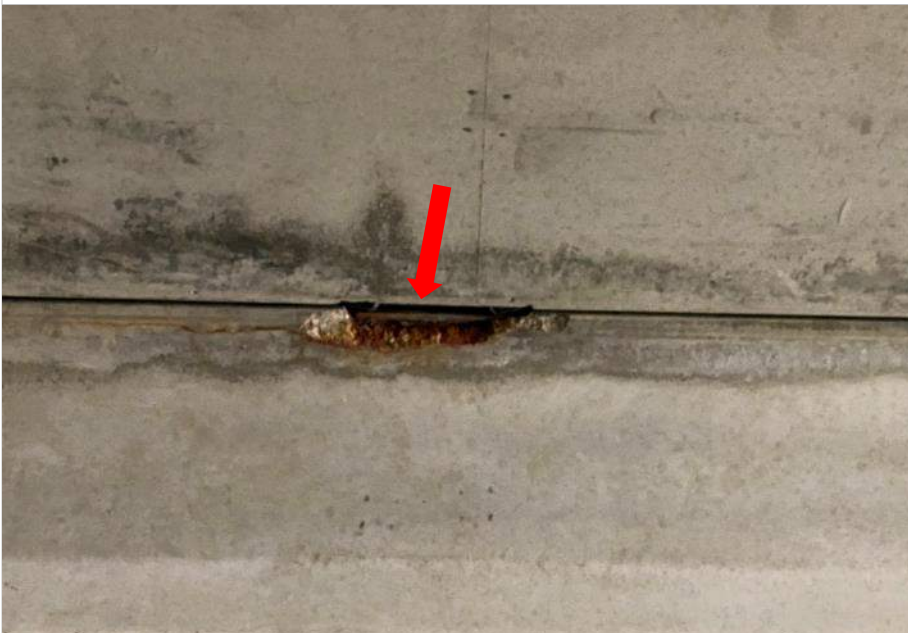
Photo 24 – Corroded double-tee shear connector noted.

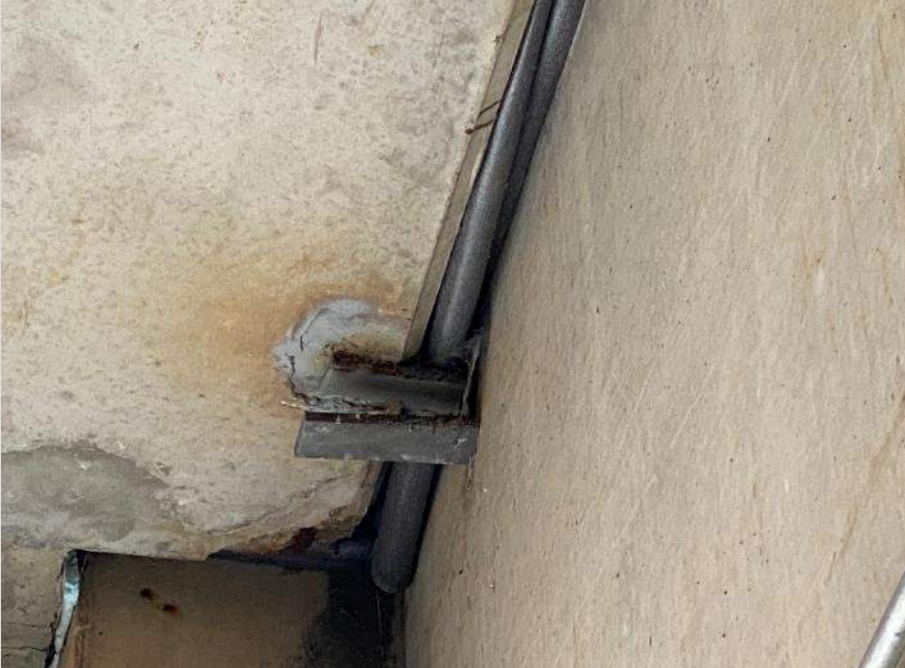
Photo 25 – Broken double-tee to wall connection observed.

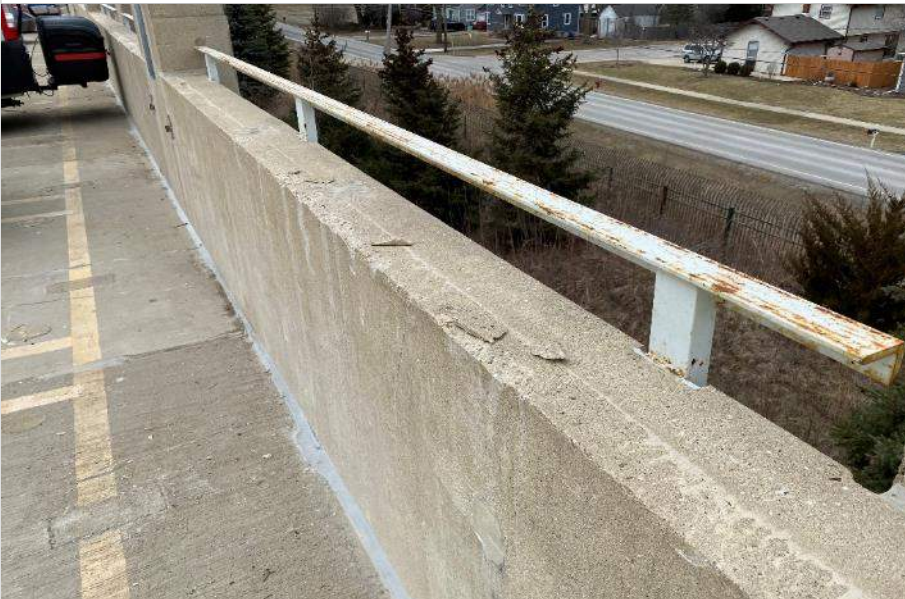
Corrosion was observed on the metal guardrails anchored to the top of the precast wall along the north elevation of the structure. We recommend that the guardrails are cleaned and painted to avoid further corrosion. It is crucial that guardrails that contribute to the fall protection system of the Upper Level are properly maintained.

Photo 26 – Metal guardrail attached to top of precast wall along north elevation corroded.

1. Clean and paint metal guardrails anchored to the top of the precast wall along the north elevation exhibiting corrosion.
