Re: Well 23

CITY OF AURORA WELL #23 PUMP INSPECTION REPORT

JOB NAME	Aurora		WELL	23	DATE	1/28/2021
JOB NO.	108747	INSPECTED BY	J. Gilchrist, J. Kopp			
		BOWL ASSEMBLY	Byron Jackson 11 stage 13MQ/12MQH all bronze			
		COLUMN ASSEMBLY	903' of 8" T&C Line Pipe, SRL			
		MOTOR	Byron Jackson 350 HP, 17", 2300V, Type M			
MOTOR						
Motor Observations						
The motor windings meg dead short.						
Motor Recommendations						
Send the motor to Flowserve for inspection, report, and probable exchange motor replacement.						
BOWL ASSEMBLY

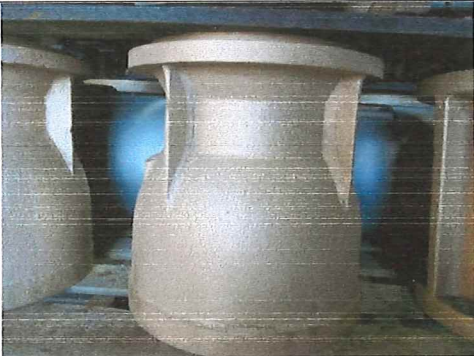
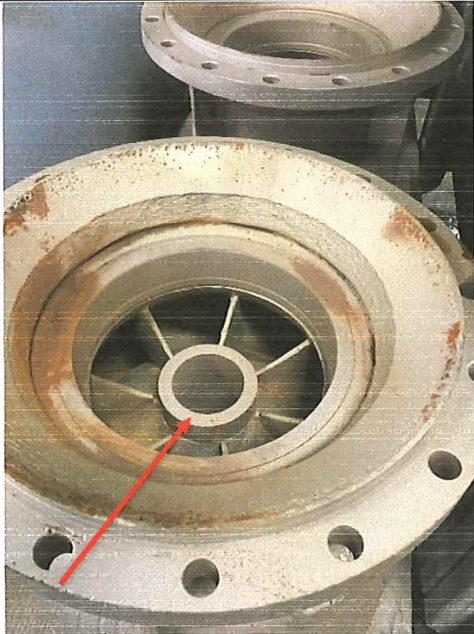
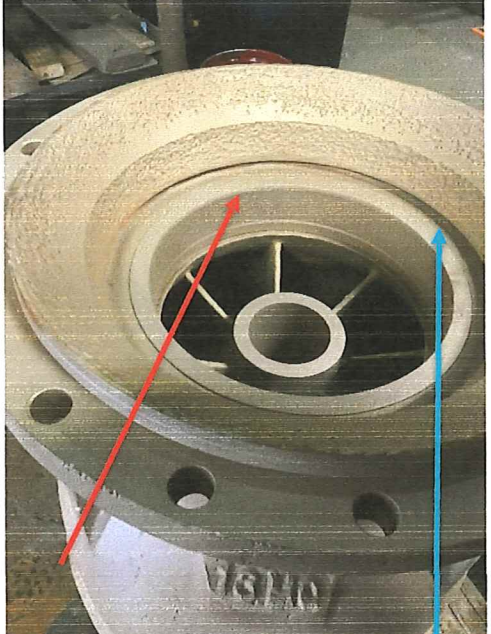
The bronze bowl exteriors are in excellent condition.		Bowl bushings exhibit minimal wear and all are within specified tolerance.		Wear ring clearances exceed acceptable tolerances and range from .059" to .084". There is moderate undercutting in the volutes above the wear rings (Typ.).

Replace ten impellers with good used. True the impeller skirts and bore wear rings to fit for proper running clearances. Replace stainless lock washers. Apply ceramic coating to the bowls' lower and upper sections, particularly in the undercut areas on the volutes.

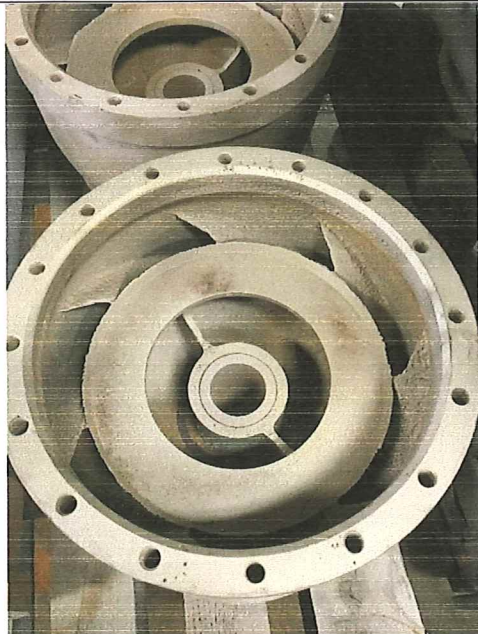
The casting interiors are in good condition (Typ.)

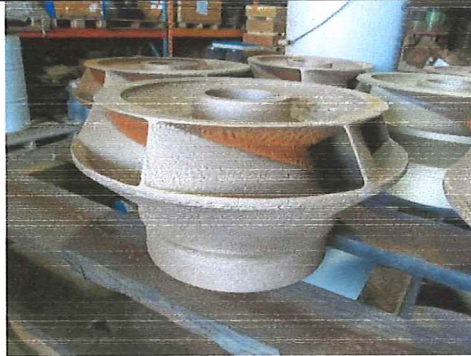
Ten of the eleven impellers have thin cross-sectional measurements...

This all bronze bowl was installed in Well 23 in 1985. According to Layne records, it had previously been installed in Well 16. The bowl's bronze casting are in very good condition. Ten of the eleven impellers are showing their age with thinning skirts structural members and general metal loss deterioration. The eleventh impeller was installed as a good used impeller during the 2015 repair, replacing one impeller at that time that was also thin and worn. The impeller shaft is in good condition. The bushings are in good condition and meet clearance specification. The wear rings exceed acceptable clearances. The stainless steel strainer and fittings, with the exception of the lock washers, are in good condition. Reference attached Bowl Inspection Report.

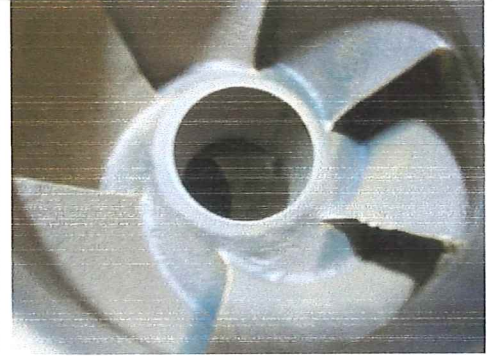
...and moderate vein tip deterioration.

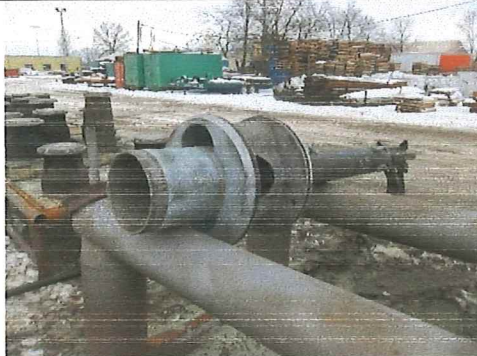
22x22 Baker pitless spool and lift out assembly after sandblasting

Consider televising the interior of the pitless body to confirm if it remains in good condition and capable of sealing the spool port discharge. Consider replacing the spool and lift out assembly with a new unit versus replacing the ex-heavy nipple and applying an epoxy coating to the current spool.

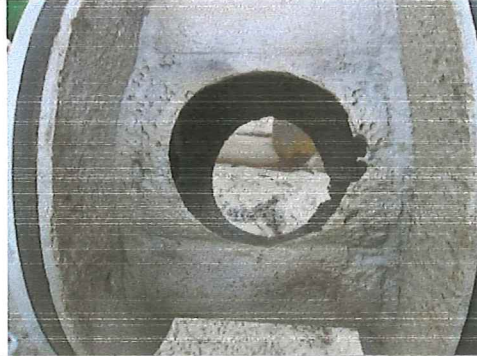
Spool ports have heavy corrosion at their edges.

The round ports in the spool have heavy corrosion on their edges. The interior of the spool and the spool flanges have moderate pitting but the corrosion does not appear to threaten the spool's integrity. The flanges' o-ring slots are in good condition. The worst of the spool's corrosion is at the spool port edges. The spool structure that is vital to sealing the spool within the pitless body has some corrosion but is still functional. The 2015 TV survey showed the interior of the pitless body in good condition.

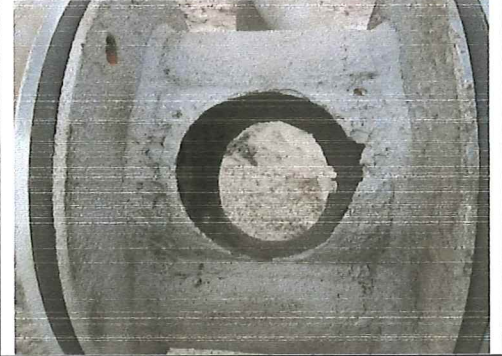
Same, opposite port.

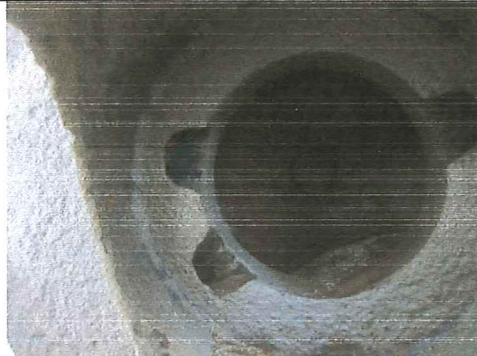
Interior of the spool has moderate metal loss

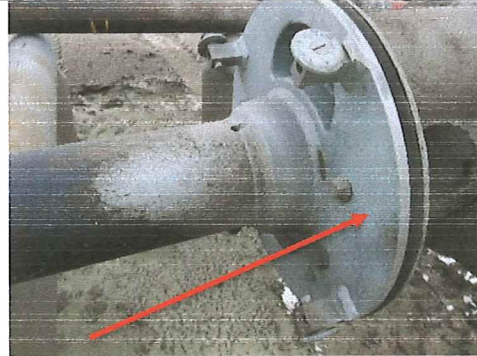
Outside o-ring flanges are in good condition (typical of both)

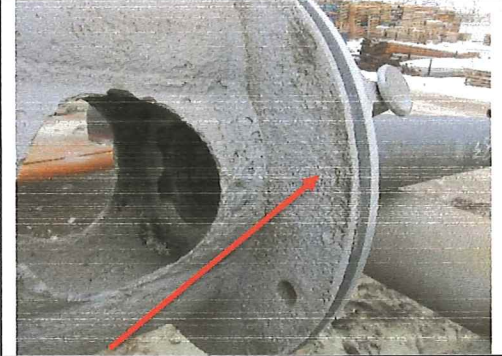
Interior o-ring flanges have moderate pitting (typical of both)

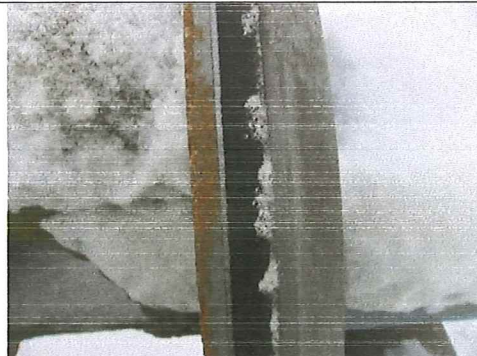
O-ring slots are in good condition (typical of both)

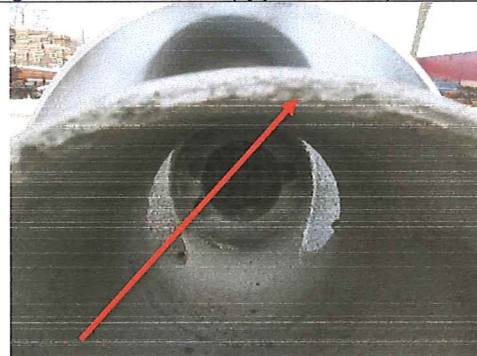
The ex-heavy 10" nipple face is heavily pitted.
