Re: River Intake Booster Pump 5

## CITY OF AURORA RIVER INTAKE 5 PUMP INSPECTION REPORT

JOB NAME	Aurora	River Intake	5	DATE	09/23/2021
JOB NO.	1135081	INSPECTED BY	J. Kopp		
		BOWL ASSEMBLY	Byron Jackson 1 stage 18KXL		
		COLUMN ASSEMBLY	16'-11" of 12" flanged x 2 1/2" x 1 11/16"		
		MOTOR	US 100 HP, 460V, VSS		
<b>MOTOR</b>					
<b>Motor Observations</b>					
The US 100 HP VSS motor was left on site for City motor service pick up.					
<b>Motor Recommendations</b>					
Per motor service					
<b>BOWL ASSEMBLY</b>

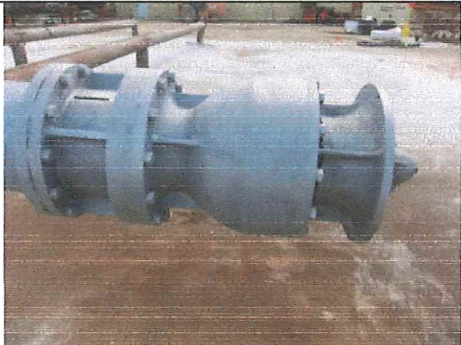
Side view of bowl after sandblast		Suction casting and bell end.		Suction casting.

The 1 Byron Jackson stage 18KXL impeller has a 10.50" impeller trim. The shaft projection is 14" (1 11/16" 8THD) and the oil tube projection is 11". The suction casting is destroyed due to cavitation wear at the volute. The stainless suction screen is in good condition.

Replace bowl reusing stainless suction screen.

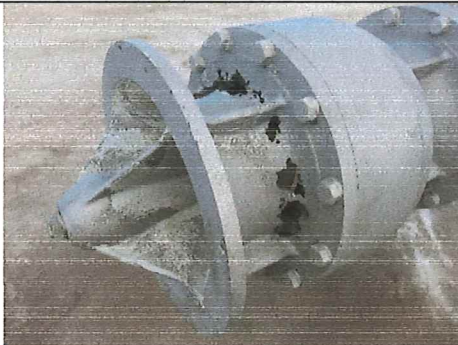
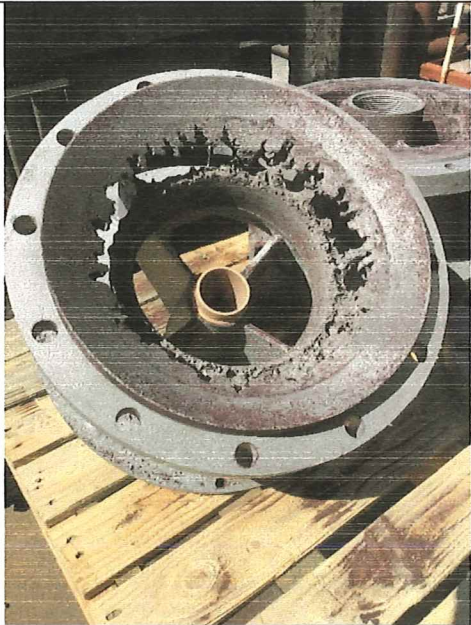
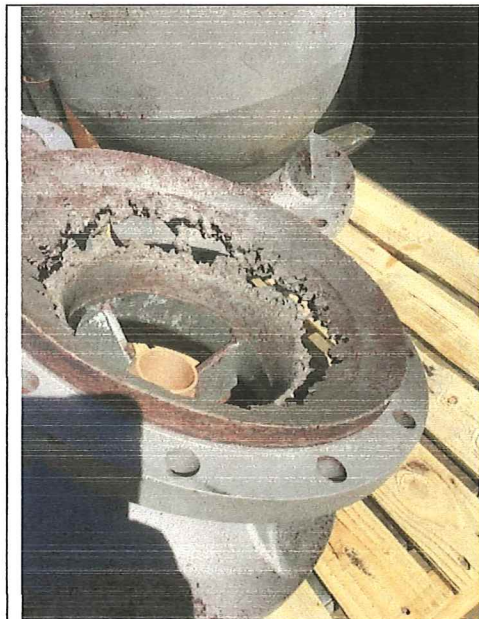
Suction casting.

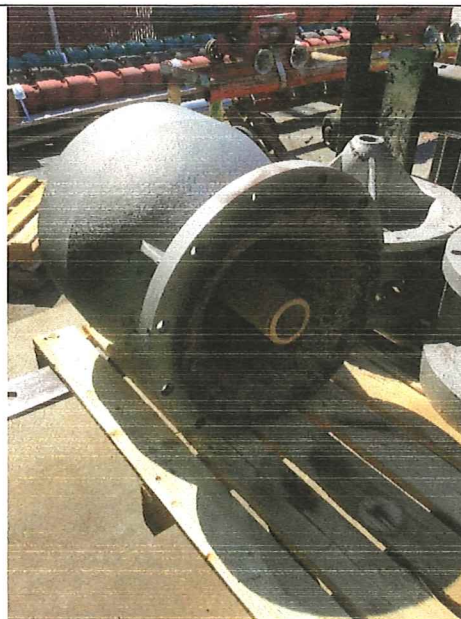
Intermediate casting

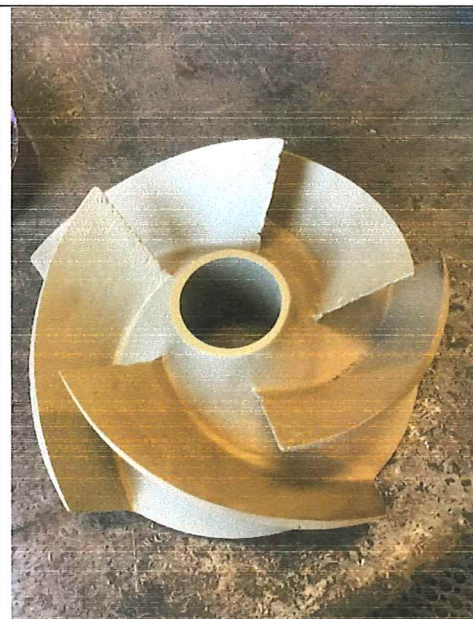
Impeller.

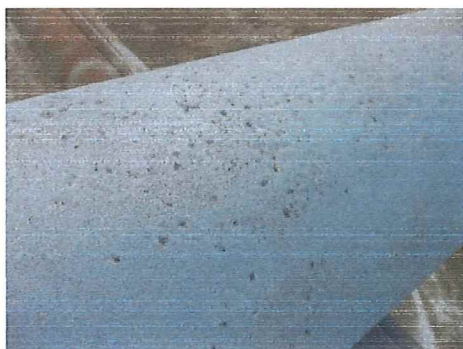
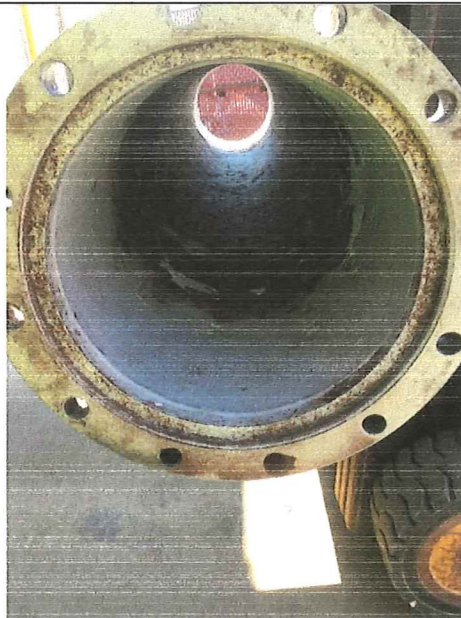
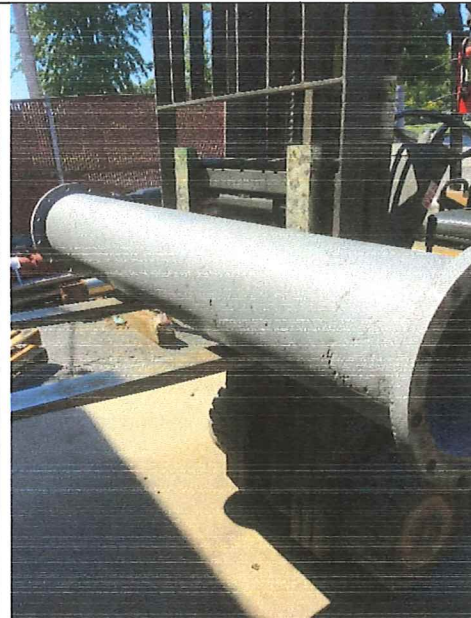
12" column exterior – typ.

The 12" flanged column show wear but appears OK for reuse with secondary blasting to remove the residual build up inside and application of steel epoxy filler to divots/pits on exterior and epoxy coat to OD and ID.

Apply steel epoxy filler to divots/pits on column exterior. Epoxy coat column OD and ID.  
Replace head shaft.  
Replace all tubing and support spiders.

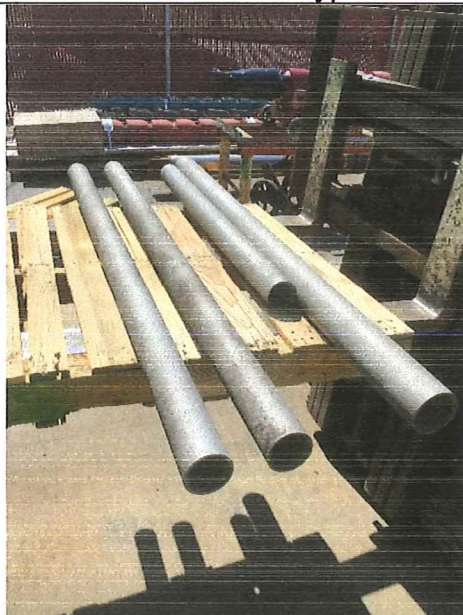
"Oil" tubes exterior

All tubing needs to be replaced due to excessive pitting/erosion on the interior. Tubing bearings are OK for reuse. The inner column spyder supports are in very poor condition.

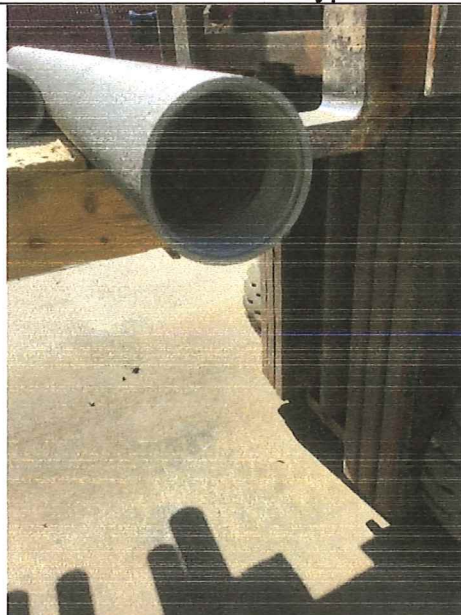
"Oil tube threads, typ.

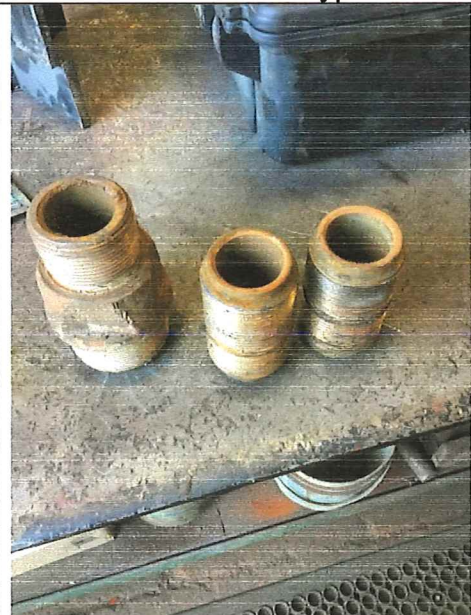
Tube bearings

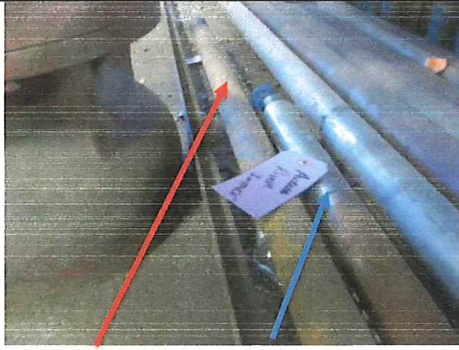
Intermediate and head shafts

Intermediate shaft (1 11/16" – 8 THD x 10' SST) appears reusable with complete polish and check for straightness. Head shaft (1 11/16" – 8THD x 100 1/4" SST) needs to be replaced due to excessive pitting at the top of the shaft. (Custom fit for 4-piece solid shaft coupling.) Shaft couplings OK for reuse with clean.

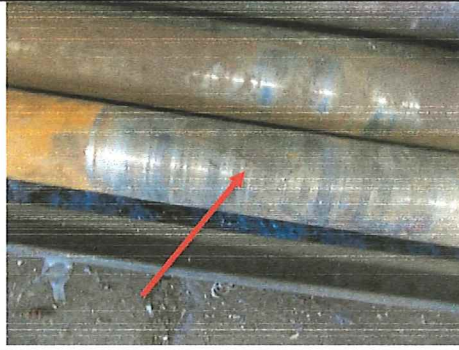
Light grooving on intermediate shaft

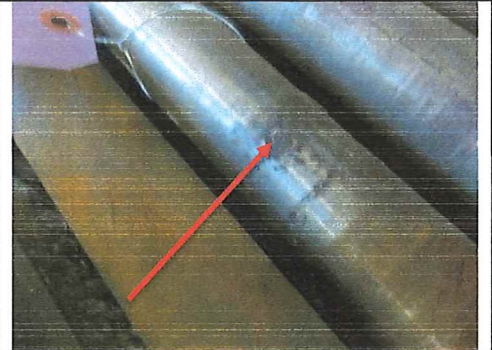
Heavy pitting on head shaft

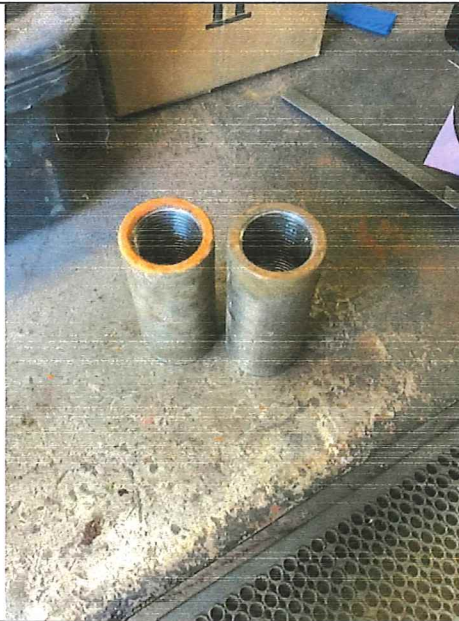
Shaft couplings

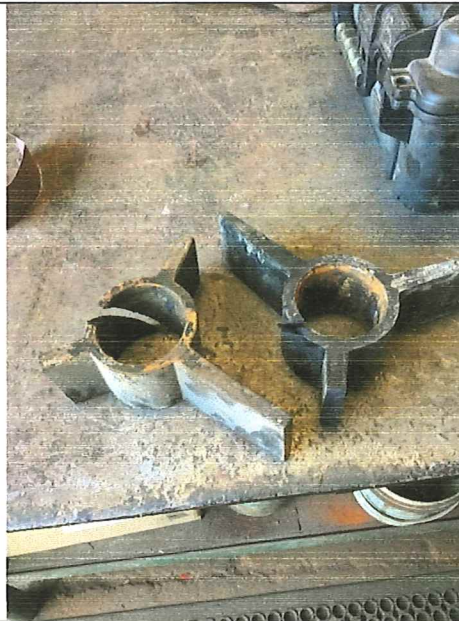
12" x 2 1/2" inner column support spyders

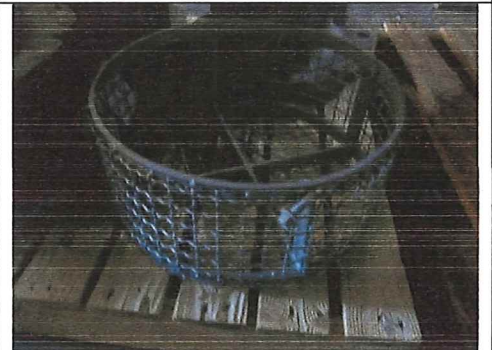
Stainless basket strainer

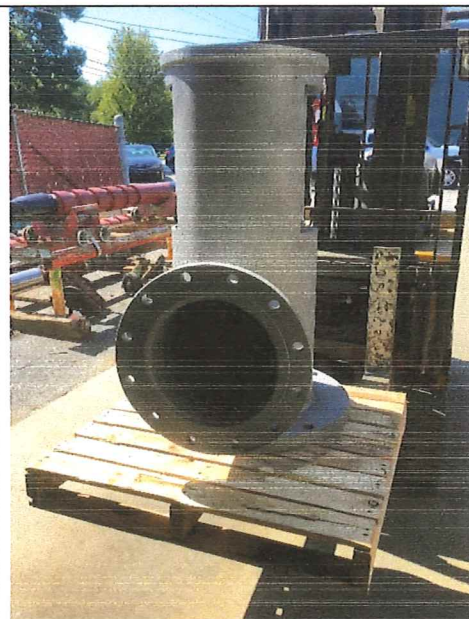
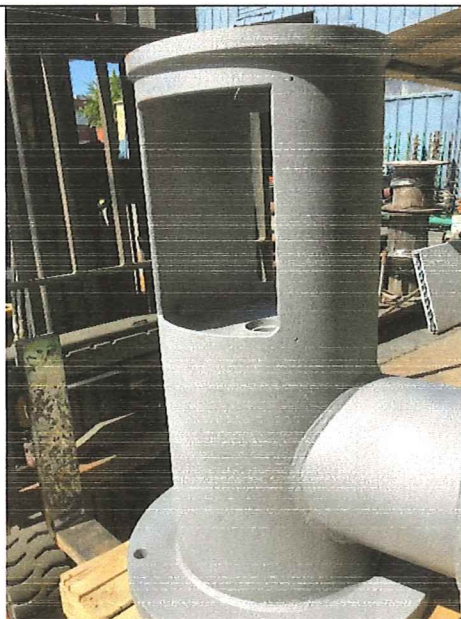
Dischagre Head

Discharge Head

The discharge head is OK for reuse. The mechanical seal is in poor condition.

Standard recondition of flanged face. Epoxy coat ID and exterior of the head inside the rotating safe guards. Replace or rebuild mechanical sleeve.

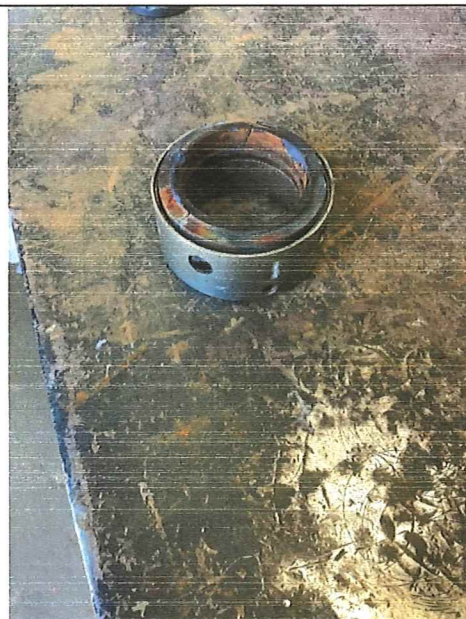
John Crane mechanical seal component
