Aurora West Dam and Canoe Chute Inspection Report

PRELIMINARY
November 25, 2020
City of Aurora
West Dam and Canoe Chute Inspection
RS&H No.: 113-4293-001

Prepared by RS&H, Inc.
at the direction of
The City of Aurora

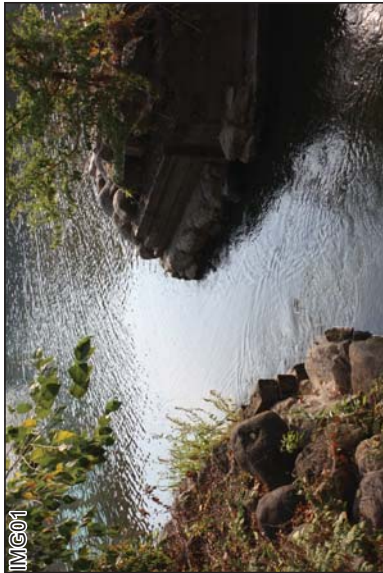
IMG01: Canoe Chute Inlet

The inlet structure was observed to be in good shape. The slots in the timber on the east and west side of the inlet structure appeared to be in satisfactory condition but can trap debris.

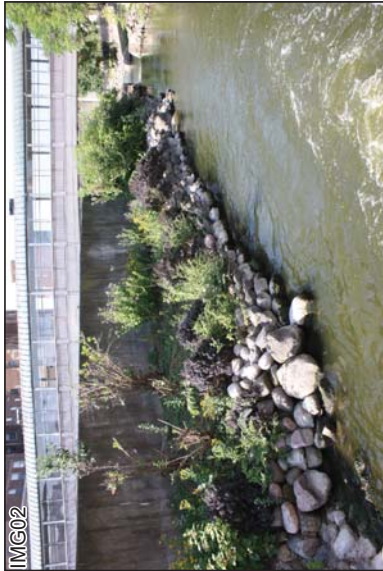
IMG02: Canoe Chute Channel & East Wall

The geotechnical investigation did not identify any visible areas of seepage along the east wall but recommended removal of shrub overgrowth along the bank to provide an unobstructed view of the bank to note potential seepage locations. The dive inspection also included an overall inspection of the Canoe Chute and the drop structure bottoms (see Photo CC-4). The bottoms of the drop structures are composed of concrete and no erosion was observed. Repairs and maintenance of the Canoe Chute is discussed in the next section.

2. The banks of Canoe Chute should have the shrub overgrowth removed and managed as well as the large tree on the west bank removed. The roots of the unmanaged vegetation can pose potential damage to the walls, especially to the east wall. Roots along the east wall may lead to seepage. Overgrowth on the east wall along with the roots should be removed and the voids filled. The removal of the overgrowth on the east wall bank will also allow maintenance of potential seepage issues observed in future inspections.

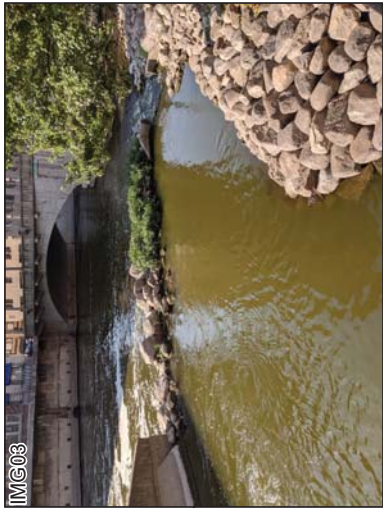
IMG03: Canoe Chute Outlet & Spillway

DS5 was observed to have some minor erosion issues on the downstream side. The west side of the structure and the west wall show concrete cracking. Additionally, there were branches caught along the upstream side of this structure. The downstream pool connects to the chute outfall and there is a spillway along the east side of the chute to the Fox River. This spillway appeared functional; however, the grading of the top of the spillway was irregular.

The outlet to the Canoe Chute had numerous dislodged stones but did have a clear outfall channel to the Fox River. A pipe outlet along the west wall appeared to be in satisfactory condition, although the source of the pipe outlet is unknown.

6. The spillway just upstream of the outlet should be regraded or have stones reset to create a uniform spillway crest.
7. The construction joint of the Canoe Chute East Wall on the Fox River side where seepage was observed should be sealed as necessary if this joint is unable to be fully sealed in (4). The undermining voids located at the downstream toe are not believed to pose an
