Re: NP3 Repairs

CITY OF AURORA
 WTP NP3 PUMP
 INSPECTION REPORT

JOB NAME	Aurora NP3	WTP Booster	NP3	DATE	10/05/16
JOB NO.	42647	INSPECTED BY	J. Poppen, J. Kopp, B. Balluff		
		BOWL ASSEMBLY	Byron Jackson 2 stage 18KXL		
		COLUMN ASSEMBLY	18' 3 1/4" of 12 x 2 1/2 x 1 11/16 flanged in two pieces		
		MOTOR	US 200 HP, 460V VHS

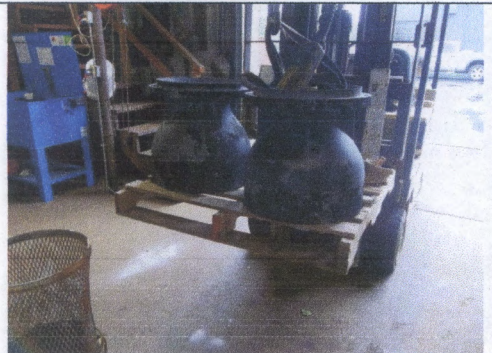
Two intermediate 18KX castings in Layne shop with moderate to severe exterior erosion.

Bowl castings have moderate severe exterior corrosion and the interior of the suction casting is severely corroded. The bowl is to be modified with larger diameter impellers to meet a COS of 3000 GPM at 223' TDH

Replace bowl with impellers trimmed at 11.68"

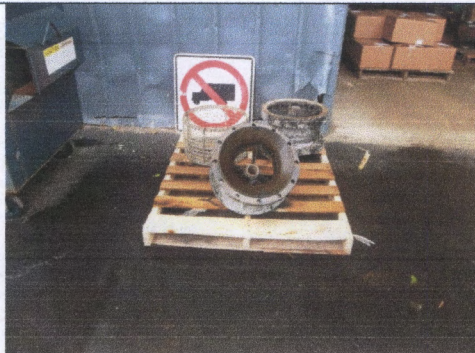
Suction casting, discharge casting, and basket strainer in Layne yard. Basket strainer is in good condition.

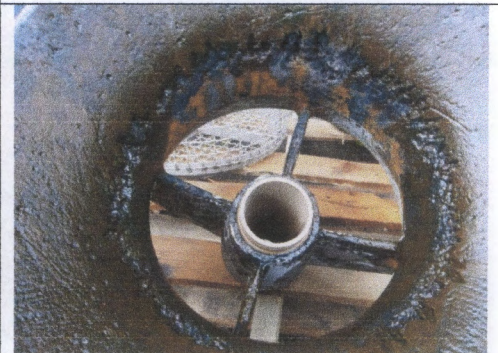
Severe pitting and erosion in suction casting interior.

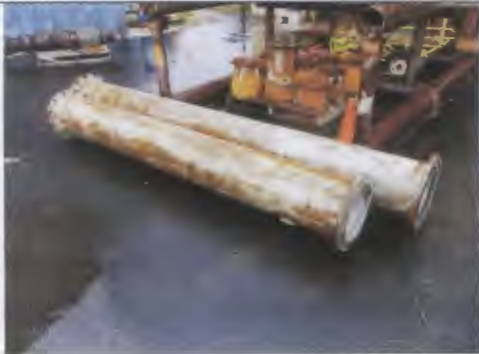
NP3 flanged column pipe racked in Layne yard. One 10' length, one 8' 3 1/4" length.

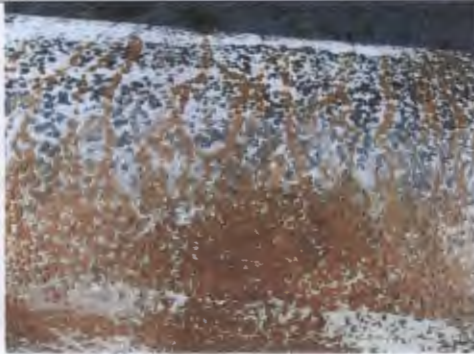
The 10' length has a "rash" of pitting throughout its length...

The upper 12" flanged column has mild exterior pitting. The lower 10' length of 12" flanged column has moderate pitting throughout with numerous severe pits. The length of 10' column section had extremely close tolerances with the Plant's overhead crane when removed. The line shaft was very difficult to extract from the oil tubing indicating heavy buildup of scale/or corrosion in the interior of the tubing (confirmed). This is undoubtedly the primary cause of the pump's vibration. The top shaft is heavily scoured at the mechanical seal journal. The lower shaft has some wear at the bearing journals.

Replace the 12" x 10' flanged column. Replace all tubing, bearings, and top shaft. Reinstall pump with lower shaft end-for-end.

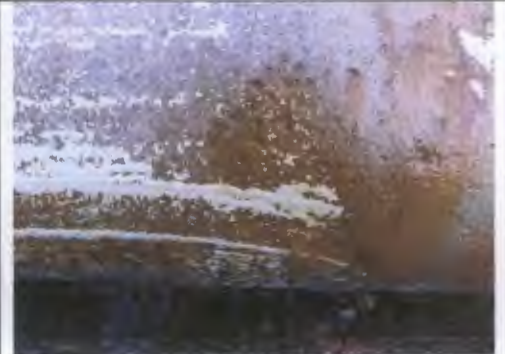
...with numerous deep pits.

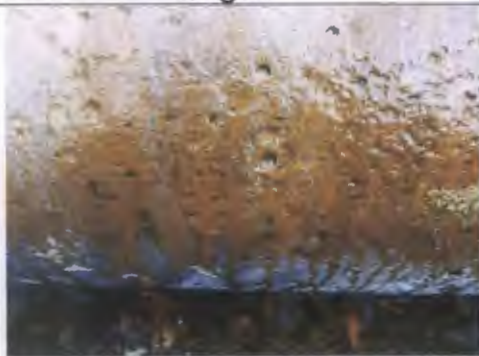
Deep pits on 10' length.

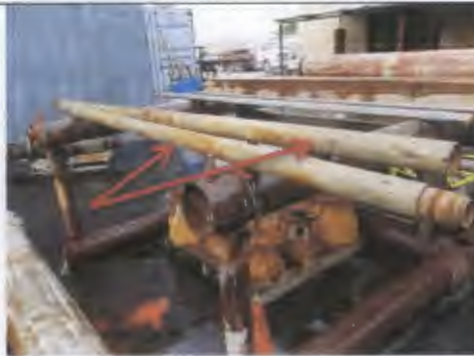
NP3 oil tubing racked in Layne yard.

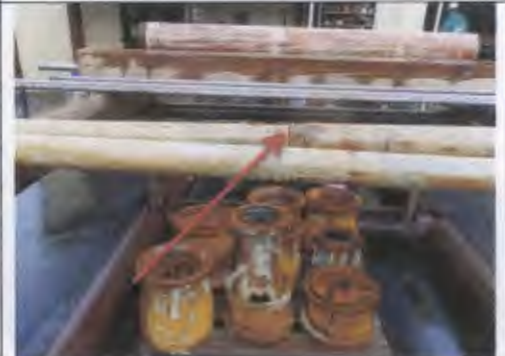
NP3 tubing illustrating 3 x 2 1/2 transition

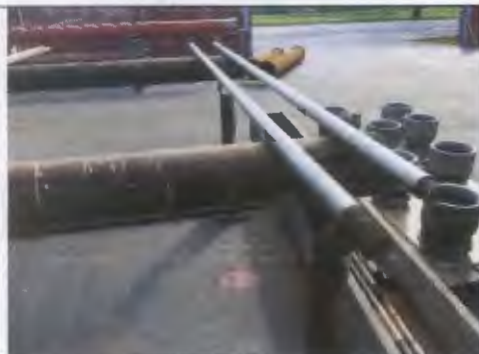
Shafts racked in Layne yard after clean up.

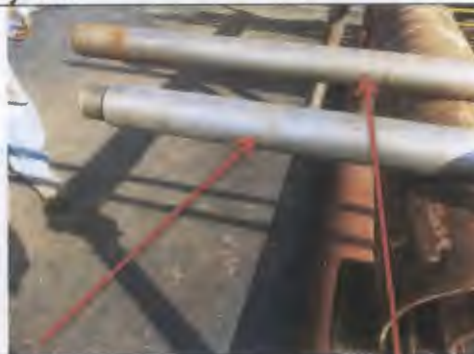
Heavy scouring at seal location on top shaft. Lower shaft has some wear at bearing journals.
