Re: Well 28

## CITY OF AURORA WELL #28 PUMP INSPECTION REPORT

| JOB NAME | Aurora | WELL | 28 | DATE | 01/13/2020 |

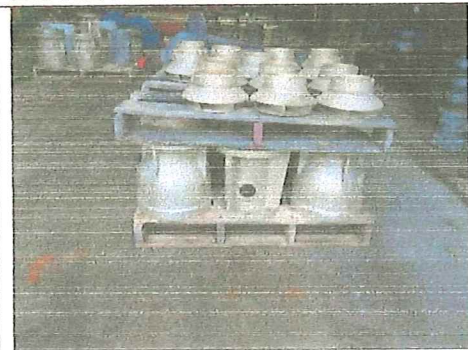
Byron Jackson 13MQ/12MQH all bronze bowl assembly components after disassembly and clean up

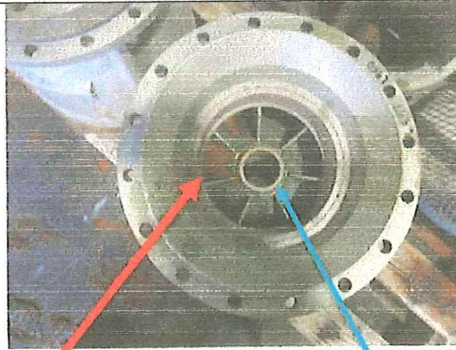
Wear ring clearances exceed acceptable tolerance. Bushing clearances on high end, or exceed acceptable tolerance. (Photo typical of all castings)

The bowl assembly is all bronze construction. All wear ring clearances exceed acceptable tolerance. Bowl bushing clearances either are on the high side of tolerance or exceed tolerance. The impeller shaft has light wear but is acceptable for reuse. The stainless fasteners and collets are in good condition. The bronze castings and impellers are in excellent condition. The stainless strainer was symmetrically "sucked in" on four sides. Reference attached Bowl Inspection report.

Rebuild bowl with custom wear rings and bushings. Replace strainer with stainless that has more inlet area.

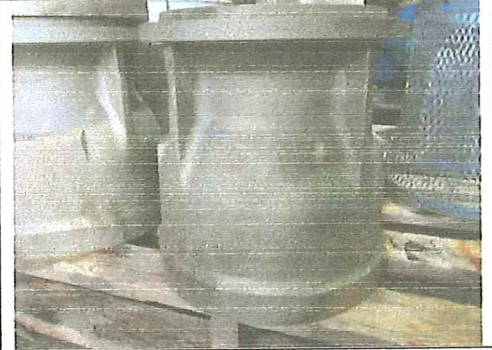
Casting exteriors in excellent shape. (Photo typical of all castings)

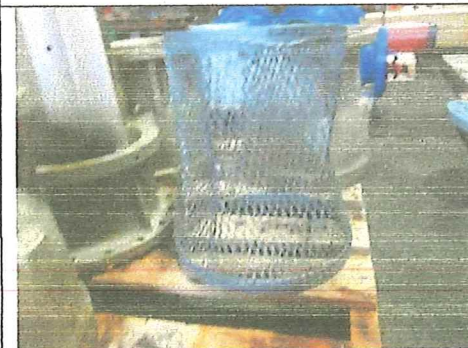
Stainless strainer symmetrically deformed.

| Strainer | SST – Appears the iron build up caused it to distort. | | | | | | |

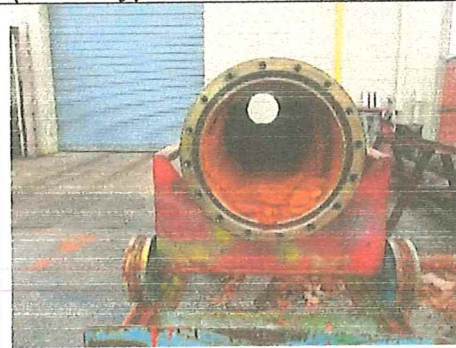
Heavy iron build up in stainless nipple off of bowl. Similar to heavy iron build up in interior of bowl assembly prior to sandblast.

- **Bronze castings and impellers are in excellent condition.**
- **Interior of bowl was packed with thick iron deposition prior to clean up.**

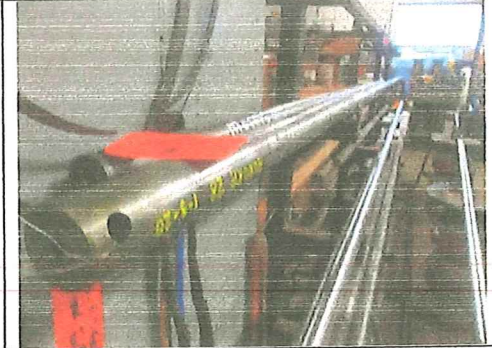
1 15/16" x 19 1/4" stainless impeller shaft.

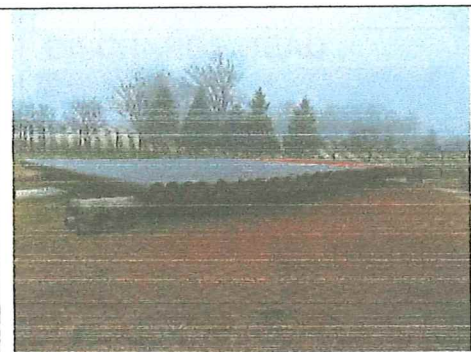
10" pipe racked on site.

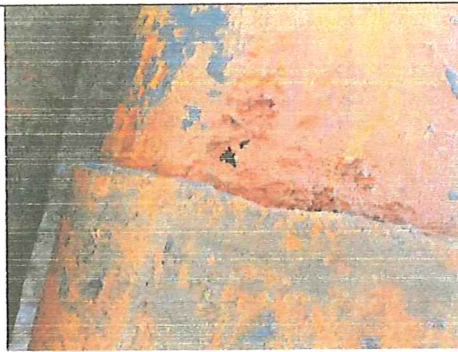
The Aurora Well 28 Byron Jackson submersible pump has been removed; 10" Line Pipe racked on site; and the bowl and motor have been inspected. Please find the Aurora Well 28 Pump Inspection Report (PIR) attached. The reason for the pump's low capacity is apparent via a large hole in the Line Pipe just below the lower surge control valve.

Hole in pipe just below lower surge control valve.

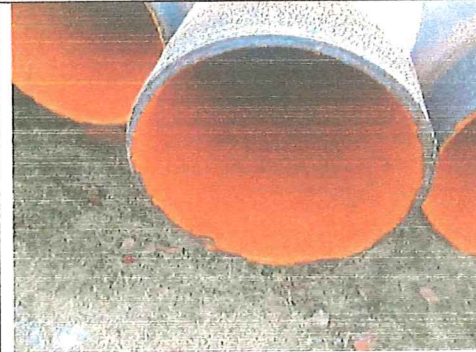
Heavy build up on pipe interior (typical of all).

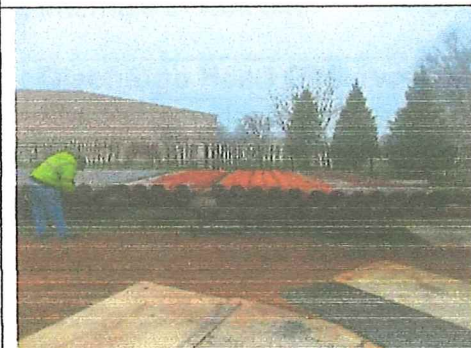
The seventeen lowest pipe joint, on right, were submerged under static water level. Build up is too heavy to determine pipe integrity prior to sand blast.

The 10" column pipe remains racked on the well site. All pipe have a heavy interior buildup of deposition. The lowest seventeen joints, which were submerged below static water level, have a moderate to heavy buildup of deposition on their exteriors. Final inspection and repair determination on these seventeen joints cannot be accomplished until they are sandblasted for inspection. A hole was

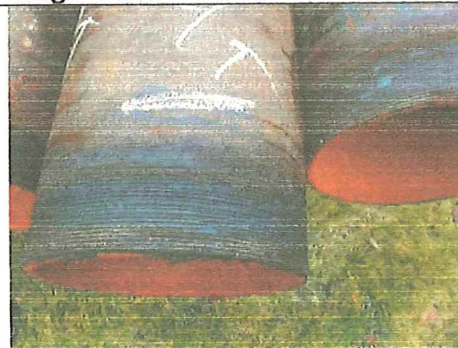
Damaged male threads above static water level. Typical of seven pipe joints.

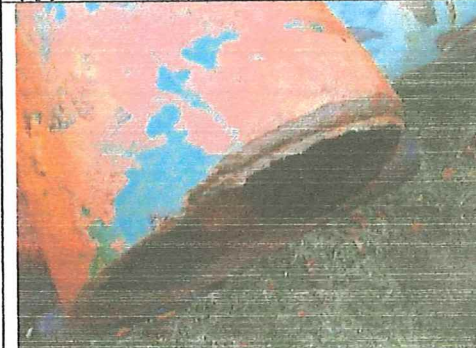
Eroded coupling above static water level. Typical of eleven couplings.
