# *AURORA WEST DAM AND CANOE CHUTE INSPECTION REPORT*

December 30, 2025  
City of Aurora,  
Kane County,  
Illinois

Purchase Order:  
311184  
RS&H No.:  
1056-0079-000

Prepared by RS&H, Inc. at the  
direction of The City of Aurora, Illinois

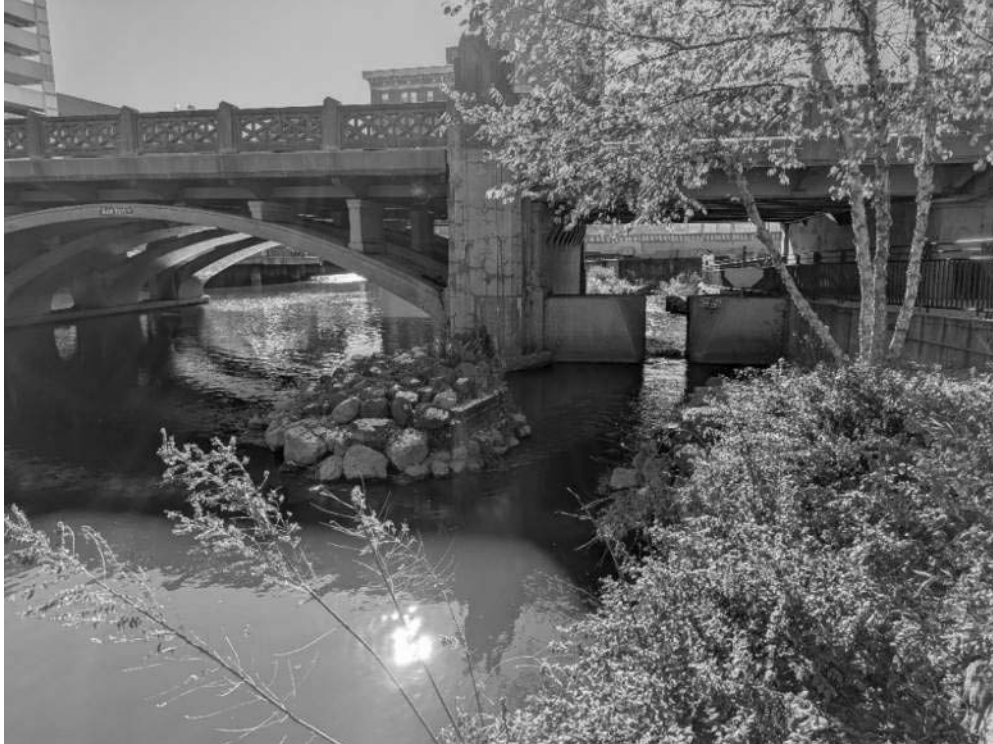
***PHOTOGRAPH IN-1: INLET STRUCTURE UPSTREAM SIDE***

The inlet structure was observed to be in good shape. The slots in the timber on the east and west side of the inlet structure appeared to be in satisfactory condition but can trap debris. See Photos **IN-1** and **IN-2**.

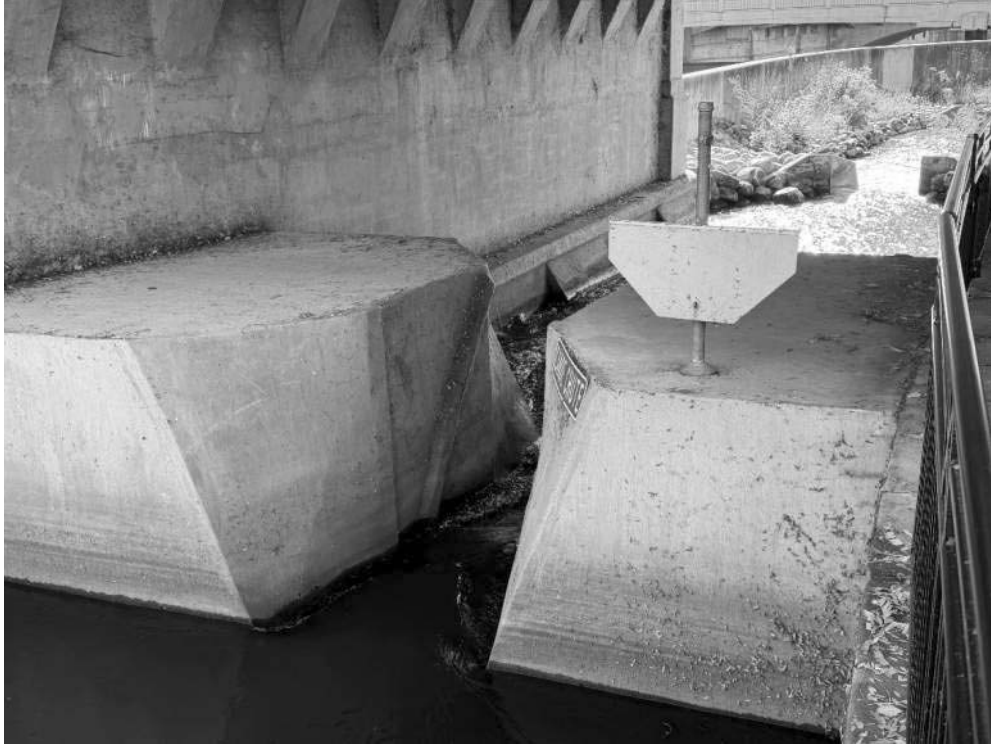
***PHOTOGRAPH DS1-1: UPSTREAM FACE OF DROP STRUCTURE 1 (DS1)***

DS1 was observed to be in good shape overall. The depth of flow through the structure was at a higher velocity, but no erosion was observed through the structure or downstream channel. The Obermeyer Pneumatic Crest Gate is situated on the downstream side of this structure, was repaired after the 2020 inspection report, and is assumed to be operational. See Photos **DS1-1** to **DS1-4**.

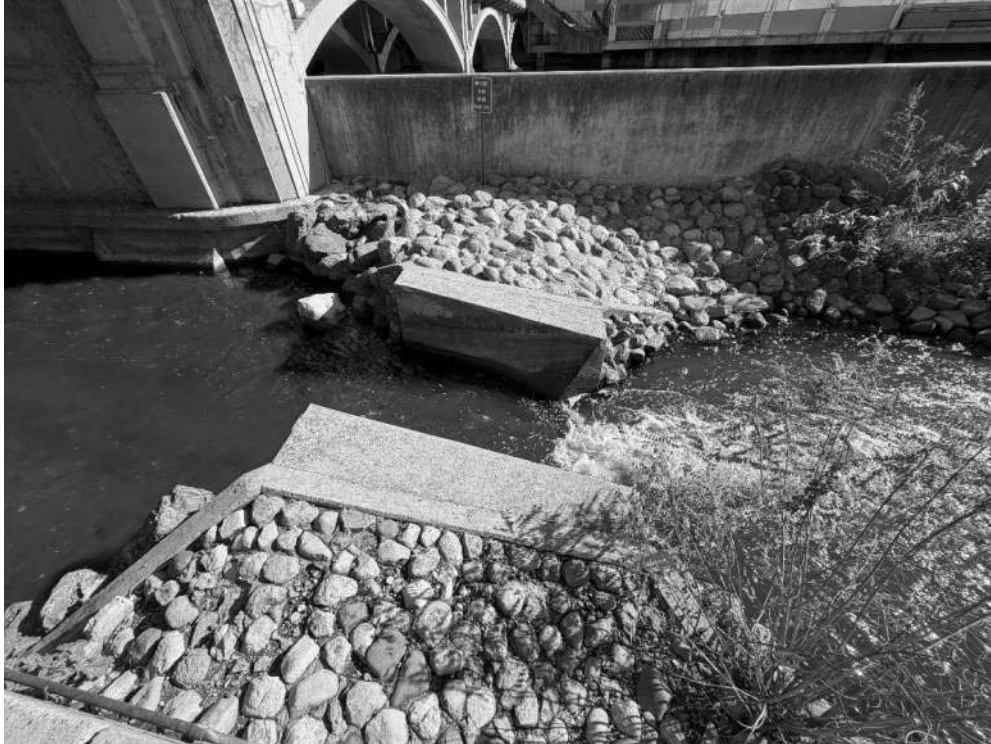
***PHOTOGRAPH DS2-1: DROP STRUCTURE 2 (DS2) OVERALL VIEW***

DS2 was observed to have damaged riprap and erosion along the upstream flares of the drop structure. There is a void between the south side of the New York Street bridge pier and the chute bank on the upstream side of DS2 (see Photo **DS2-2**) and erosion-related damage to riprap upstream and downstream of DS2. Shrubbery downstream of the drop structure is recommended to be managed. Some erosion was observed along the west sidewalk wall. Overall, the condition of the structure itself appears satisfactory. See Photos **DS2-1** to **DS2-4**.

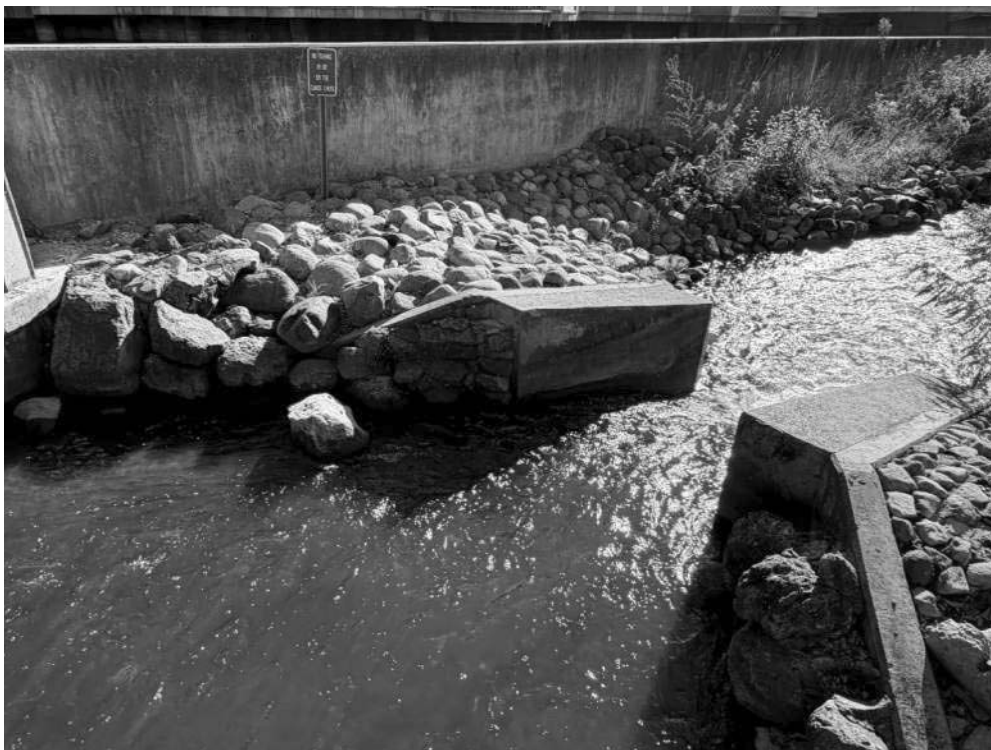
***PHOTOGRAPH DS2-2: EROSION AT DS2 UPSTREAM RIPRAP***

2. The drop structures were observed to have erosion and scour mostly along the concrete flares which included undercutting and riprap pop outs. It is recommended that void areas be filled with grout, and that riprap be reset along the concrete flares, in areas of undercutting, and along the pool walls. At the time of the inspections, pockets of branch and stone debris were noted, and these should be removed during regular Canoe Chute maintenance to keep continuous flow and prevent additional buildup in the chute. The West Dam also had two tree trunks trapped against the dam crest that should be removed.

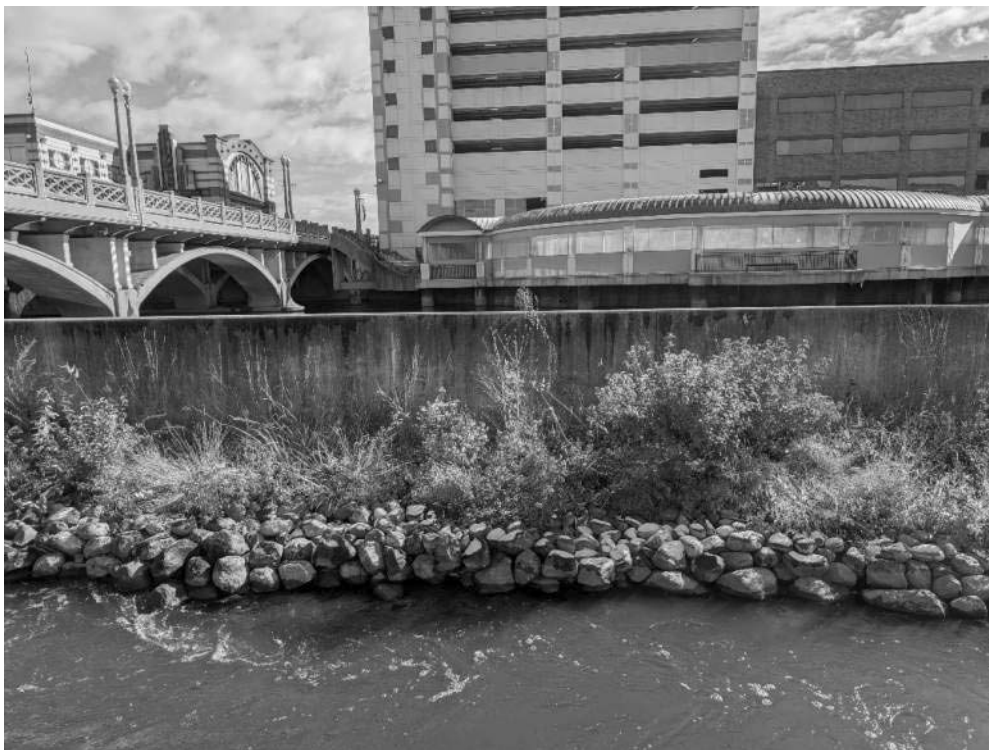
***PHOTOGRAPH DS2-4: TYPICAL CANOE CHUTE EAST WALL SECTION***

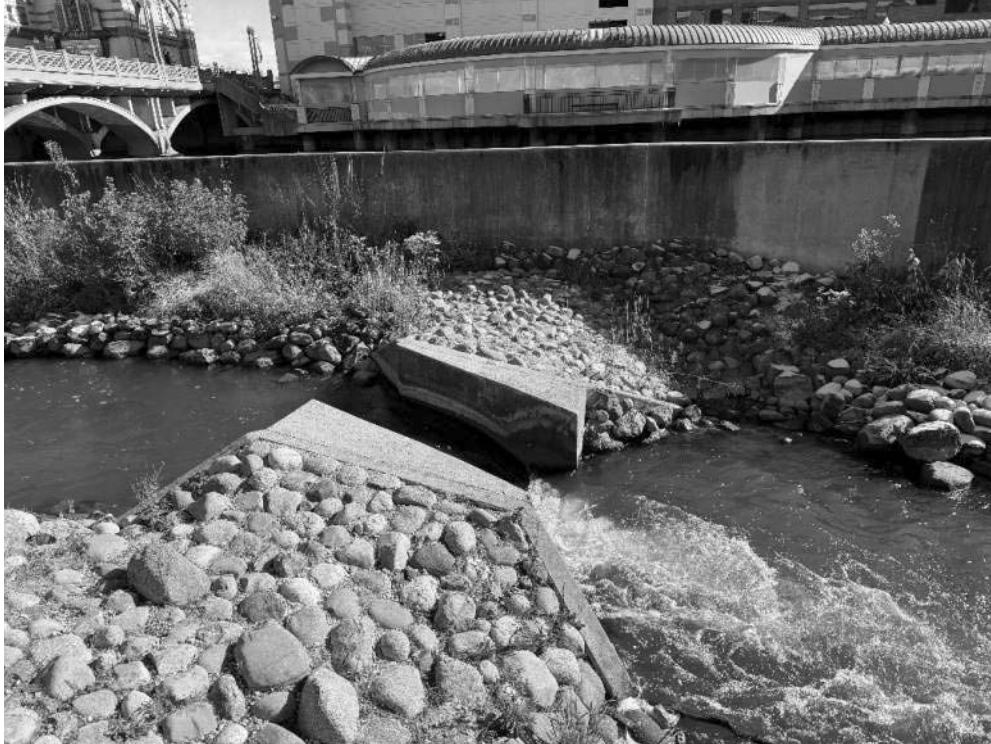
***PHOTOGRAPH DS3-1: DROP STRUCTURE 3 (DS3) OVERALL VIEW***

DS3 was observed to have some minor erosion issues on the upstream and downstream sides but was in good shape overall. Erosion has dislodged riprap as noted at other drop structure locations, creating voids in riprap. Shrubbery upstream and downstream of the drop structure is recommended to be managed. Cracking was observed along the west

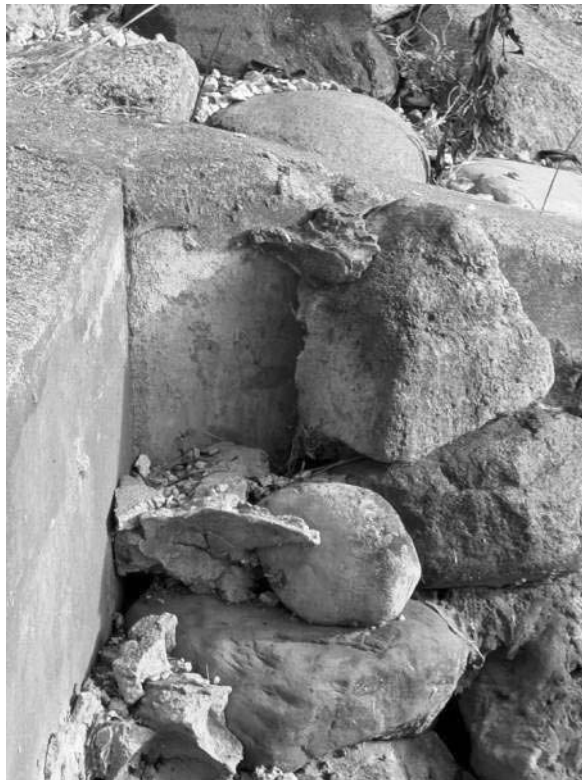
***PHOTOGRAPH DS3-2: TYPICAL EROSION CONDITION***

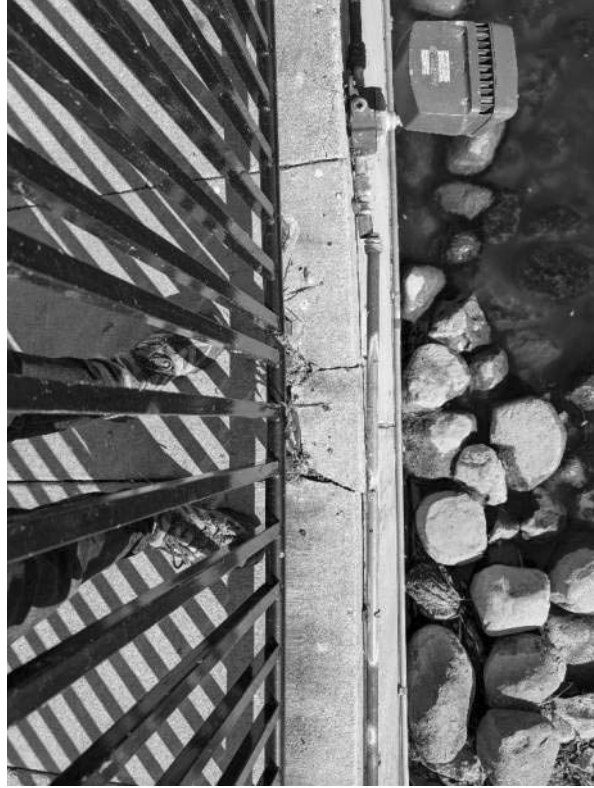
sidewalk and wall. Overall, the condition of the structure itself appears satisfactory. See Photos **DS3-1** to **DS3-4**.

***PHOTOGRAPH DS3-3: CRACKING IN SIDEWALK AT CANOE CHUTE WEST WALL***

3. The Canoe Chute East Wall was observed to have approximately eighteen hairline cracks that should be epoxy sealed on both sides of the wall. The Canoe Chute West Wall adjacent to the Fox River Trail had concrete cracking and exposed rebar that should be repaired and sealed. There are multiple areas of cracking and spalled concrete at railing post and conduit attachment points that could cause localized failures if not repaired. See Photos DS2-3, DS3-3, DS3-4, DS4-6, & DS5-4.

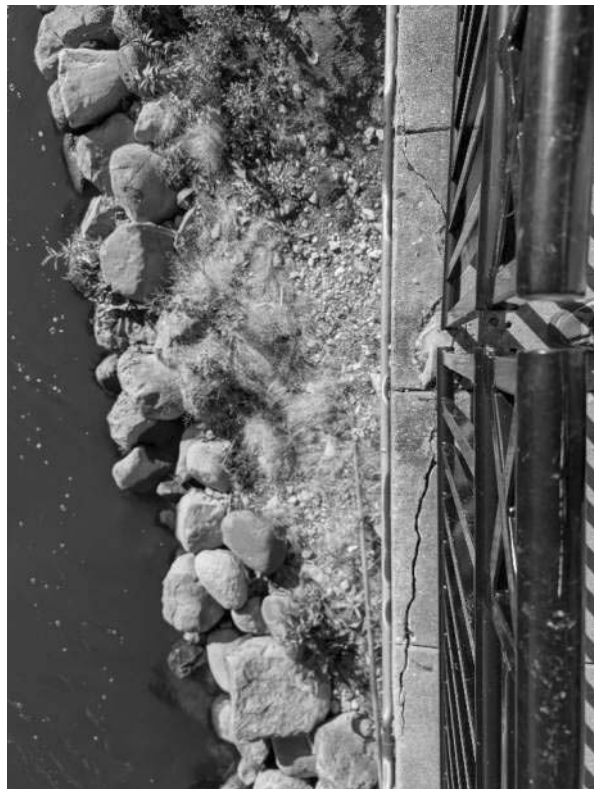
***PHOTOGRAPH DS3-4: CRACKING IN SIDEWALK AT CANOE CHUTE WEST WALL***

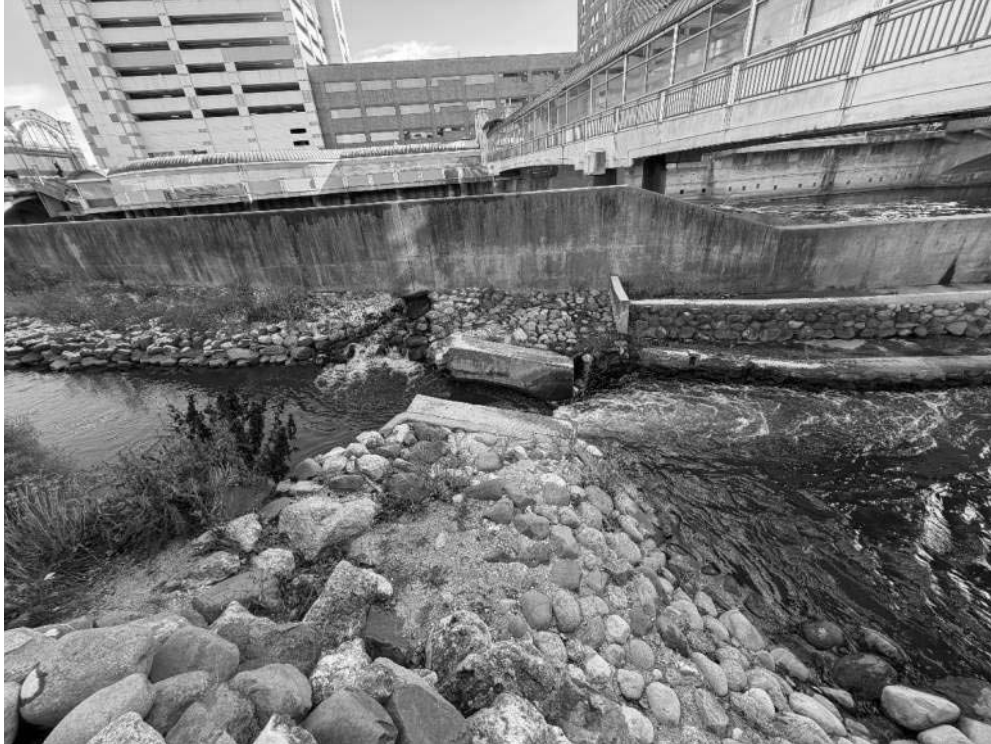
***PHOTOGRAPH DS4-1: DROP STRUCTURE 4 (DS4) OVERALL VIEW***

DS4 was observed to have active water flowing into the Canoe Chute from the Fox River on the upstream side. The water was coming into the Canoe Chute at a high volume and velocity from a void at the base of the wall (see Photo **DS4-2**). Seepage and erosion were also observed on the downstream side. Cracking was observed along the west sidewalk and wall. See Photos **DS4-1** to **DS4-6**.

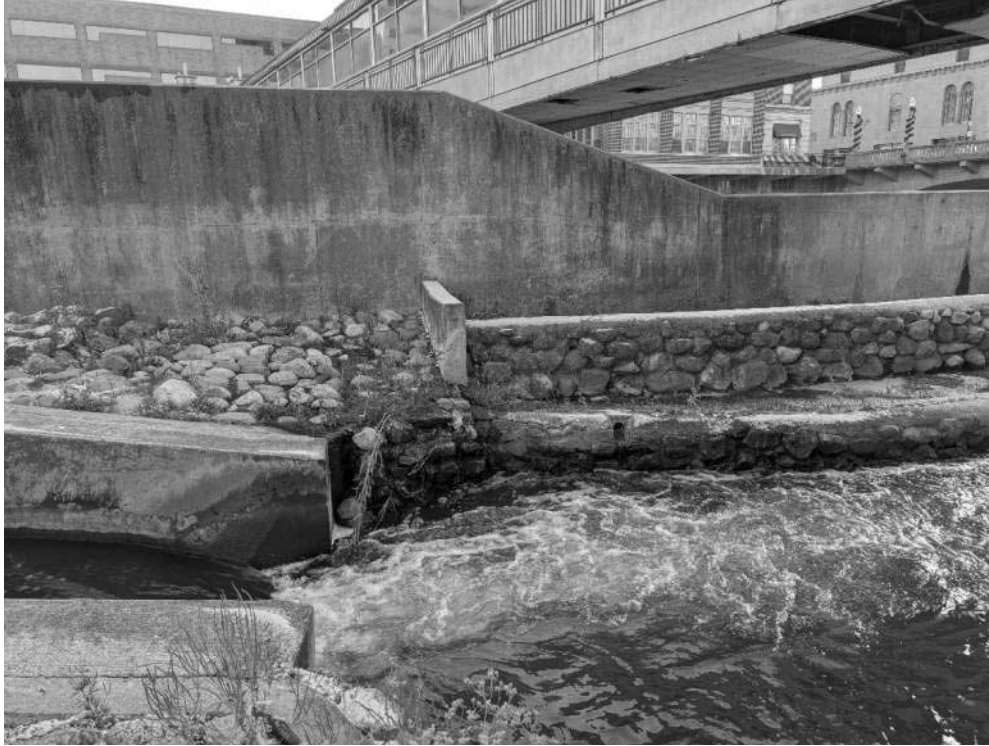
***PHOTOGRAPH DS4-3: DS4 DOWNSTREAM VIEW***

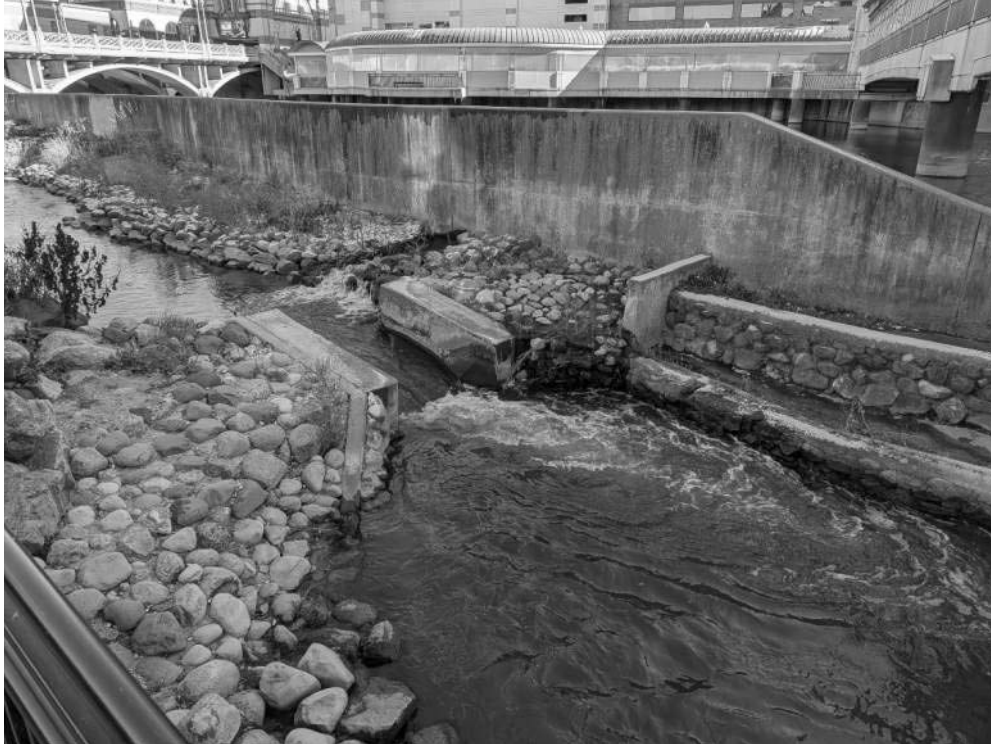
***PHOTOGRAPH DS4-5: DS4 DOWNSTREAM VIEW LOOKING UPSTREAM***

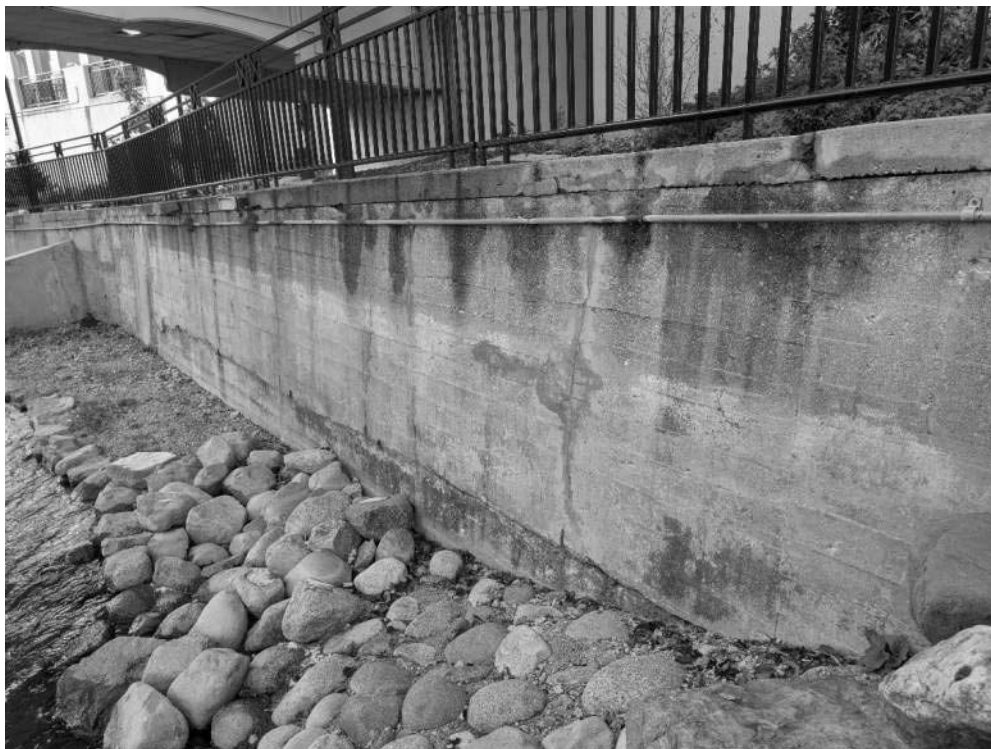
***PHOTOGRAPH DS4-6: CRACKING ON DOWNSTREAM CANOE CHUTE WEST WALL***

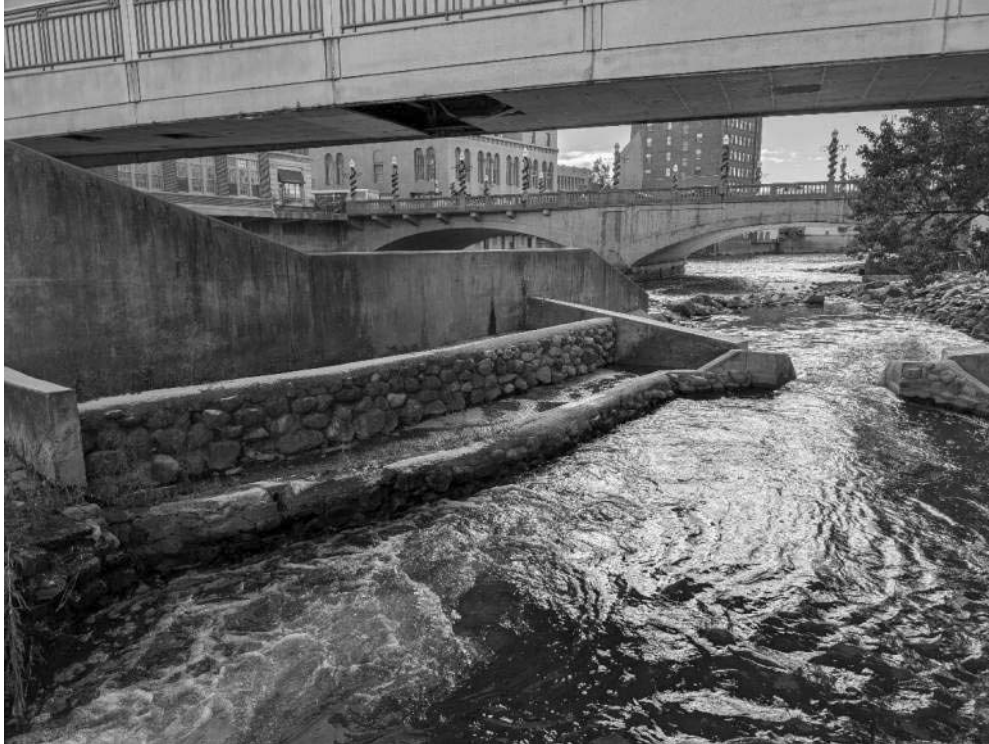
***PHOTOGRAPH DS5-1: DROP STRUCTURE 5 (DS5) UPSTREAM VIEW***

DS5 has some minor erosion issues on the downstream side. The west side of the structure and the west sidewalk wall show concrete cracking. Seepage was observed upstream of the structure along the west Fox River wall. The downstream pool connects to the chute outfall and there is a spillway along the east side of the chute to the Fox River. This spillway appeared functional; however, the grading of the top of the spillway was irregular. See Photos **DS5-1** to **DS5-4**.

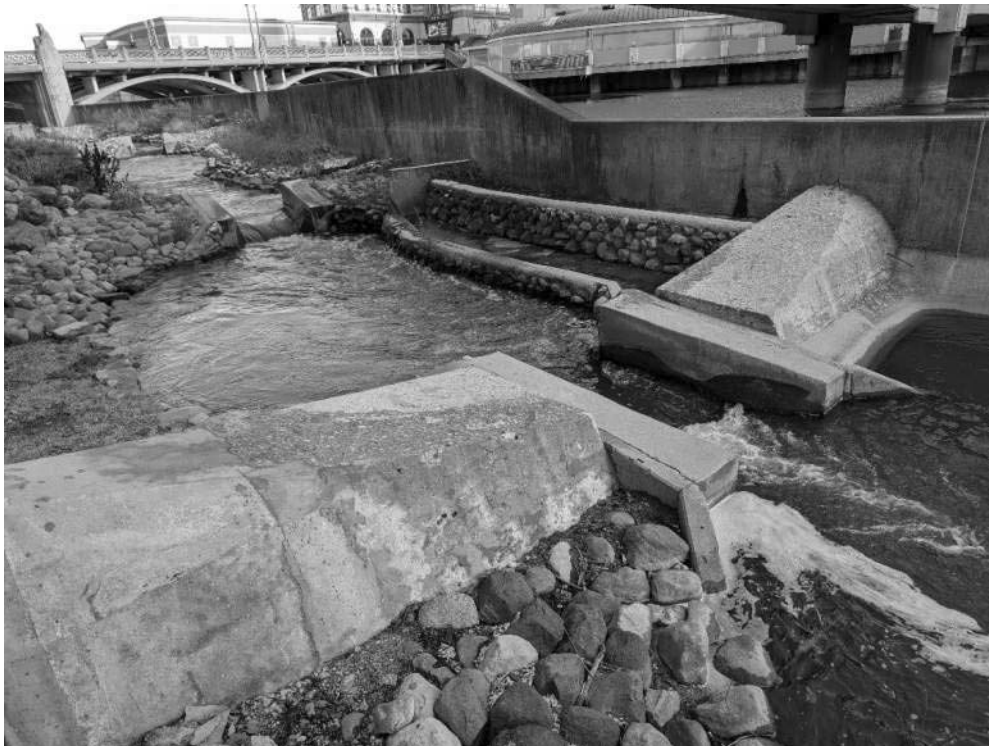
***PHOTOGRAPH DS5-2: CRACKING AND SPALLING AT DS5***

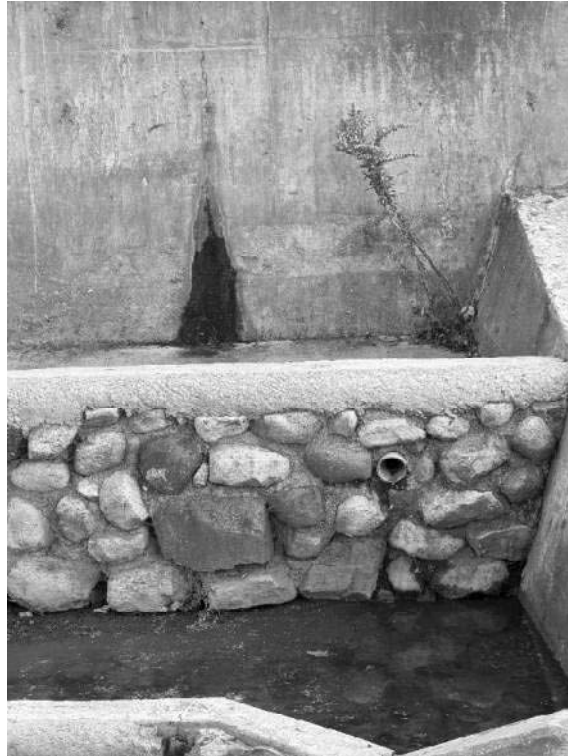
***PHOTOGRAPH DS5-3: CANOE CHUTE EAST WALL SEEPAGE UPSTREAM OF DS5***

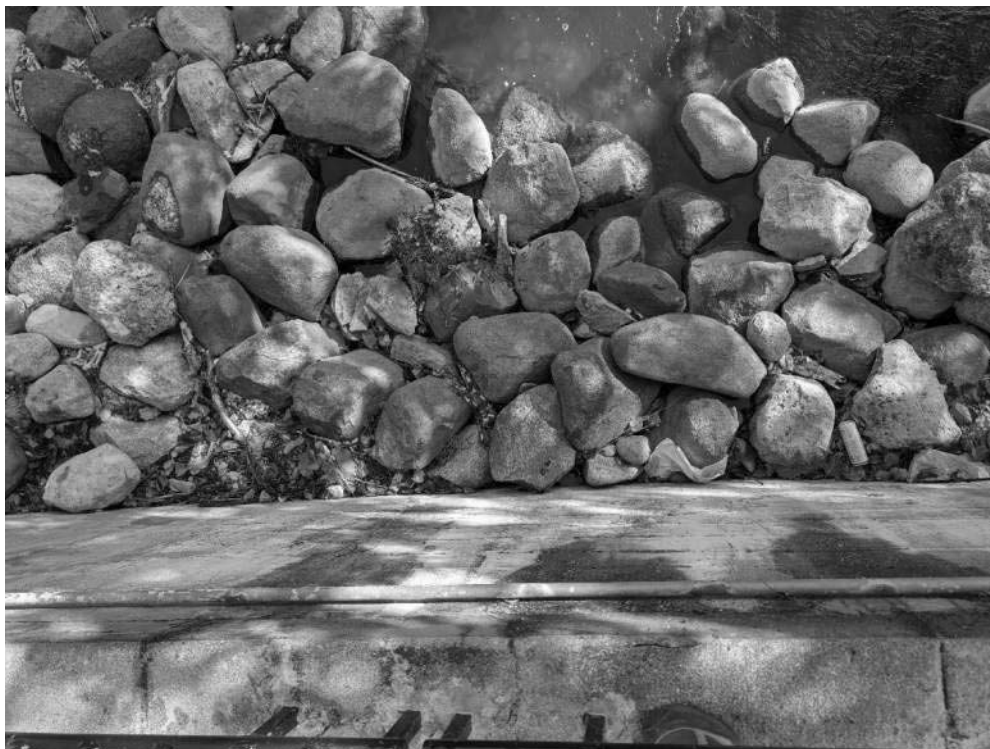
***PHOTOGRAPH DS5-4: CRACKING IN CANOE CHUTE WEST WALL***

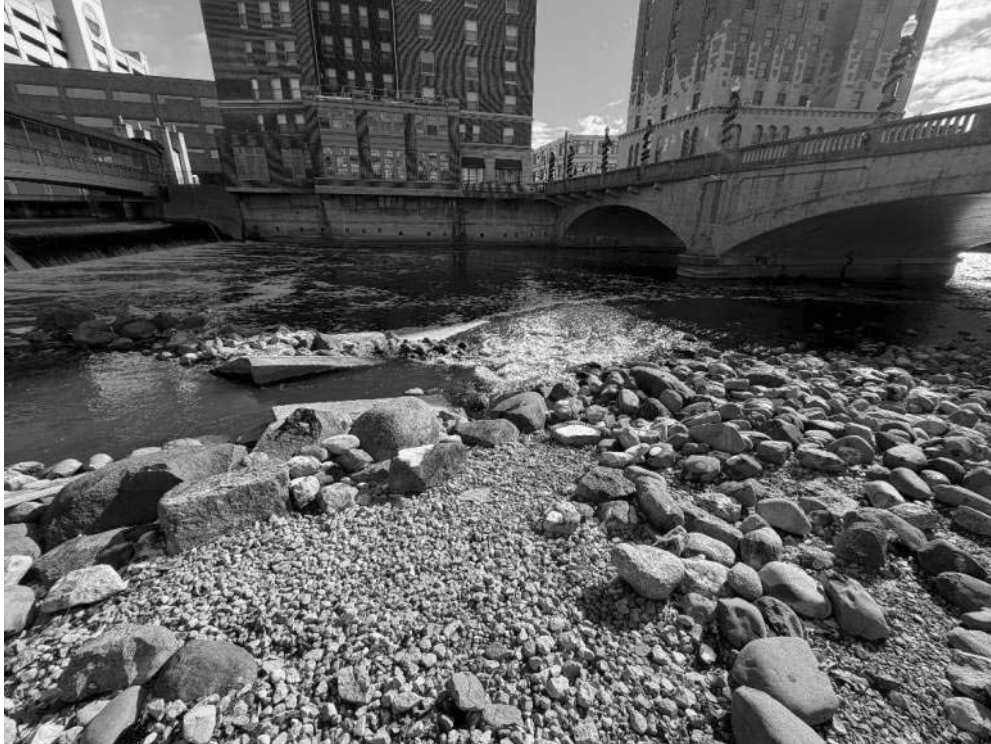
***PHOTOGRAPH OUT-1: OUTLET STRUCTURE LOOKING DOWNSTREAM***

The outlet to the Canoe Chute had dislodged riprap/concrete along the Canoe Chute East Wall, along the Fox River, but did have a clear outfall channel to the Fox River. A pipe outlet along the Canoe Chute West Wall appeared to be in satisfactory condition, although the source of the pipe outlet is unknown. See Photos **Out-1** through **Out-3**.

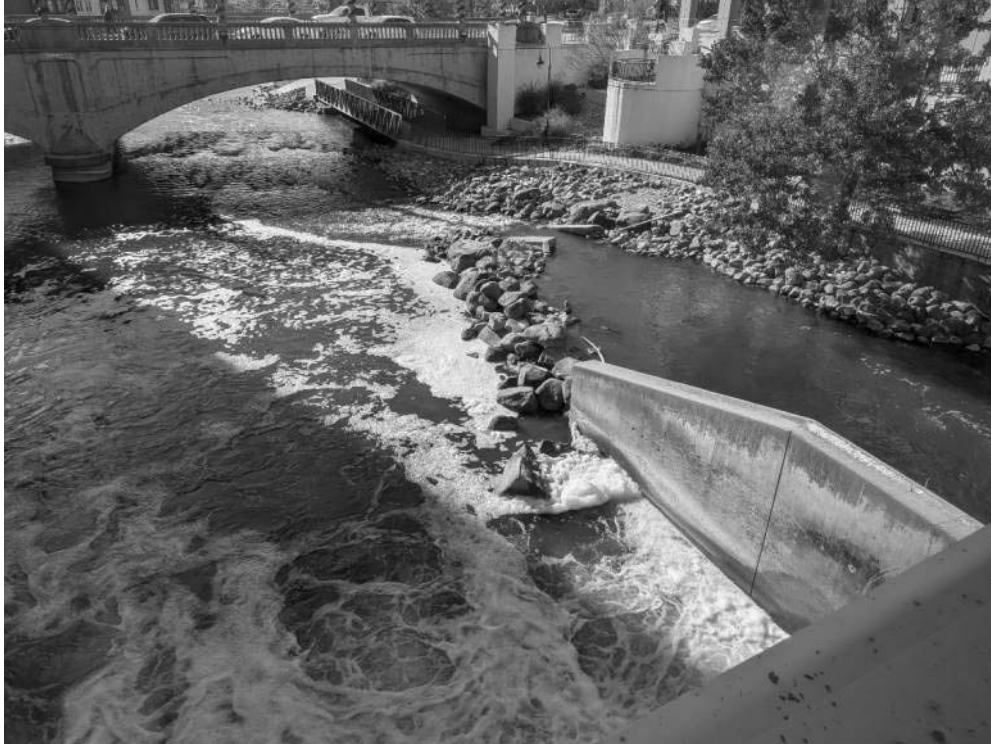
***PHOTOGRAPH OUT-3: LOOSE RIPRAP/CONCRETE CANOE CHUTE EAST WALL ON FOX RIVER SIDE***

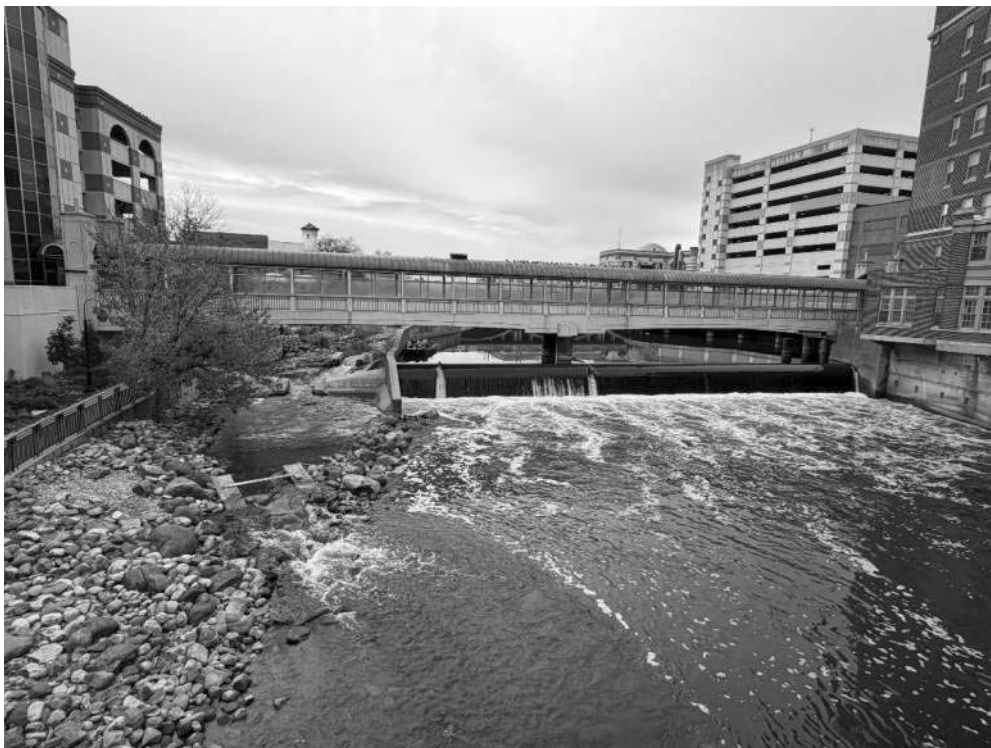
***PHOTOGRAPH WD-1: WEST DAM OVERALL VIEW  
– LOOKING AT DOWNSTREAM SIDE***

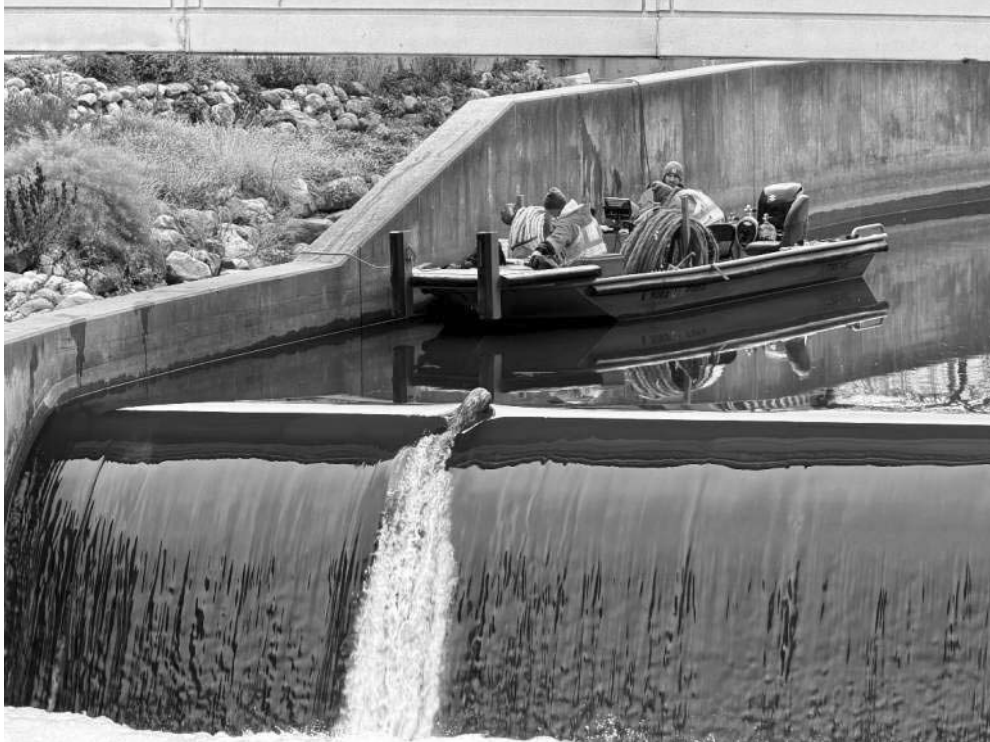
***PHOTOGRAPH WD-2: WEST DAM CANOE CHUTE EAST WALL ALONG FOX RIVER***

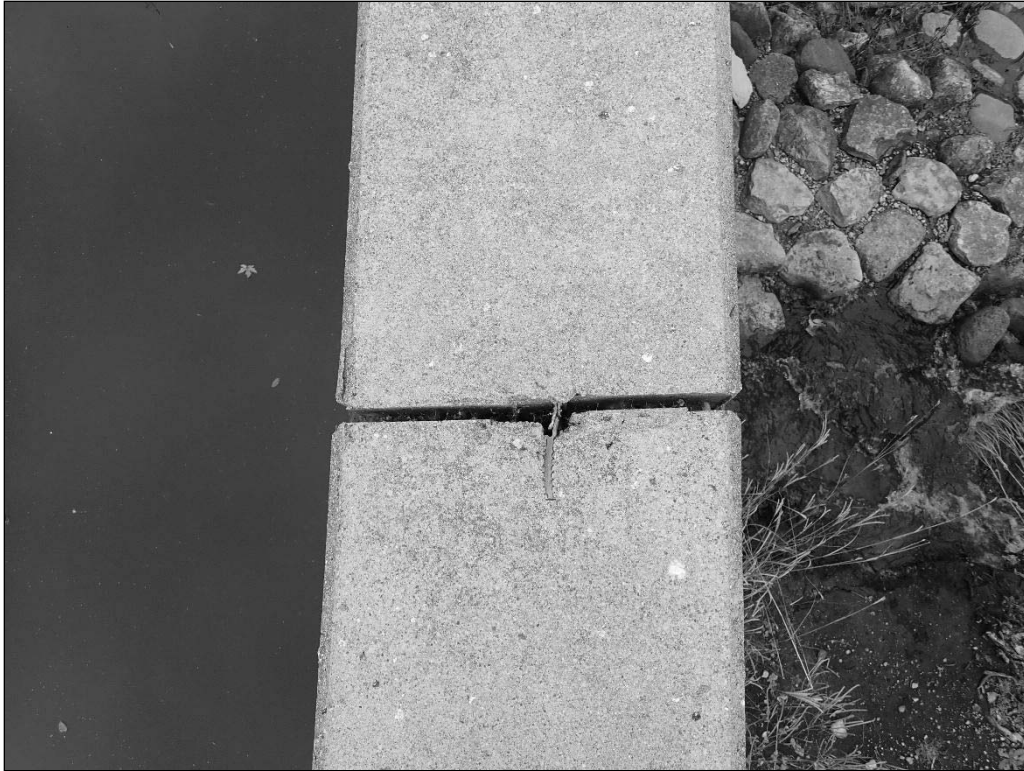
Overall, the Aurora Dam was generally in fair condition at the time of the inspection. An area of active water discharge and associated void were observed along the outboard side of the Canoe Chute East Wall near the construction joint at Station 1+80. Based on review of the available construction drawings and diver-obtained water depth soundings, the observed void is interpreted

to be indicative of the bottom of the wall, allowing passage of water beneath the structure. This condition has resulted in localized bank erosion and loss of stone along the west side of the wall and, if left unaddressed, may lead to further erosion and progression of the void. Although the wall is supported by steel-encased concrete caissons keyed into bedrock and the observed condition is not yet considered a bearing concern, it is recommended that this condition be repaired at this time to eliminate water flow and associated erosion. Repairs may include but are not limited to placement of grout bags along the outboard side of the wall to seal the void and limit water passage, or restricting water flow on the inboard side of the wall and pumping a flowable concrete or grout mix into the void to reduce seepage and erosion.

Photograph 13. View of the Top of the Canoe Chute East Wall at Station 1+80, Looking South. Note Active Water Flow on the West Side of the Wall.

1. The construction joint and void at the Canoe Chute East Wall should be sealed and filled, respectively. This location was observed with active water flow from the Fox River into the Canoe Chute. The wall is supported by steel-encased concrete caissons keyed into the bedrock and the condition is not yet a bearing concern for the wall. The repair is recommended to eliminate this active flow of water and additional erosion concerns.

Repair the Canoe Chute East Wall leakage at Sta. 1+80.

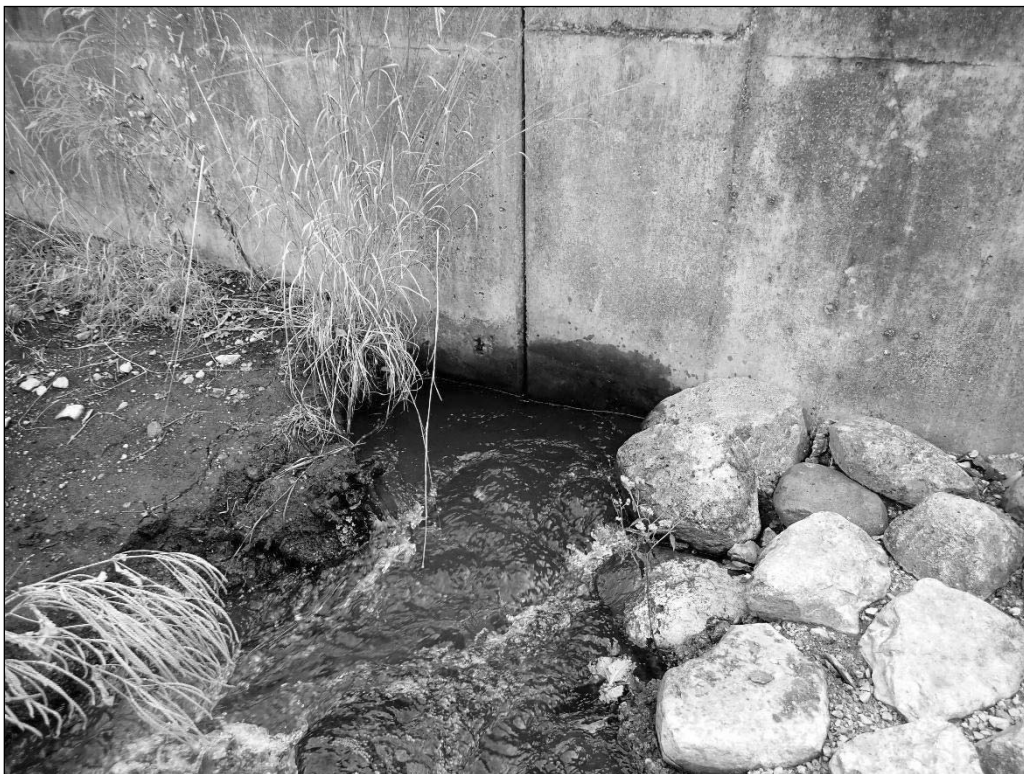
Photograph 14. View of Active Water Flow and Bank Erosion on the West Side of the Canoe Chute East Wall at Station 1+80, Looking East.

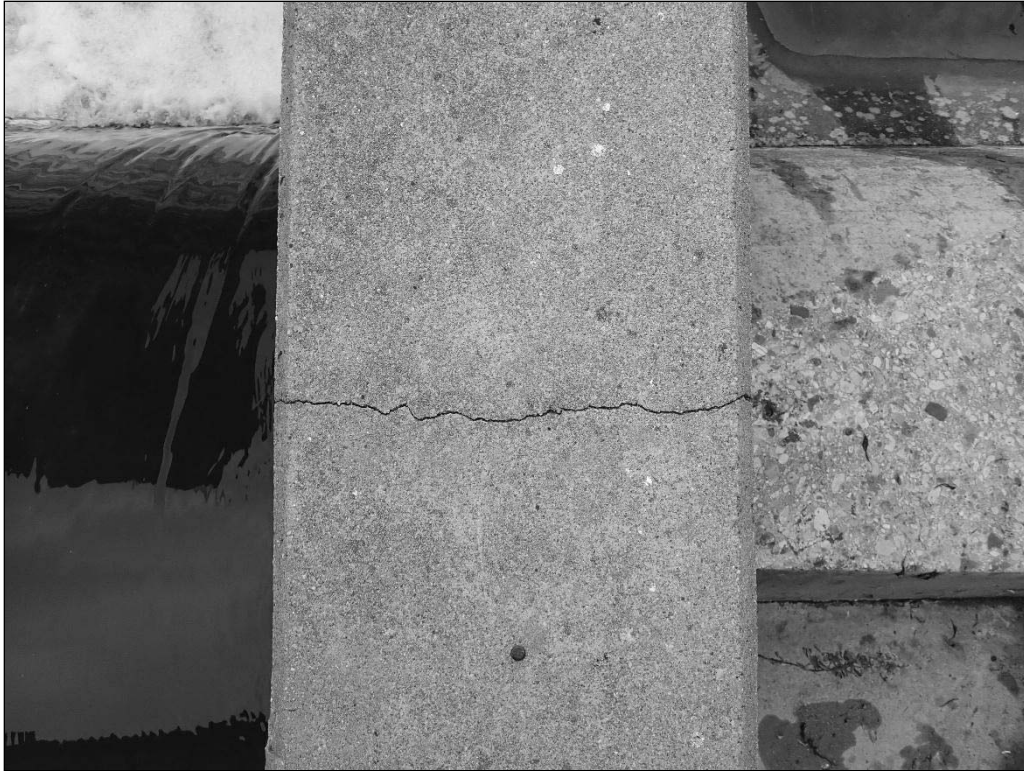
The Canoe Chute East Wall was generally in satisfactory condition. The wall exhibited hairline to 1/16-inch-wide vertical cracks extending the full height of both wall faces and across the top at 18 locations along the wall. No water seepage was observed at any of these cracks. An active water discharge was observed at the base of the Canoe Chute East Wall on the west side near the construction joint at Station 1+80. A void measuring approximately 1.5 feet in length by 2 inches in height was observed at the river bottom along the outboard side of the wall at this location. The water discharge has resulted in minor bank erosion and localized loss of stone along the west side of the wall. The east wall downstream of the dam was undermined by up to 3 feet vertically, exposing one steel caisson supporting the wall. The caisson did not exhibit any defects. The Canoe Chute pool adjacent to the east wall is constructed of a concrete apron floor and did not exhibit any defects. Refer to Figures 2 and 3 in Appendix A for detailed inspection notes and Photographs 5 through 16 for views of the Canoe Chute Pool and the East Wall.

Cracking observed along the Canoe Chute East Wall is not considered a concern at this time. These cracks should be monitored during future inspections for evidence of active seepage or progression.

Photograph 15. View of a Typical Crack across the Top of the Canoe Chute East Wall, Looking South.

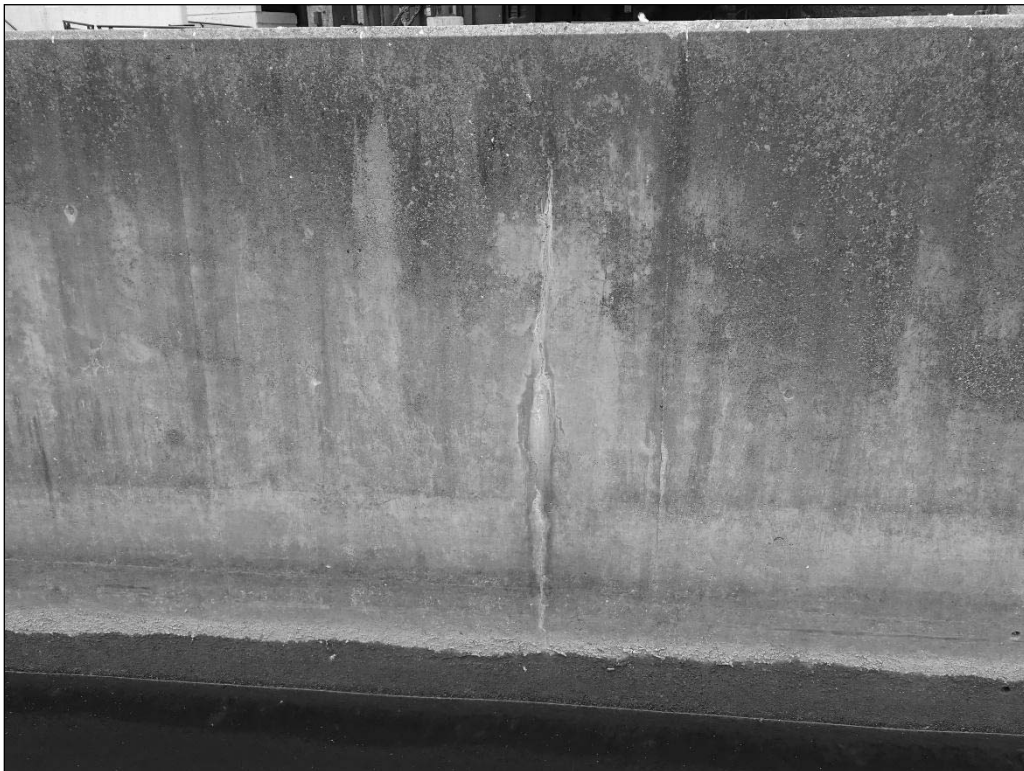
Photograph 16. View of a Typical Crack on the East Face of the Canoe Chute East Wall, Looking West.

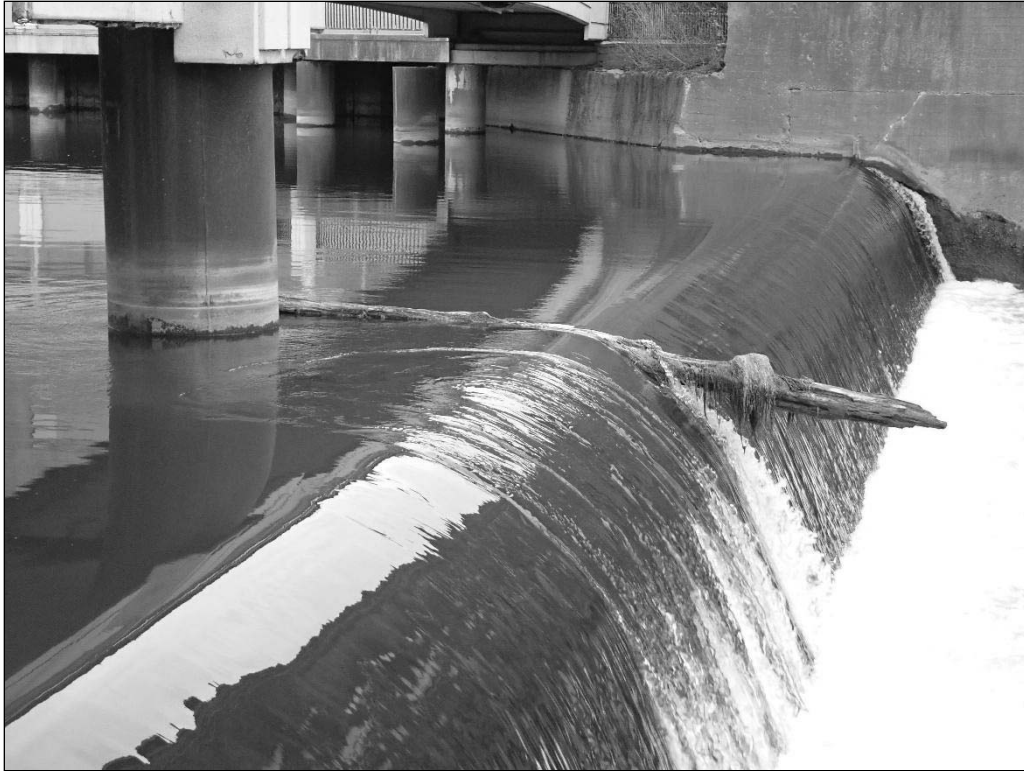
measured approximately 2 to 13 feet in width by 4 to 12 inches in height, with penetrations ranging from approximately 3 to 8 inches. Upstream of the dam, approximately 13 feet of a concrete apron was exposed along the channel bottom near Station 0+30 at 9 feet below the waterline. The concrete apron extended approximately 10 feet upstream before becoming covered with silt and gravel. Tree trunks were observed lodged within the dam spillway near Stations 0+10 and 0+50.

Photograph 17. View of the Timber Debris over the Dam near Station 0+50, Looking East.

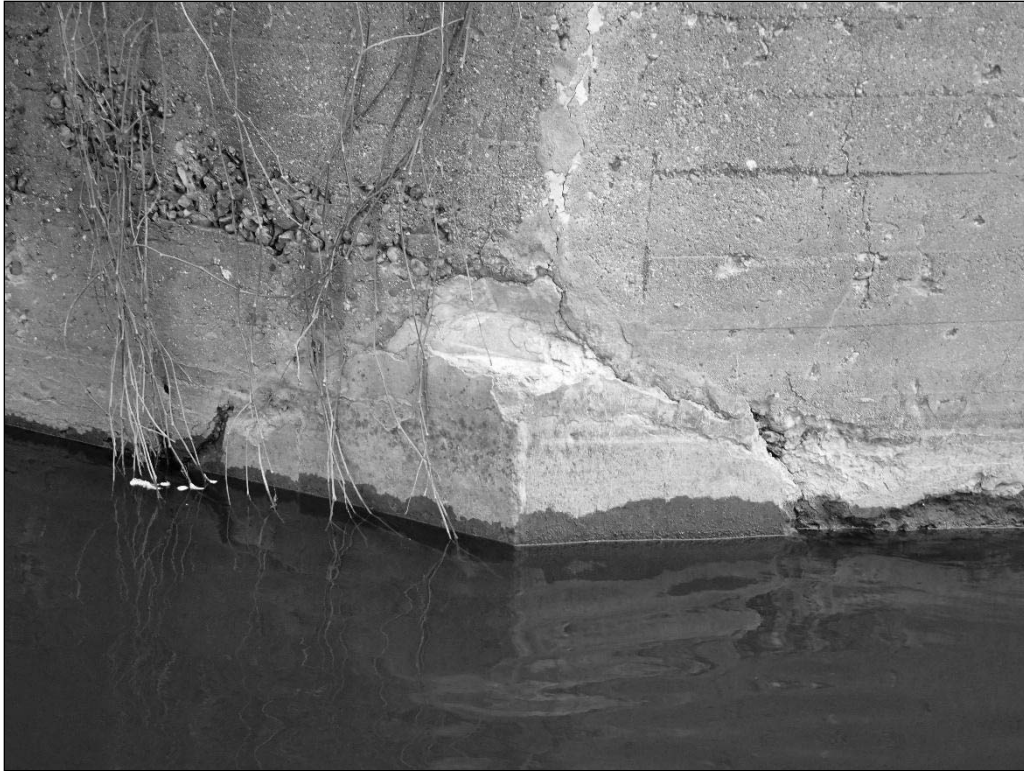
The areas of poor concrete consolidation and scaling observed along the upstream face of the dam are not considered structural concerns at this time. Given the current size and extent of these deficiencies and the considerable effort required to perform repairs to submerged portions of the dam, repairs are not recommended at this time. These areas should continue to be monitored during future inspections. If the size or extent of these defects is found to increase or to adversely affect the stability of the dam, repairs may be warranted at that time.

Photograph 19. View of the Scaling at the East Abutment Upstream of the Dam, Looking Southeast.

| Table 1 West Dam and Canoe Chute<br>Conceptual Opinion of Cost | | | | | | |
|---|---|---|---|---|---|---|
| | Scaling Repair on East Wall of West Dam | 0.3 | CY | \$ 10,000 | \$ 2,500 | Pump grout suitable for underwater application |

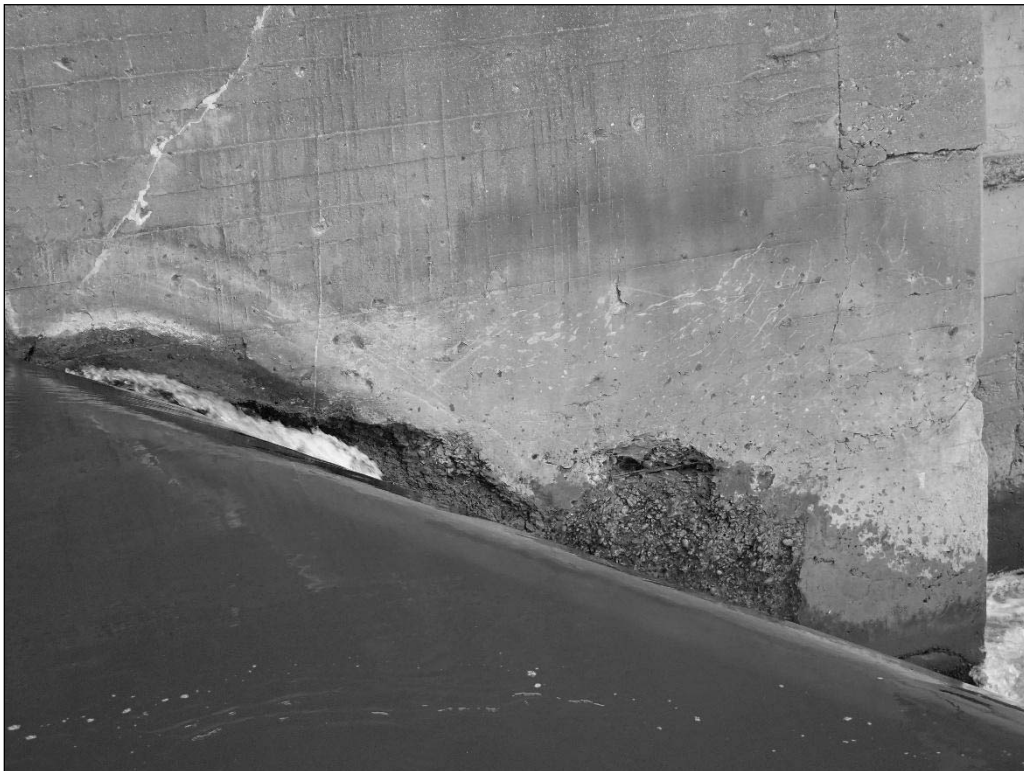
Photograph 20. View of the Scaling on the East Abutment at the Dam, Looking Southeast.
