Re: Aurora Well 29

CITY OF AURORA
 WELL NO. 29
 INSPECTION REPORT

JOB NAME	LN NE AURORA 29	WELL NO.	29	DATE	2/11/2025
JOB NO.	1568152	INSPECTED BY	J. Kopp, J. Iverson, J. Geltz, J. Balluff		
Motor	Byron Jackson 400 HP, 2300V, 17", Type M	BOWL ASSEMBLY	12 Stage 13MQ/12MQH11L1 – All Bronze		
Serial#	17T-1031-5-1RB	COLUMN ASSEMBLY	853' of 10" Sched 60, 8' Stainless Steel Bowl Pup

DOWNHOLE VIDEO SURVEY REPORT

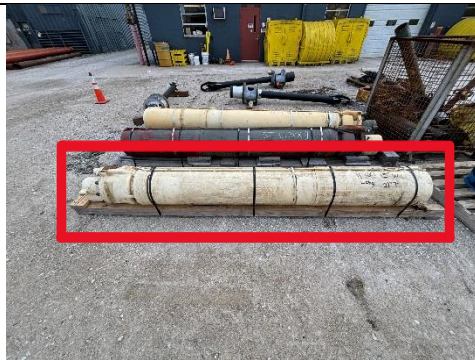
Motor on pallet

- Motor/cable assembly megged dead at the Well head and megged dead when at the surface.
- When the motor was drained of oil, it was full of water. The vent plug seen above was missing when the crew pulled the motor from the Well.
 - Layne believes the plug could have come unscrewed while pulling due to the evidence of paint being worn off near the vent plug. This also explains the water in the motor and the oil at the top of the Well.
- Once the motor dried out it began megging which was confirmed by Cory Tyner. Layne then inspected the motor for field serviceability. At which point, it was found that the motors thrust bearing was worn out.

- Layne recommends utilizing Aurora's spare motor that is in Layne's yard for Well 29
- We recommend sending the current motor back to Flowserve and utilize it as credit towards an exchange motor. Once it is returned, Layne will store it as the new spare motor.

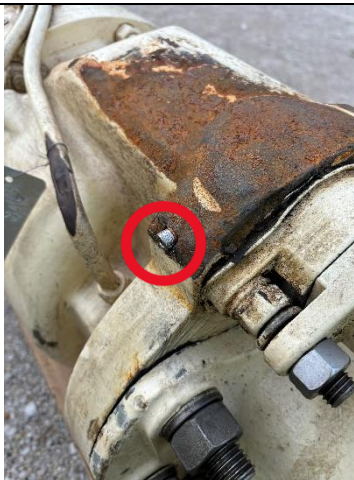
Unguarded vent screw w/ paint rubbed off

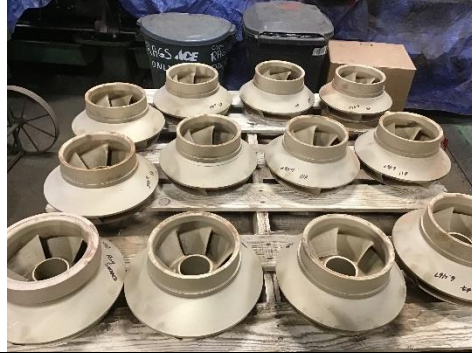
Impellers

- 12 Stage 13MQ/12MQH11L1 – All Bronze bowl assembly, with 8' stainless-steel bowl pup
- 12th stage ring seized to impeller, appears from thrust bearing reduction in motor causing the top impeller to ride at seat location for minimal period and causing a burr at the bottom of the skirt.
- All impellers in good condition.

- Layne recommends the following repairs to the bowl assembly:
 - A new impeller shaft
 - Recondition impellers
 - New wear rings
 - New bushings

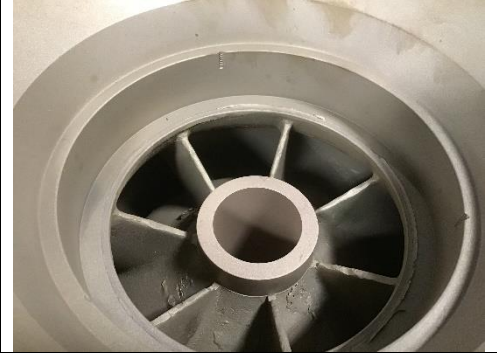
Top of bowl, bowl seat

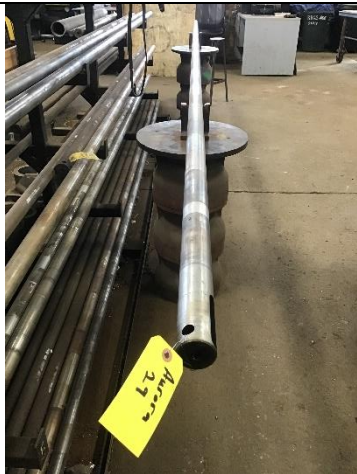
Impeller shaft

Impeller Shaft	1-15/16" X 178", mic .002 to .008 under nominal, replace with new						
Fasteners	SST, ok for reuse, replace lock washers						
Strainer	SST, ok for reuse						
Collets	SST, ok for reuse

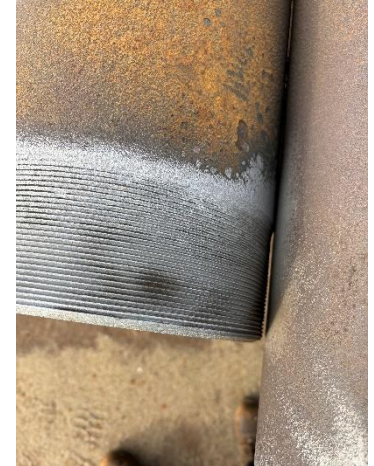
Short thread engagement and thread deterioration

- The total string includes forty, 10", sched. 60, 8RND thread pipe with one 10", 8RND pipe nipple welded to the pitless spool assembly, and one 10" stainless steel bowl pup attaching the bowl to the column pipe.
- The length of string, with pitless pipe nipple is 853'.
- The pipe is not epoxy coated as the thicker walled iron of the sched. 60 pipe takes the place of the epoxy coating.
 - The majority of the sched. 60 column appear in good condition.
- Almost all male threads presented evidence of short threading, rolled threads, cross threading, thread stretching, and thread erosion.
- Almost all couplings presented evidence of improper engagement to pipe on both ends, stretching threads, and thread erosion.
- The pitless pipe nipple shows extensive evidence of stretching.
- The stainless-steel bowl pup appears in good condition.

- Layne recommends cutting and rethreading all 40 pieces and replacing all 38 couplings to provide proper 8RND engagement to couplings per API specifications. The sched. 60 pipe adds additional weight to the string. The 8RND threading provides extra strength to better secure the additional weight, given proper engagement.
 - Most pieces appear in good condition for reusing and putting new threads on. Due to cutting loss, we are estimating 2 new pieces of 20' sched. 60 pipe. Pipe that has lost too much material, we will need to replace with new as well.
- The pitless pipe nipple can be reused, cut and threaded, and welded back to the pitless assembly.
- Replace both 10", 8RND surge control valves per best pump maintenance practice.

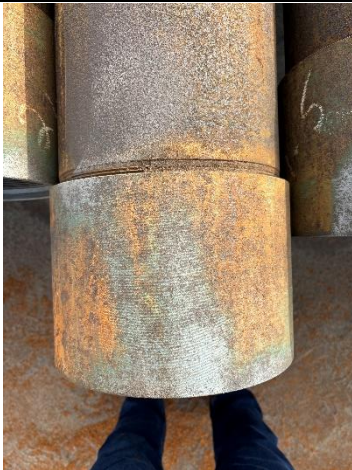
Improper thread engagement and stretched threads

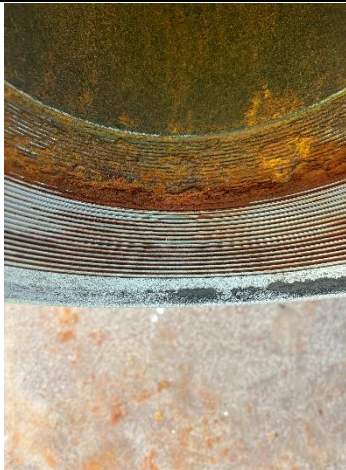
Improper thread engagement depth in coupling

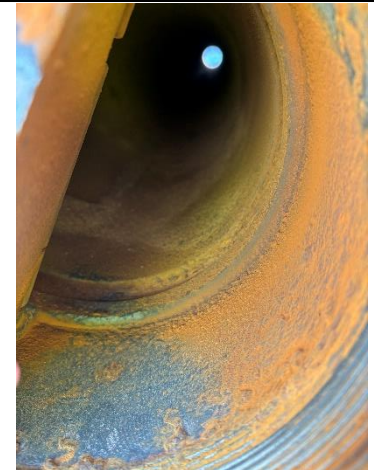
Surge control pitting

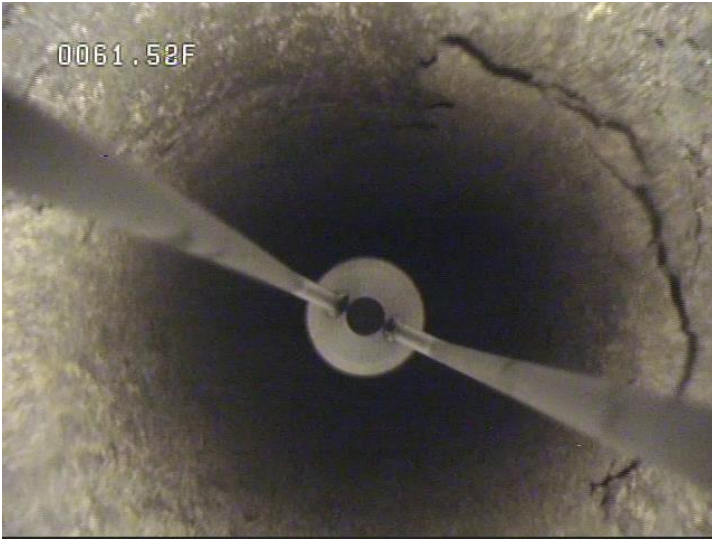
It has been noted that Well 29's specific capacity has been decreasing since repairs were made to the pump in 2017. The Galesville Sandstone Formation (the "Formation") appears healthy. Scale and sand are also building up into the Formation (total depth of 1397', formation bottom is 1398') which could begin to impact specific capacity the more it fills the formation. The scaling on the casing is heavy.

13' - 471' Heavy, large sheets of scale

- Boreblast (air blast) the formation to open it up. Bore blasting is easier on the formation to not kick up as much sand as shooting the well causes.
- Scratch the casing to break heavy scaling.
- Bail the sand and scale out of the bottom to reach original depth again.

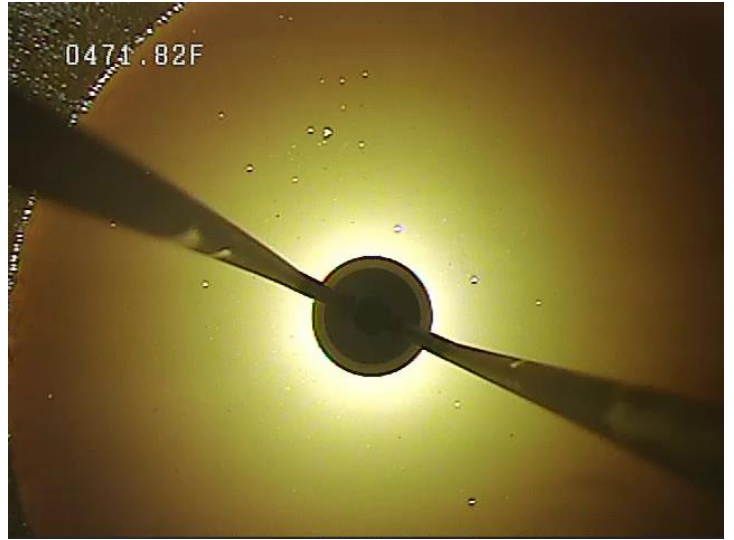
471' Static water level - Cloudy and heavy oil on top

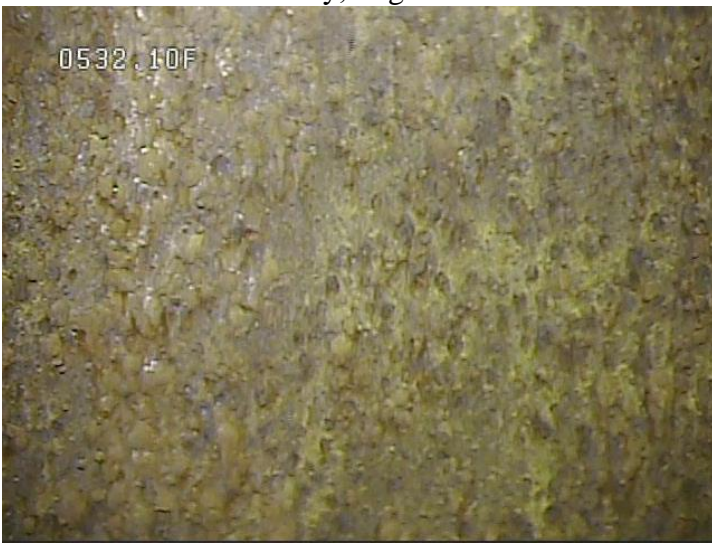
532' - 616' Light scale

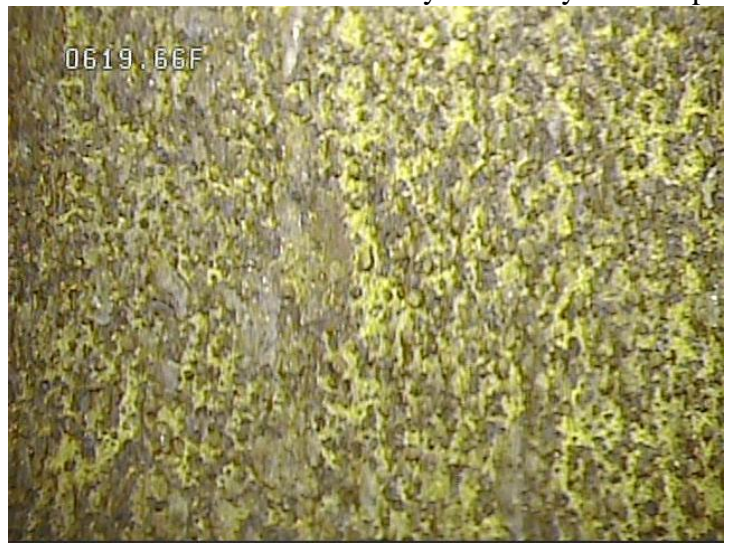
616' Scale becomes heavier

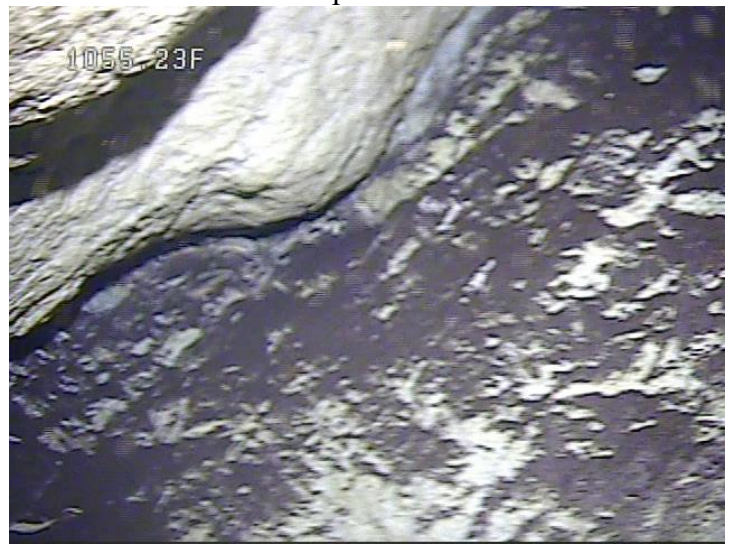
~1052' Large crevice

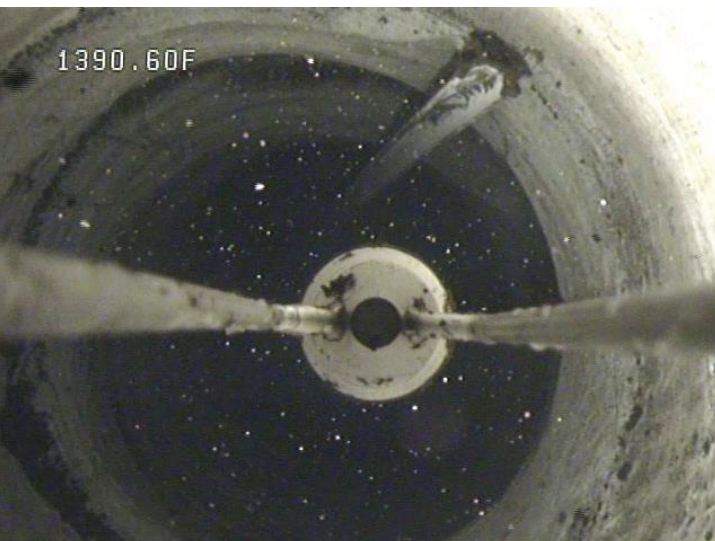
1390' Top of broken PVC at bottom

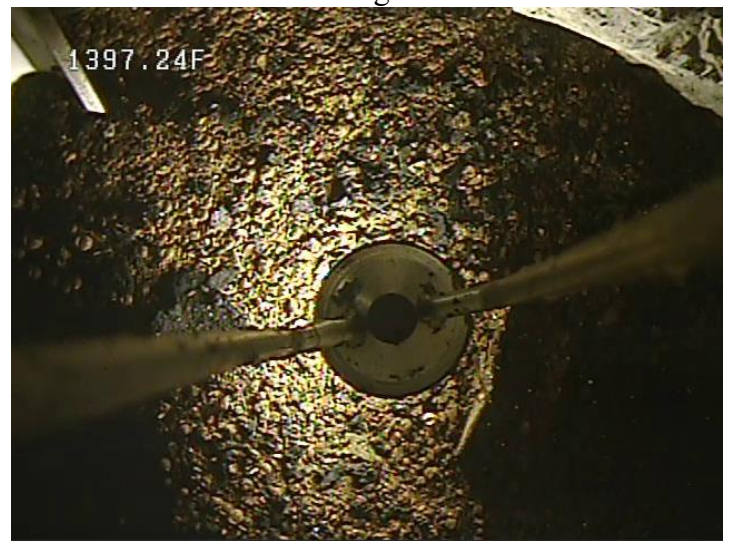
1397' Bottom settled scale/sand, soft
