Condition Assessment

## AURORA POLICE DEPARTMENT PARKING STRUCTURE

Aurora, Illinois

April 29, 2022

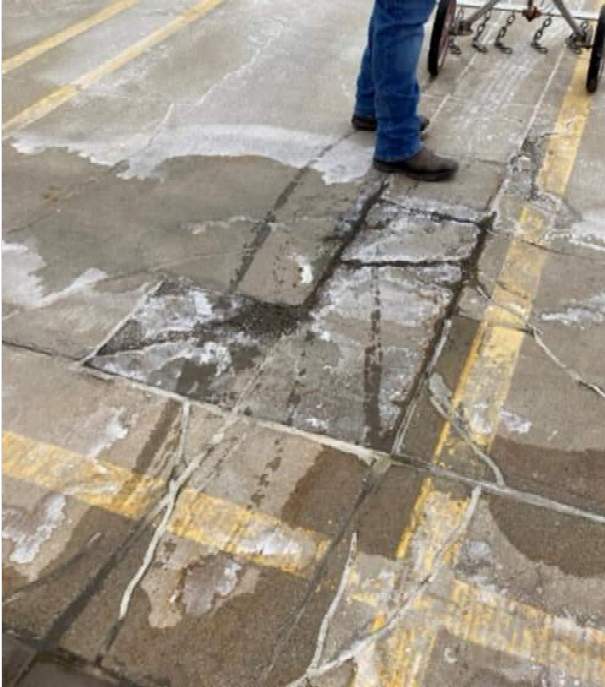
- Small concrete delamination/spalling was observed along the tee-to-tee joints and within concrete washes at isolated locations throughout the parking structure. (Photos 1 & 2)
- Delaminated concrete at lifting loop pockets on the floor surface throughout the parking structure were identified during our chain drag survey. (Photos 3 & 4)
- Isolated random cracking was noted in the precast double tees. Cracking was observed to be narrow ranging from 0.010" – 0.015".

Photo 1 – Typical spalled and delaminated concrete.

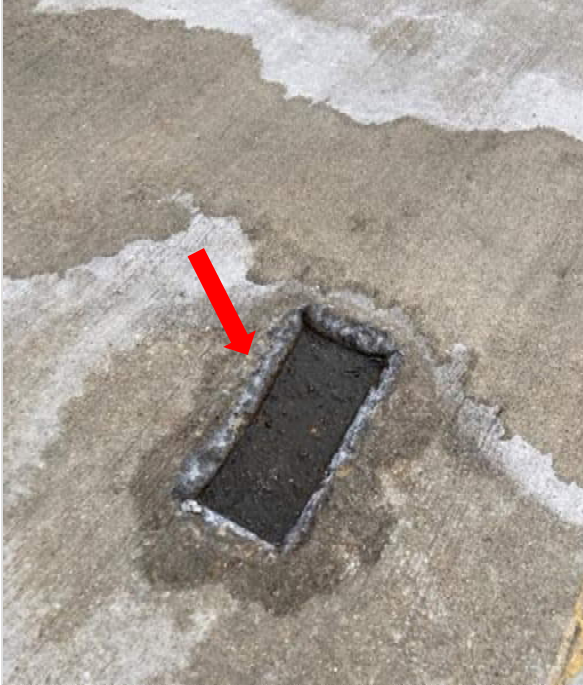
Photo 3 – Typical delaminated concrete at lifting loop pockets.

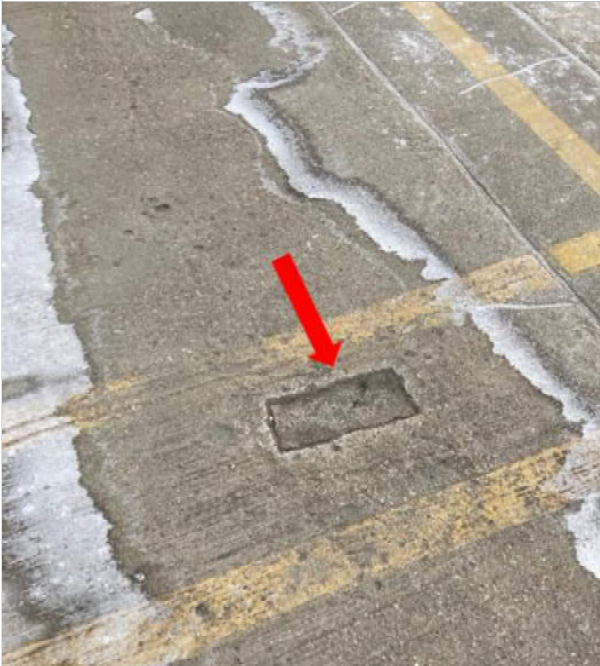
Photo 4 – Deteriorated concrete at a curb on the top level.

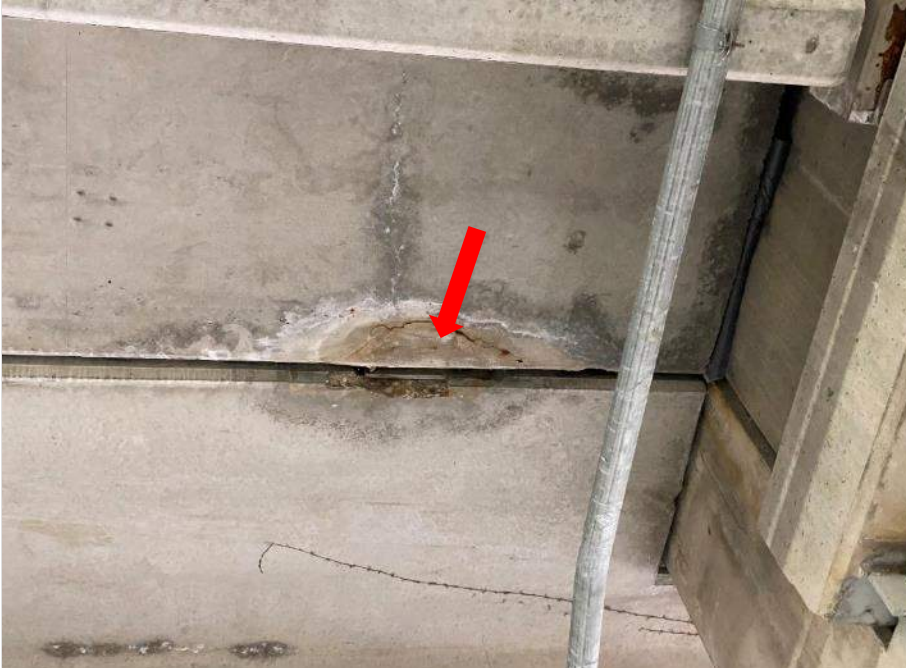
Additionally, we observed a few localized areas of overhead concrete deterioration. Further deterioration may cause the concrete to become loose, potentially falling on garage occupants. Therefore, we recommend engaging a contractor to survey all overhead surfaces and removing loose and/or deteriorated concrete.

- Spalled/delaminated concrete was observed overhead on the underside of the double-tee flanges at numerous locations throughout the structure. (Photo 5)
- Full-depth cracking and water infiltration was observed at double-tee flanges that were previously repaired. (Photos 6 & 7)
- Isolated spalled concrete and precast wall panels was observed on the top level. (Photo 8)
- Isolated delaminated grout pockets at the top of precast wall panels were identified. (Photo 9)

Photo 5 – Typical delaminated/spalled concrete on the underside of a tee flange.

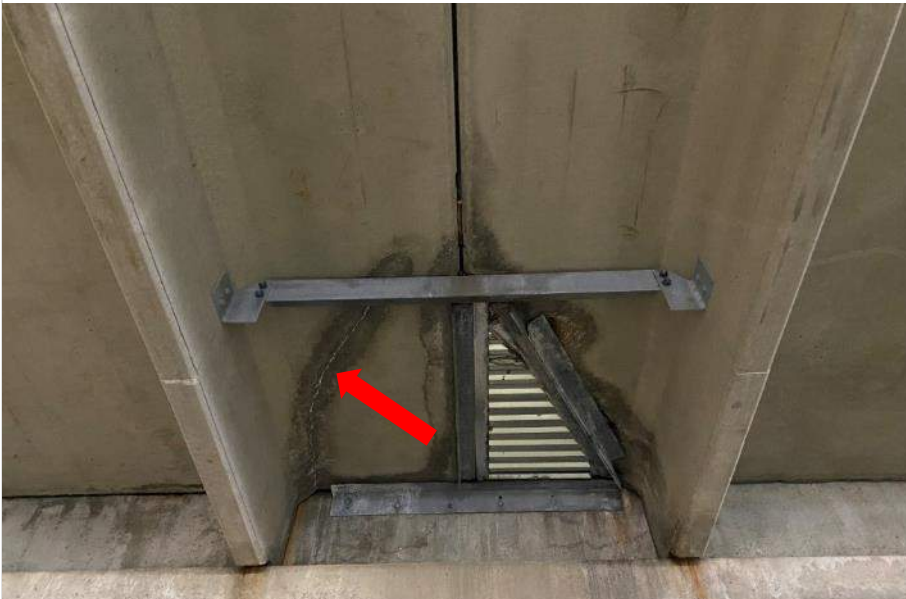
During our assessment, we observed through-depth cracking and water infiltration at double-tee flanges that were previously repaired. The cracked tee flanges are supported by a steel angle that spans between adjacent tee stems. However, cracking extends beyond the support of the supplemental steel angle. At one location, a portion of the double-tee flange that previously failed was replaced with concrete-filled metal decking. However, cracking in the tee flange adjacent to this area was still noted. Walker recommends performing full-depth tee flange repairs to replace the damaged tee flange sections and properly anchor the new sections to the existing double-tees.

Photo 6 – Full-depth cracking and water infiltration observed at double-tee flanges that were previously repaired.

1. Perform full-depth double-tee flange repairs at locations that were previously repaired but currently exhibiting through-depth cracking and water infiltration.
2. Survey and remove loose and/or delaminated overhead concrete that may be a potential falling hazard throughout the structure. This recommendation should be performed on a continuous basis.

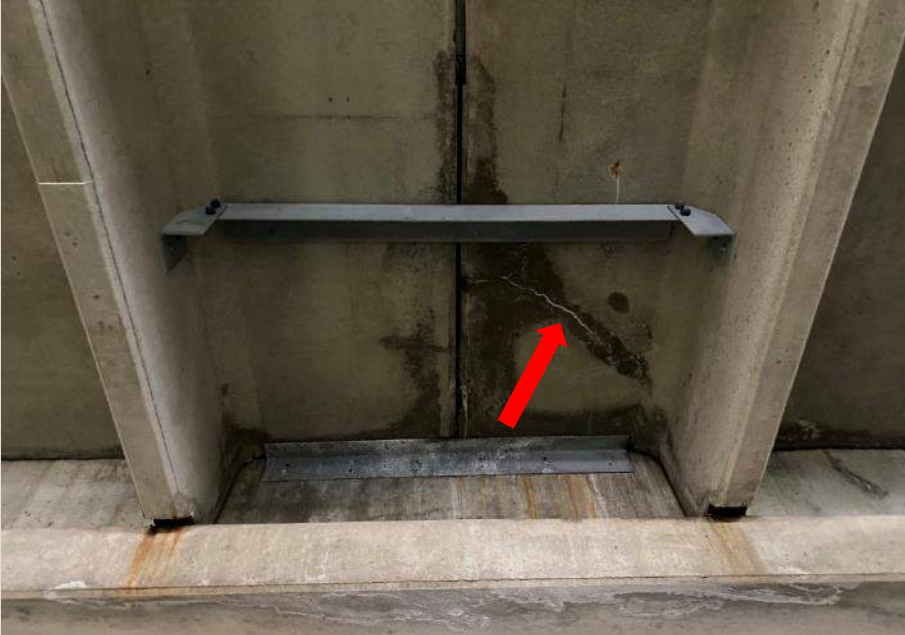
Photo 7 – Full-depth cracking and water infiltration observed at double-tee flanges that were previously repaired.

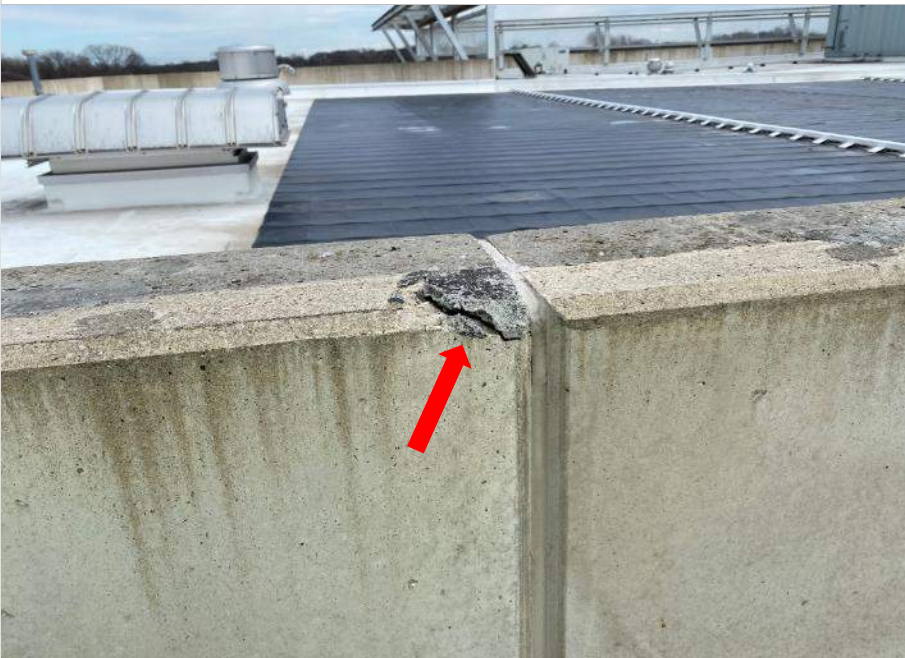
Photo 8 – Isolated spall concrete at precast wall panels observed.

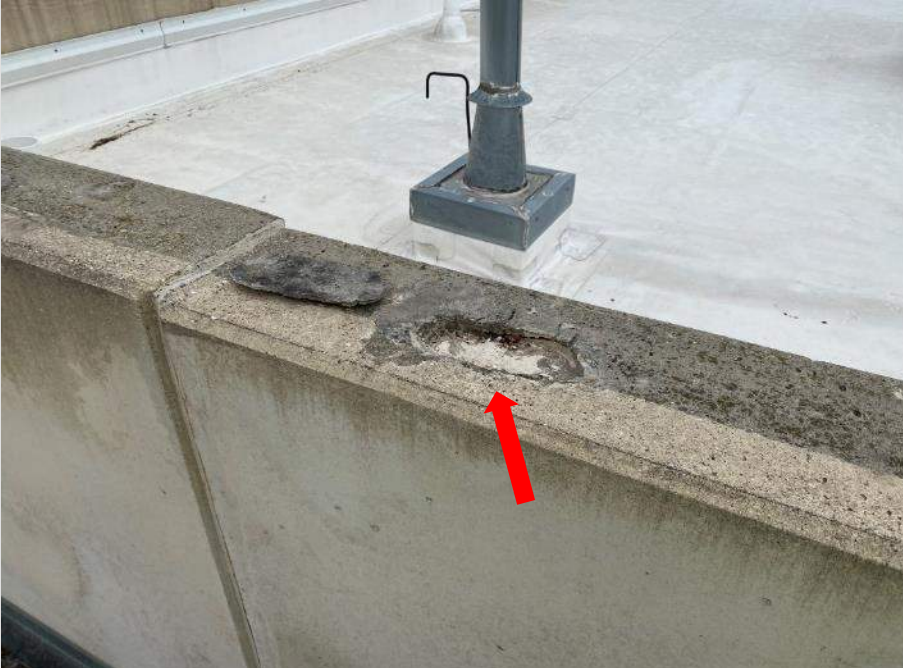
Photo 9 – Typical delaminated concrete observed at a precast wall.

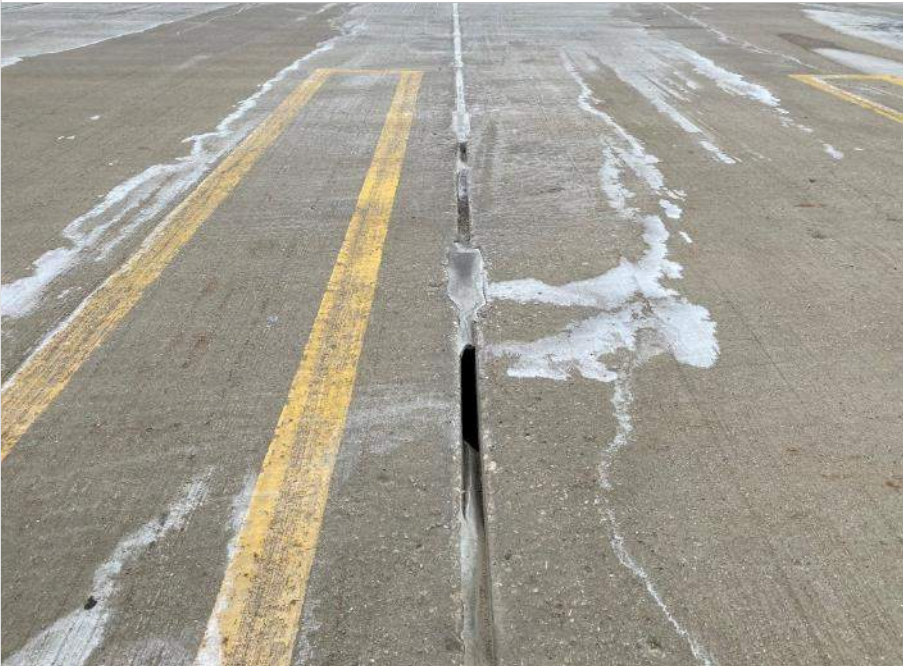
- Widespread failed tee-to-tee joint sealant was observed on the top level throughout the parking structure. (Photos 10 - 14)

Photo 10 – Widespread failed tee-to-tee joint sealant observed.

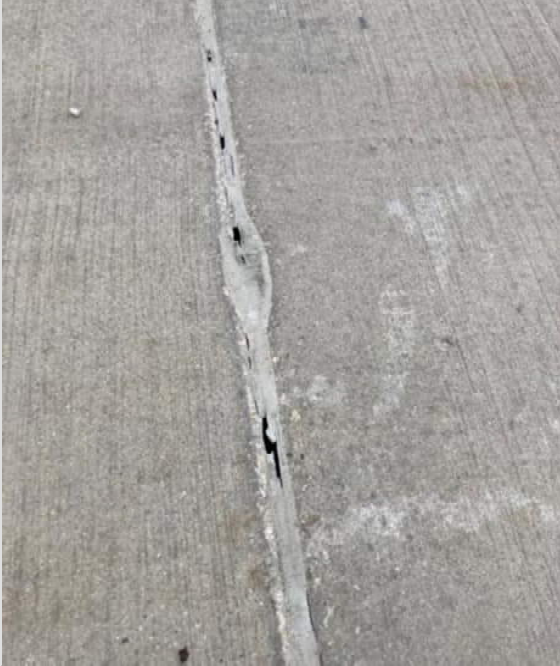
Photo 11 – Widespread failed tee-to-tee joint sealant observed.

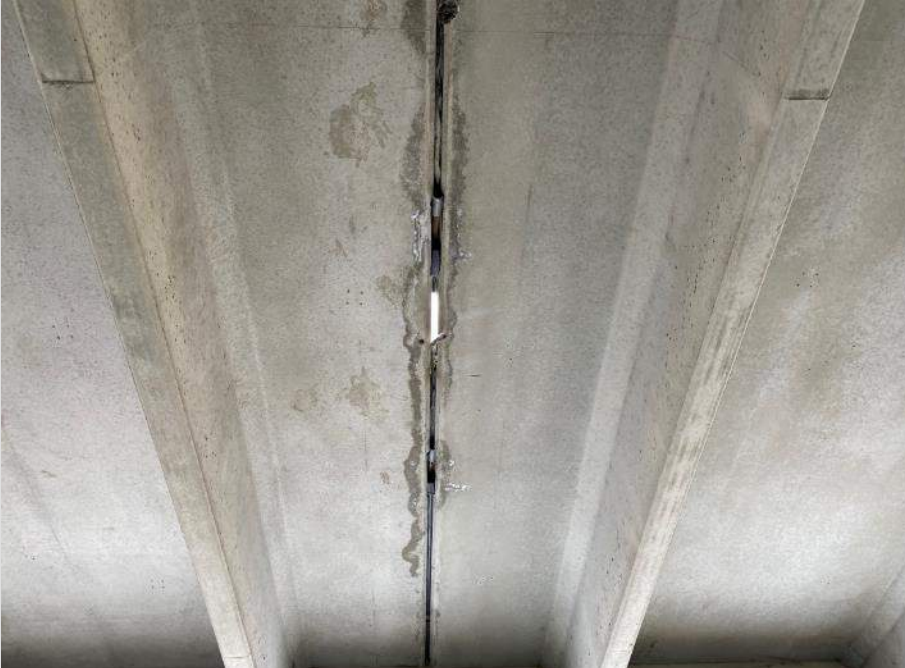
Photo 13 – Widespread failed tee-to-tee joint sealant observed.

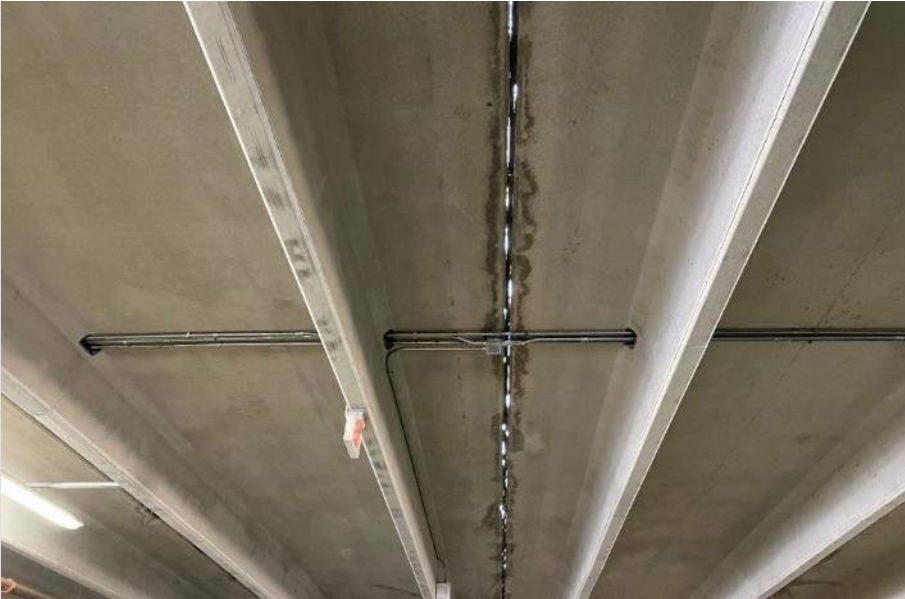
Photo 14 – Typical failed tee-to-tee joint sealant as observed from the underside at isolated locations throughout the structure. Note daylight at failed sealant.

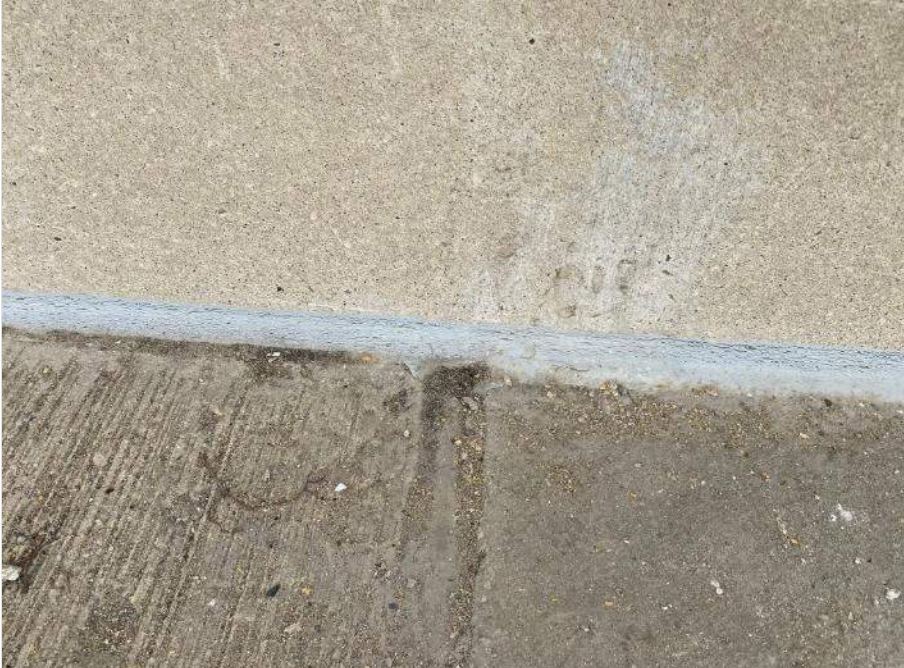
- Drying and shrinkage cracks noted on vertical joint sealant and cove sealant. (Photo 15)
- Isolated damaged cove sealant was observed throughout the parking structure. (Photo 16)

Photo 15 – Drying and shrinkage cracks noted in cove sealant.

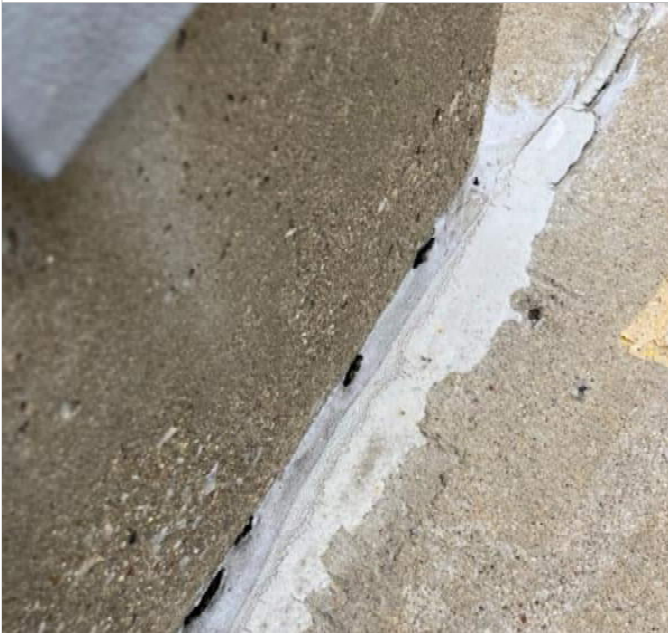
Photo 16 – Adhesion failure to cove joint sealant.

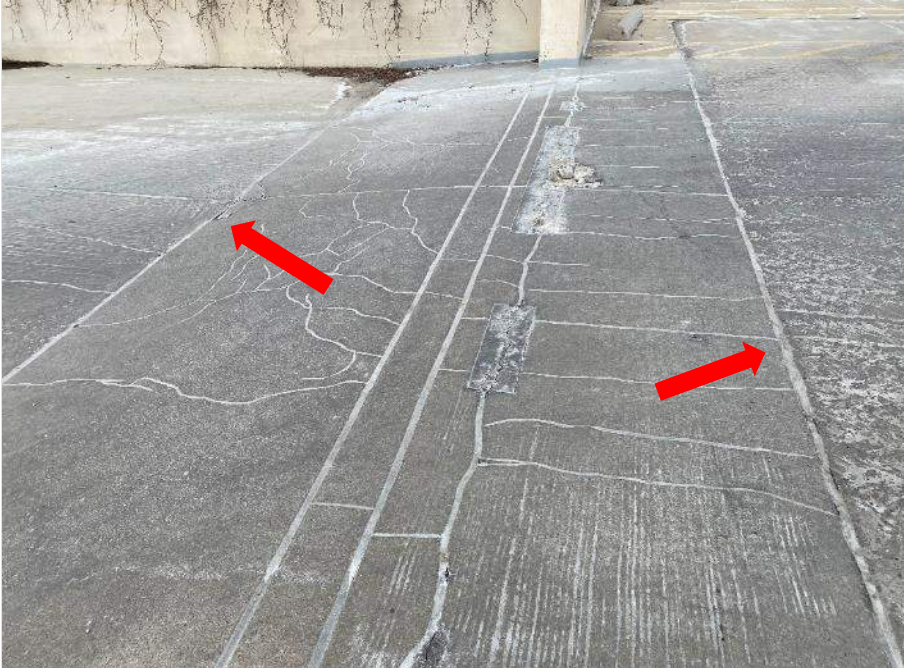
In general, construction joint sealants appeared to be in poor condition throughout the structure due to adhesion failure at multiple locations along the length of the joint. Based on the observed deterioration, we recommend that all construction joint sealants are replaced in the year 2022. Isolated damaged cove sealant was also observed. We recommend that damaged cove sealants are replaced in the year 2022.

Photo 17 – Failed construction joint sealant noted throughout parking structure.

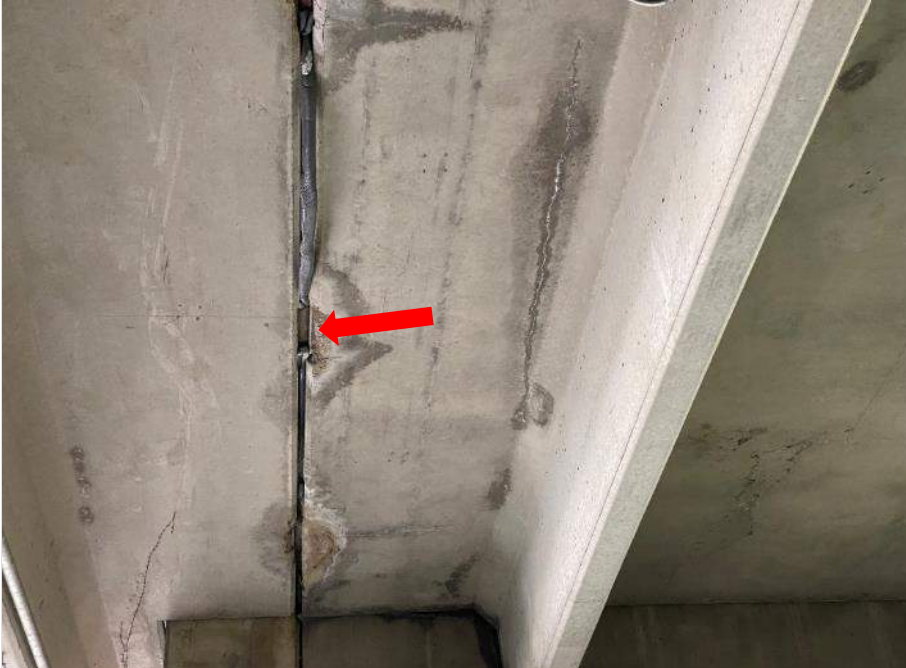
Photo 23 – Broken double-tee shear connector observed (welds broken).

1. Replace or supplement precast double-tee shear connectors throughout the parking structure.
2. Repair broken connections between precast double-tees and precast walls.

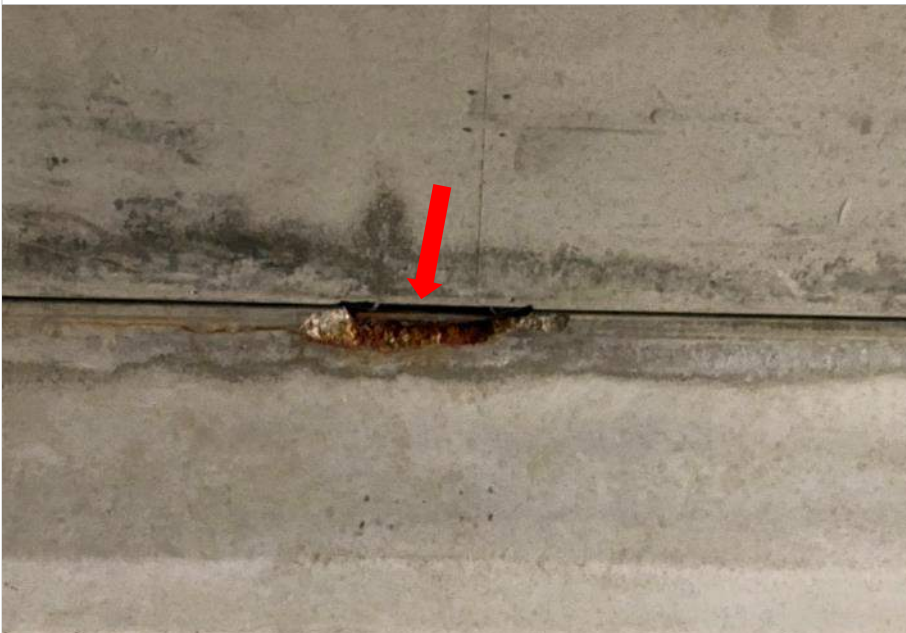
Photo 24 – Corroded double-tee shear connector noted.
