Re: Well 127

CITY OF AURORA
 WELL NO. 127 PUMP
 INSPECTION REPORT

| JOB NAME | Aurora | | WELL NO. | 127 | DATE | 10/16/2018 |

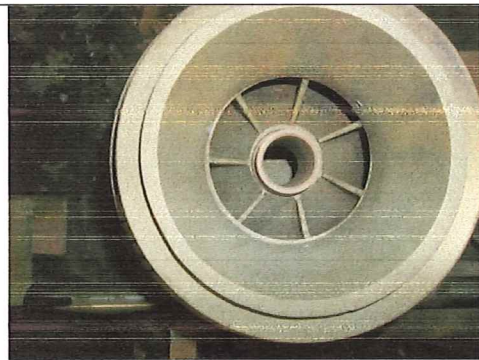
Bowl castings are in excellent condition with very little wear to internal clearances.

The wear ring clearances are well within new specification. Bushing clearances exceed tolerance. The stainless impeller shaft and collets exhibit heavy pitting and are in poor condition. It is an unusual circumstance that these stainless components are so heavily decayed. Stainless fasteners and suction strainer are in good condition. Reference attached Bowl Assembly Inspection Report.

Rebuild bowl assembly with new bushings, collets, and impeller shaft.

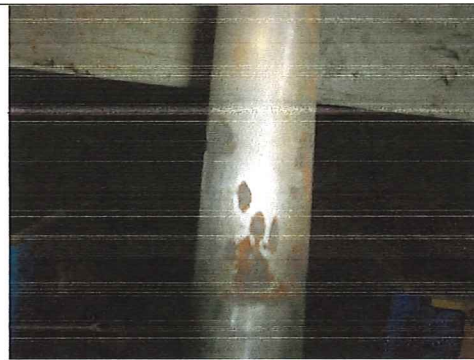
The stainless impeller shaft is heavily pitted.

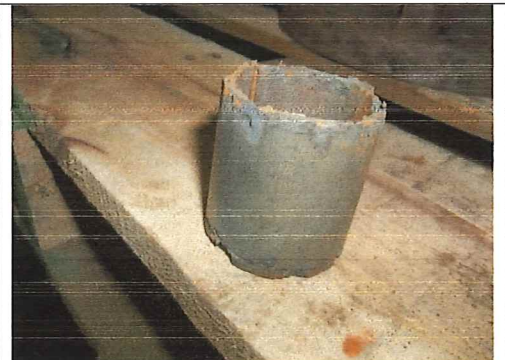
The stainless collets are in very poor condition.

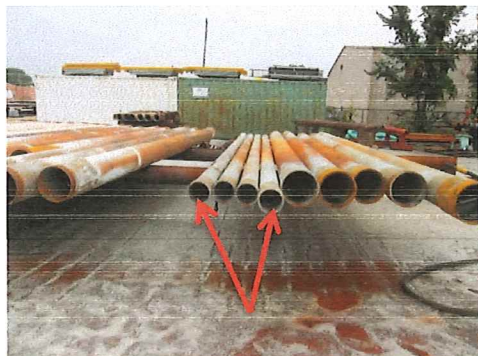
6" Line Pipe on Layne blast rack.

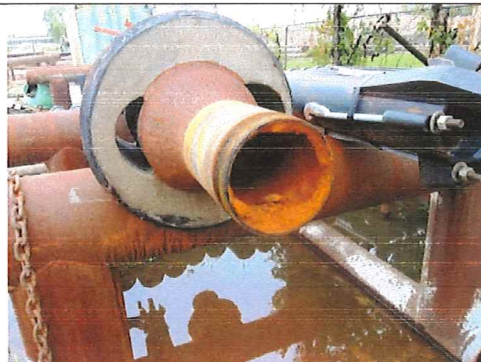
Heavy iron deposition on pipe interior prior to sand blas (typ.)

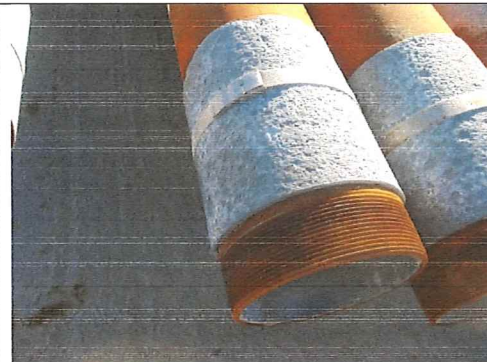
Zinc sleeve sacrificial anodes appear to have abosorbed the brunt of corrossion.

After the entire string of 6" Line Pipe required replacement in 2010, sacrificial zinc anodes were installed on the new pipe. The anodes appear to be a good investment as they have taken the brunt of the corrosion in the last eight years of operation. However, all four single random joints do require thread removal and rethread (cut & thread). Three couplings and the surge control require replacement. The pitless guts and the pitless' threaded nipple are in good condition. The 6" x 5' stainless pup off the bowl is in good condition but its associated 6" Line Pipe coupling is in poor condition. The pipe string also includes 5' of 6" black steel with surge control valve.

Cut and thread four male ends. Replace three couplings and surge control. Plan a contingency to cut and thread two ends after removing the coupling/surge control – pending thread inspection at that time. Pending lost pipe length due to cut and thread, consider replacing 5" black steel nipple with new that compensates for the lost length. Install sacrificial zinc anodes.

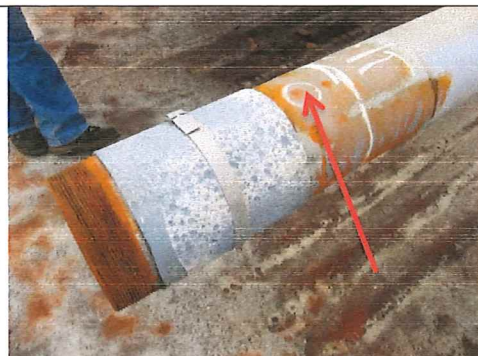
However, the pipe still has some random pitting.

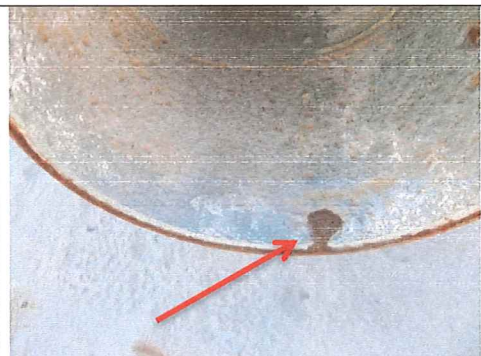
Interior pipe pit above sacrificial zinc anode.

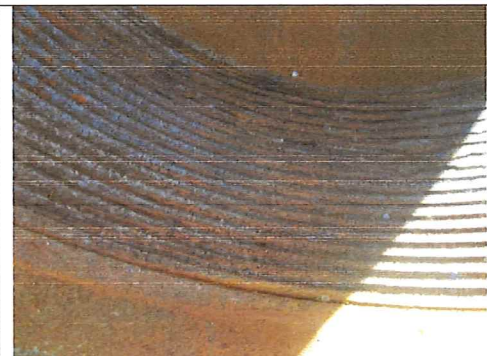
Eroded thread on coupling.

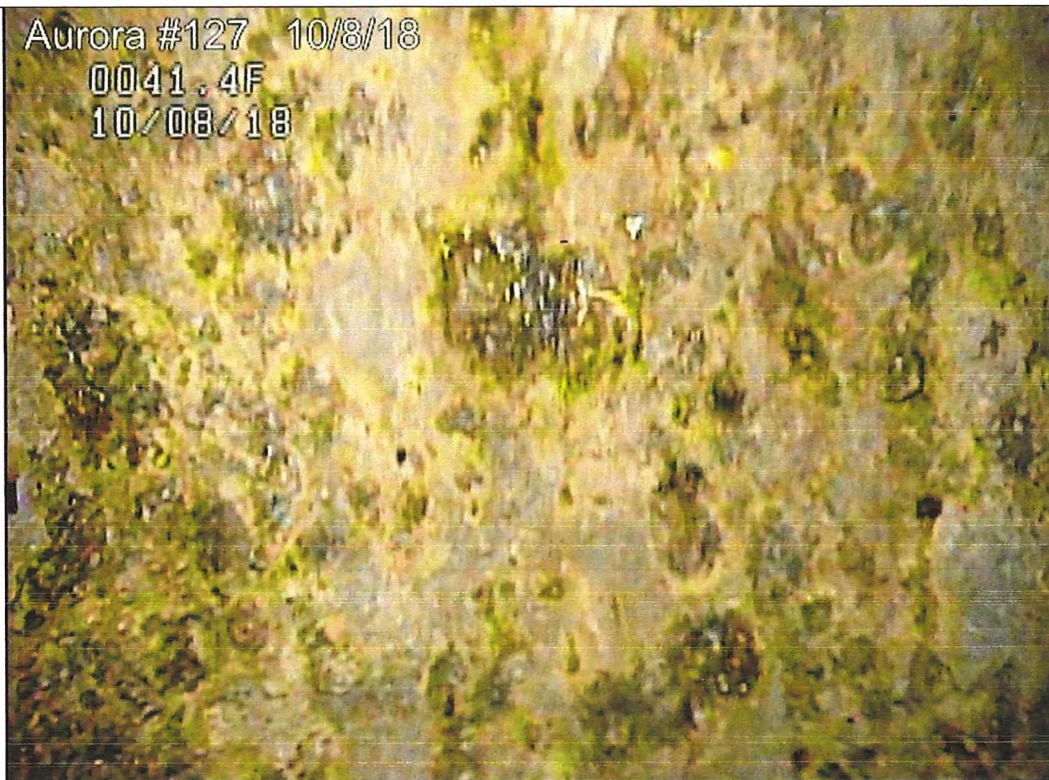
46'

Moderate
scale on well
casing.

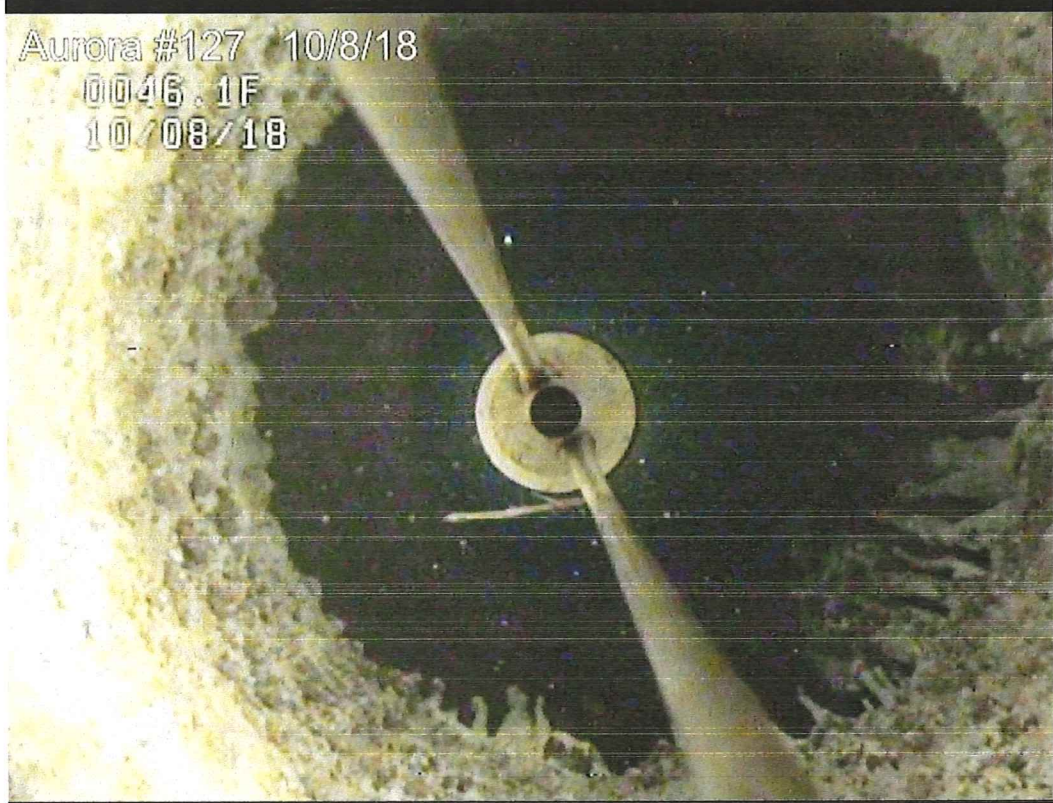
46'

Bottom of casing.

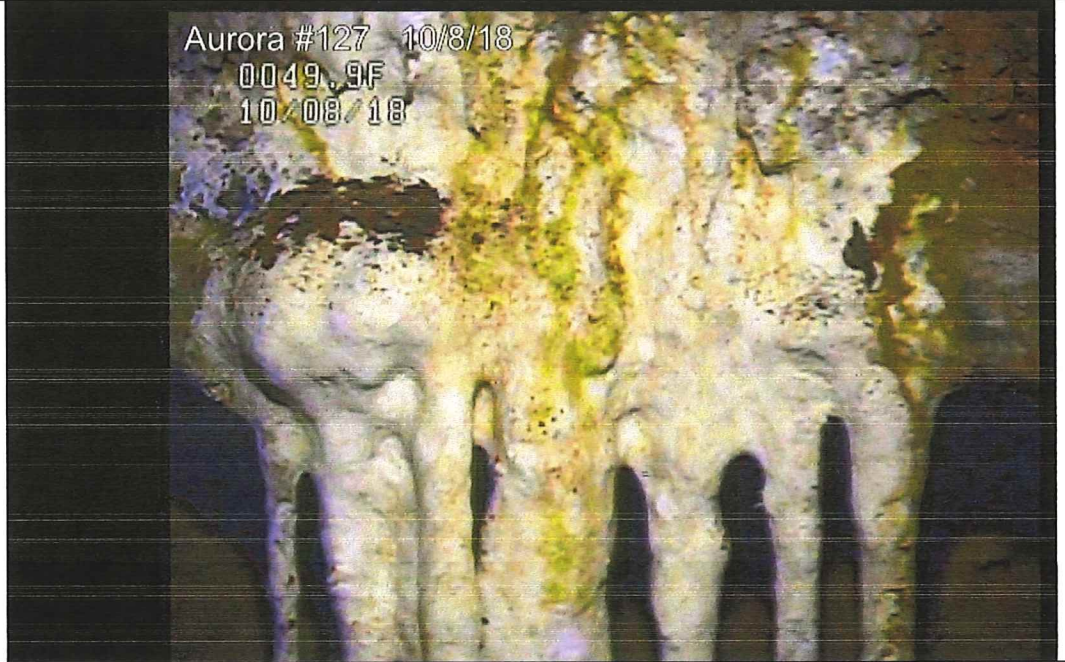
"Stalactites"
hanging from
bottom of
casing

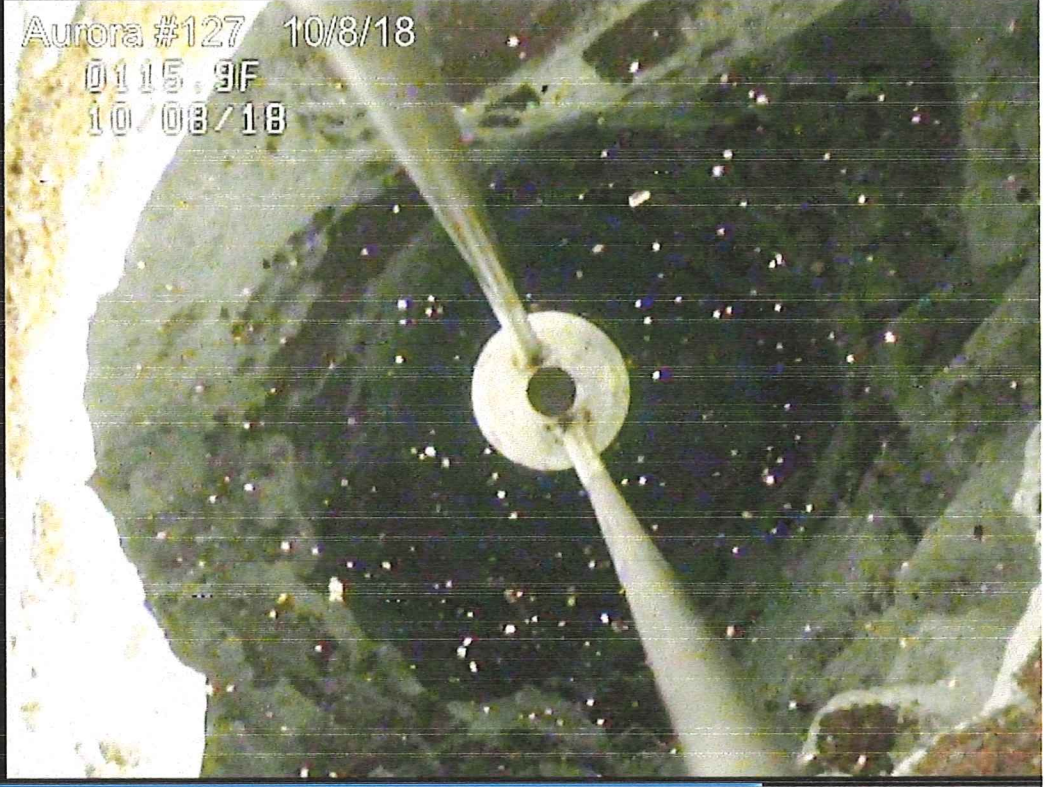
WELL – The well was televised on 10/08/2018. The formation has one area of fracturing and crevicing from 108' to 118'. The total depth was logged at 226'. This is the same TD televised in 2010. Bailing was attempted at that time with no return. Reference attached Downhole Video Survey Report.

| 108 | 118 The only significant fractures and crevicing in well's open limestone formation | <p>Aurora #127 10/8/18 0115.9F 10/08/18</p> The image shows a downhole video survey of a wellbore. A central tool joint is visible, surrounded by a dark, textured limestone formation. The formation exhibits numerous small, bright, reflective particles and irregularities, indicating fractures and crevices. The lighting is focused on the tool joint, creating a bright circular highlight. |
