J. V. Henik, Inc. — Structural Engineering

RE: **Hobbs Building**
Dome Stability Investigation
Aurora, IL

Re: LVR – Hobbs Building
Dome Roof Stability
12-14 North River Street
Aurora, Illinois 60506
Lindsay Project No. 161506

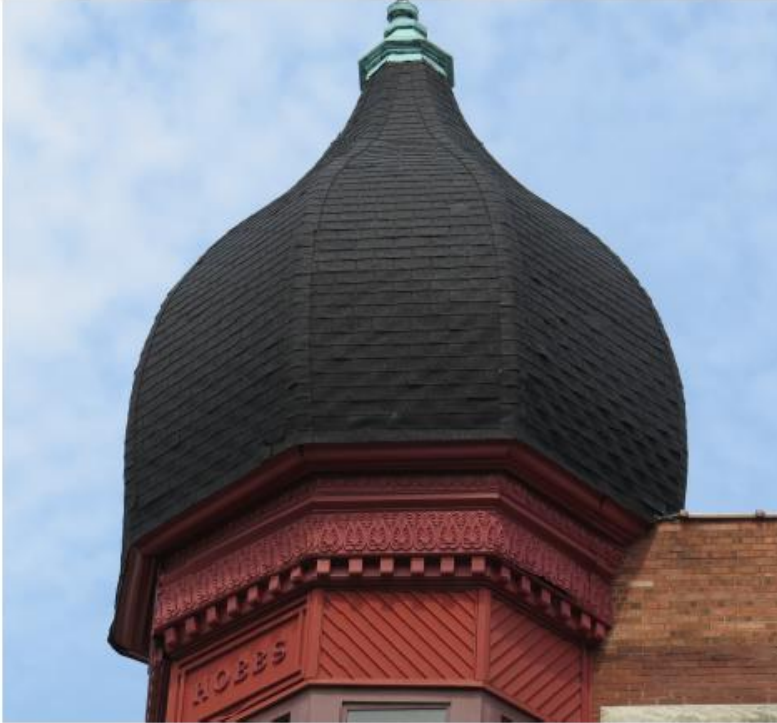
Refer to the two attached photos taken approximately one year apart. The photos indicate there have been some changes to the dome. Note on the most current photo there does appear to be a “collapsing” of the framing at the interface of the dome soffit and exterior wall.

Photo taken in 2015

The above will require extensive labor to accomplish the temporary stabilization. It is our professional opinion that no further temporary upgrades be made to the dome, but the dome be removed from the building thereby creating a safer condition.

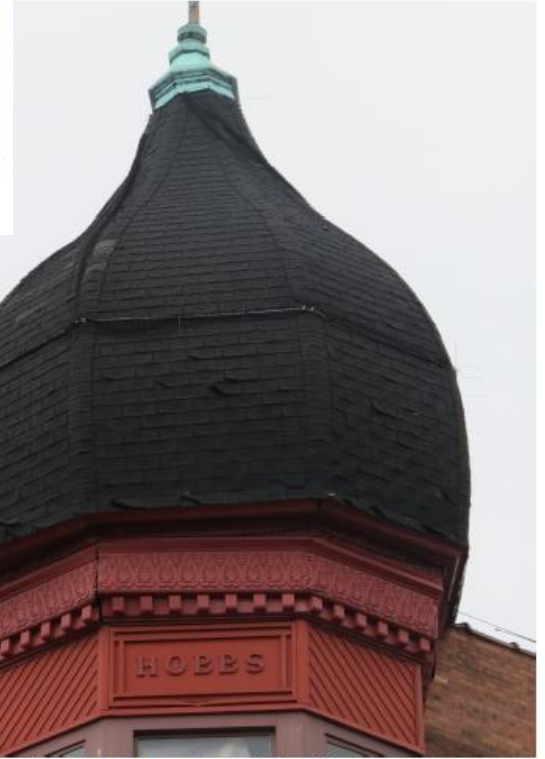
Photo taken at most recent site visit.

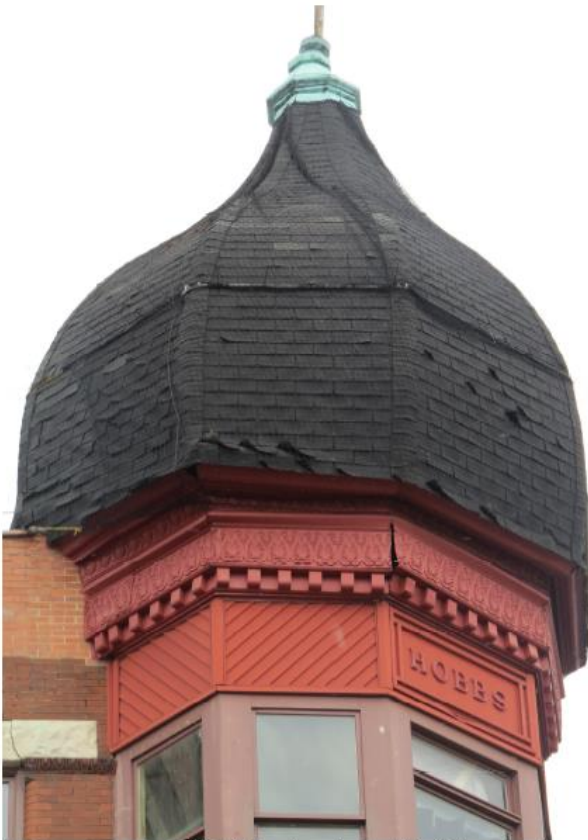
Photo taken at most recent site visit.

Comparing the most recent site visit with the earlier visit, asphalt shingles appear to be now “crimping” at the dome base. This suggests framing is collapsing along the base.
