MILLENNIUM PLAZA RENOVATION PRELIMINARY DESIGN

PREPARED FOR THE CITY OF AURORA
JUNE 2024

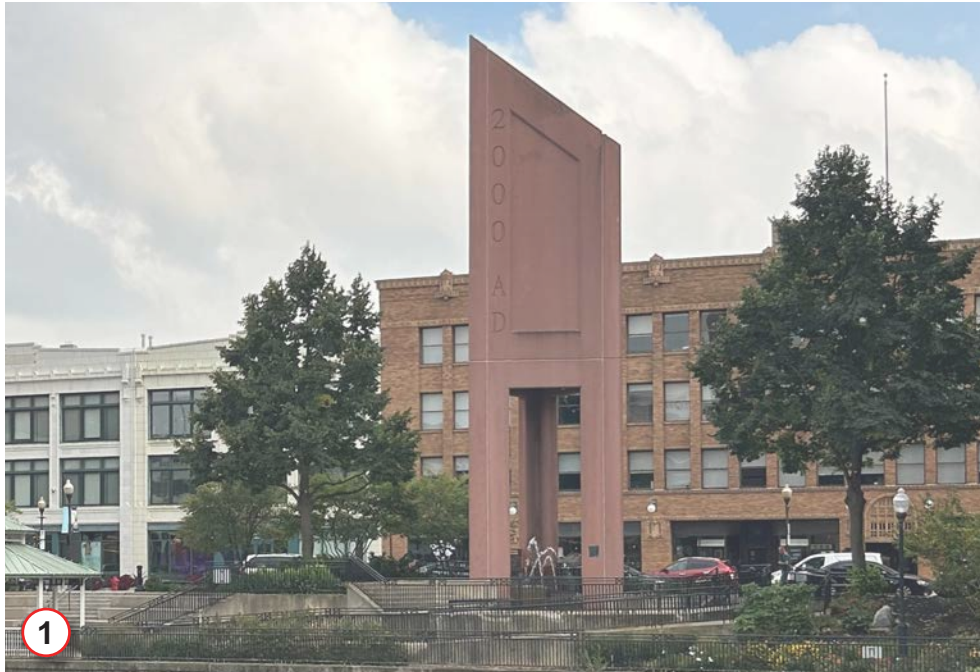
Millennium Tower is in fair condition, considered by some to be dated. Dedication plaque that tells the story and design intent is not directly adjacent to viewing platform and can be easily missed.

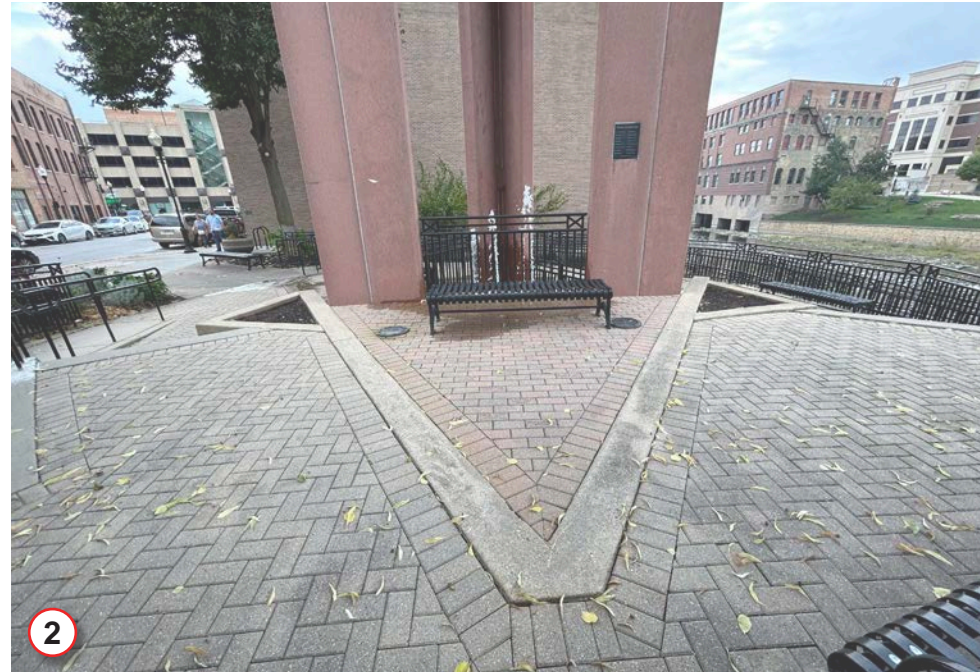
Existing fountain is functional, but is blocked off by guardrails. Existing paver field around monument contains engraved donor pavers. The existing pavers are in fair condition but have faded and lost their color.

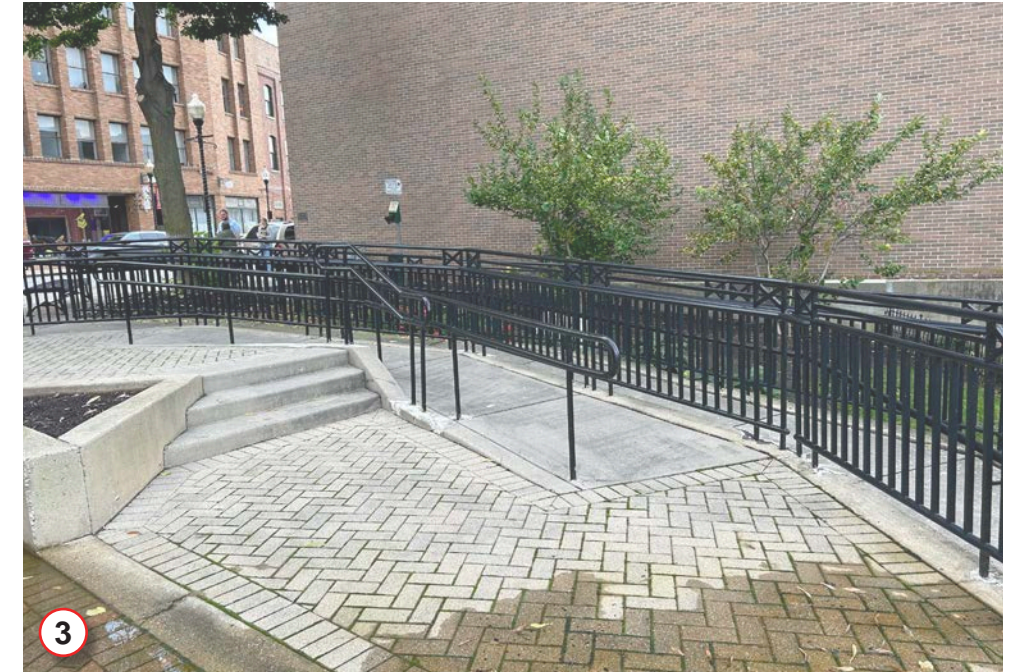
Stairs, ramps, and curbing are in fair/poor condition with visible cracking and chipping. The configuration of the stairs and ramps take up a large area.

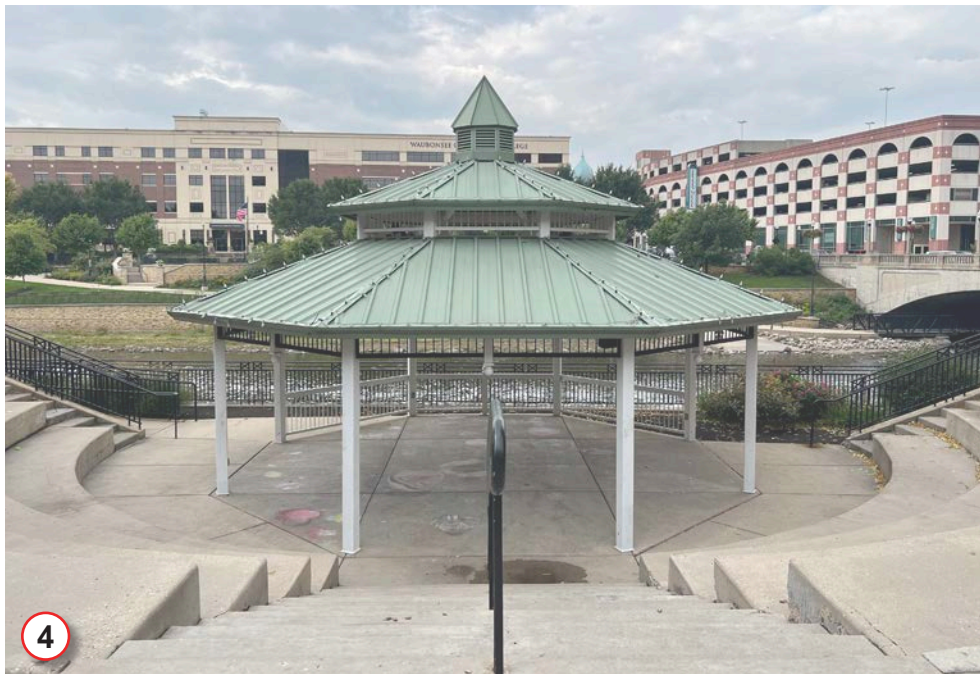
The prefabricated shelter is in fair condition but blocks views of the river.

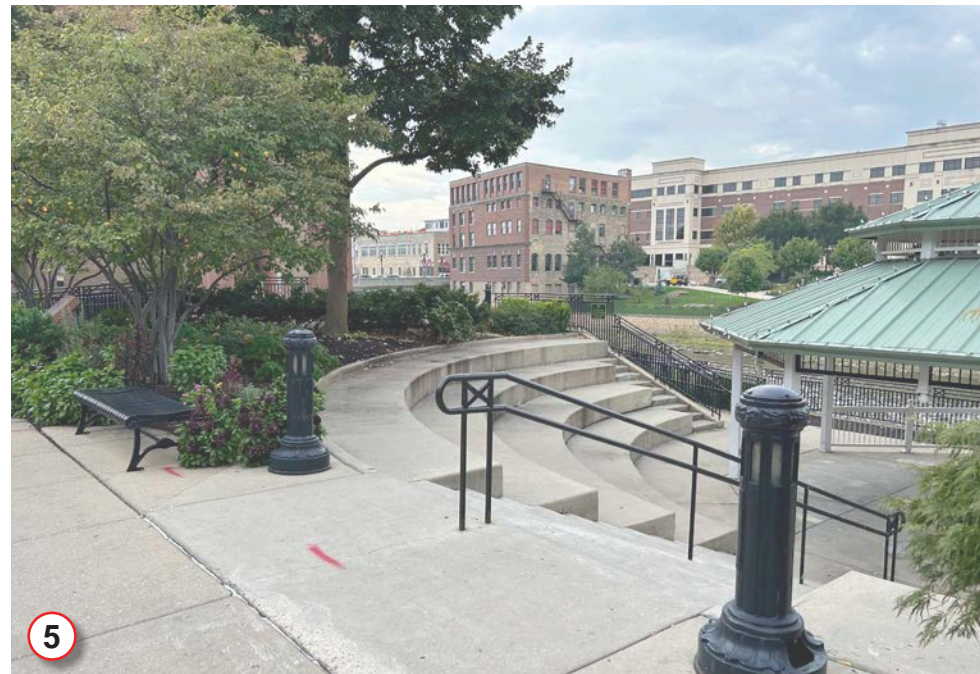
Terraced seating is centered around the shelter and takes up a large area. How often is this area used for performances and could it be better used for city events?

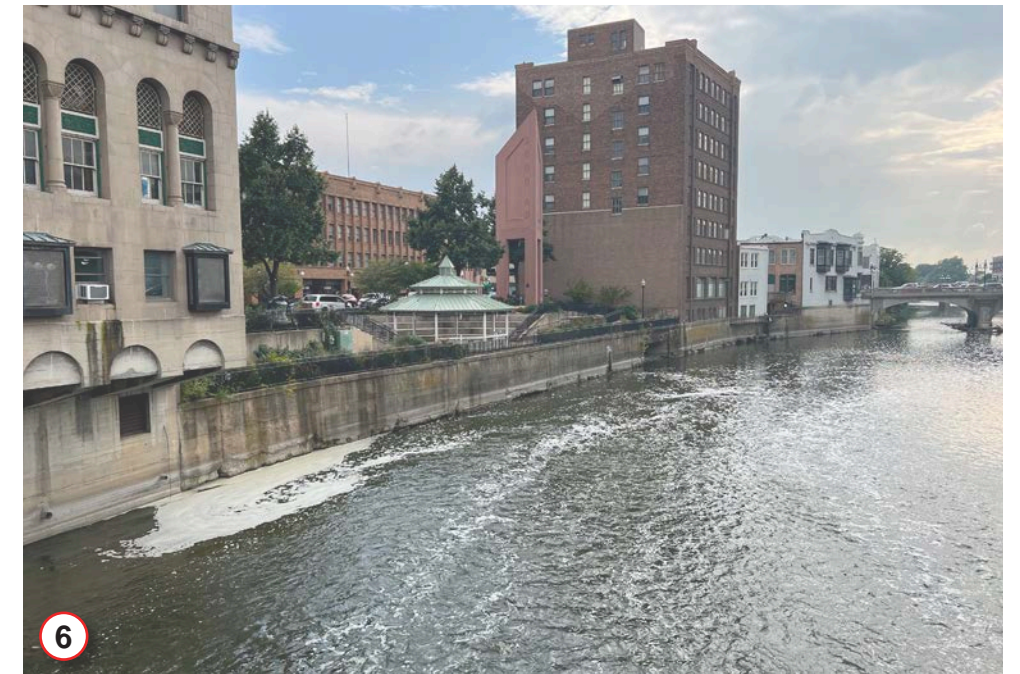
The existing river wall looks to be in poor condition, but a recent structural evaluation confirmed that it is structurally sound.

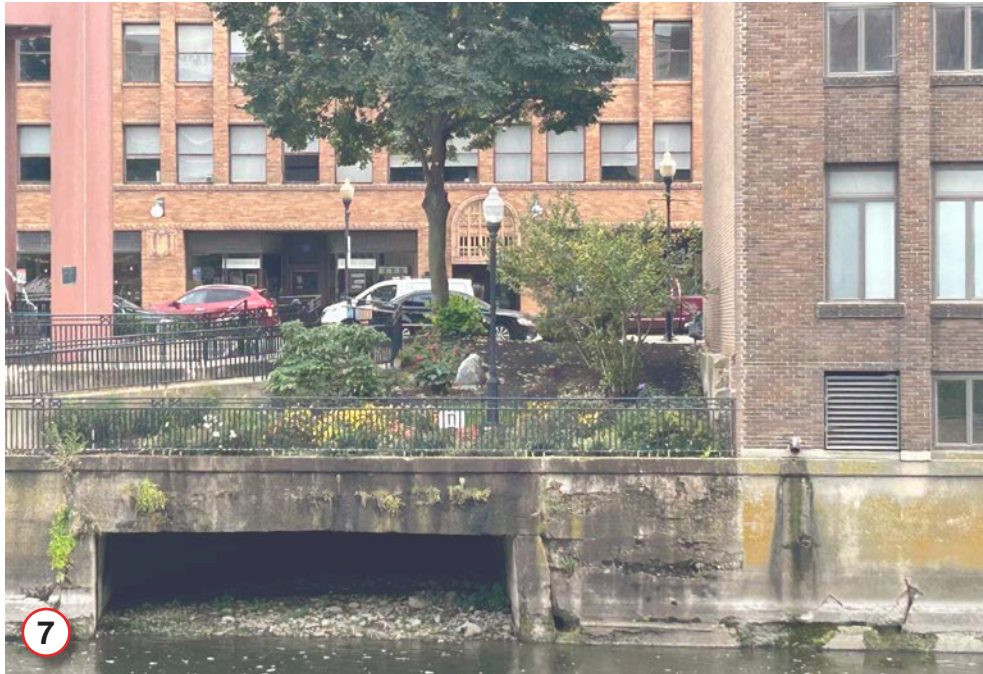
7 There is an existing culvert in the river retaining wall that is a relic of an old mill on site - opportunity to tell this story.

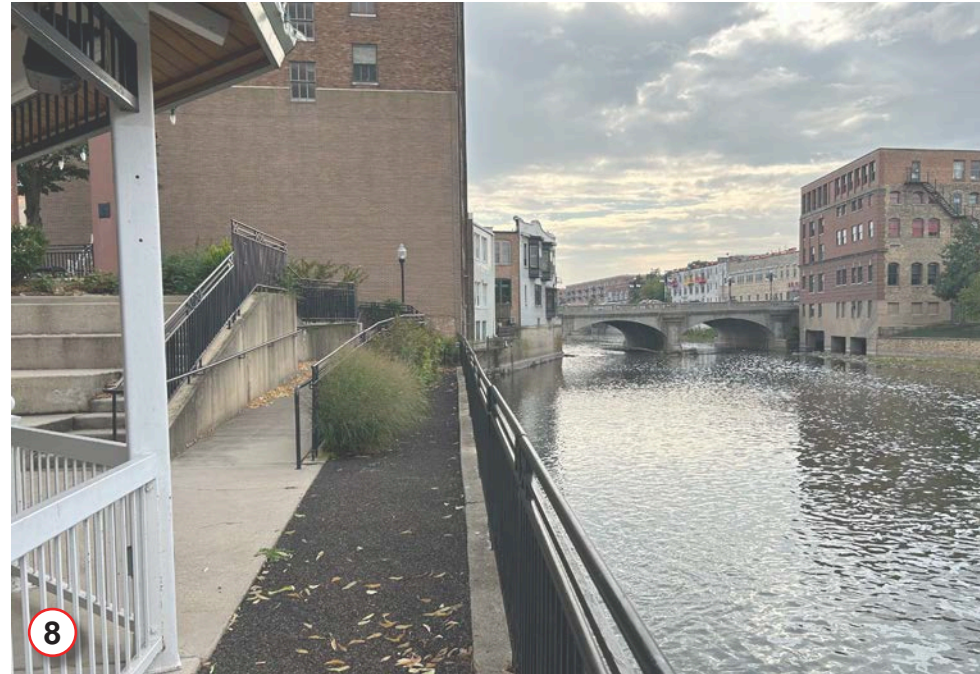
8 Limited space along the river edge. Current pavement is a rubberized surface. Existing guardrails are loose and some are zip-tied together.

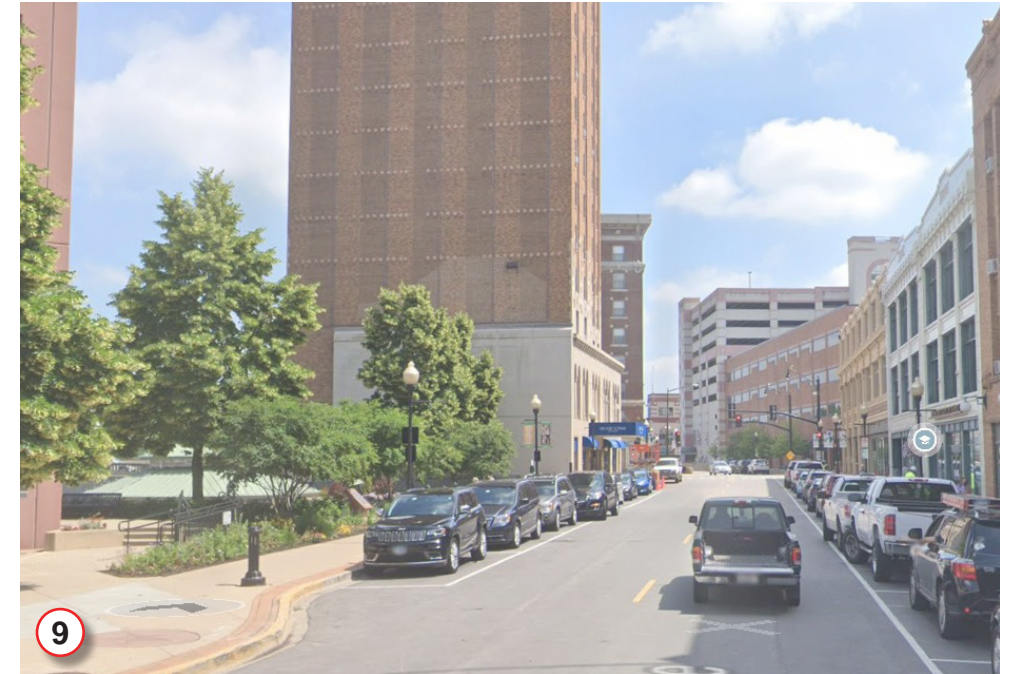
9 The existing streetscape is heavily used for festivals and events.

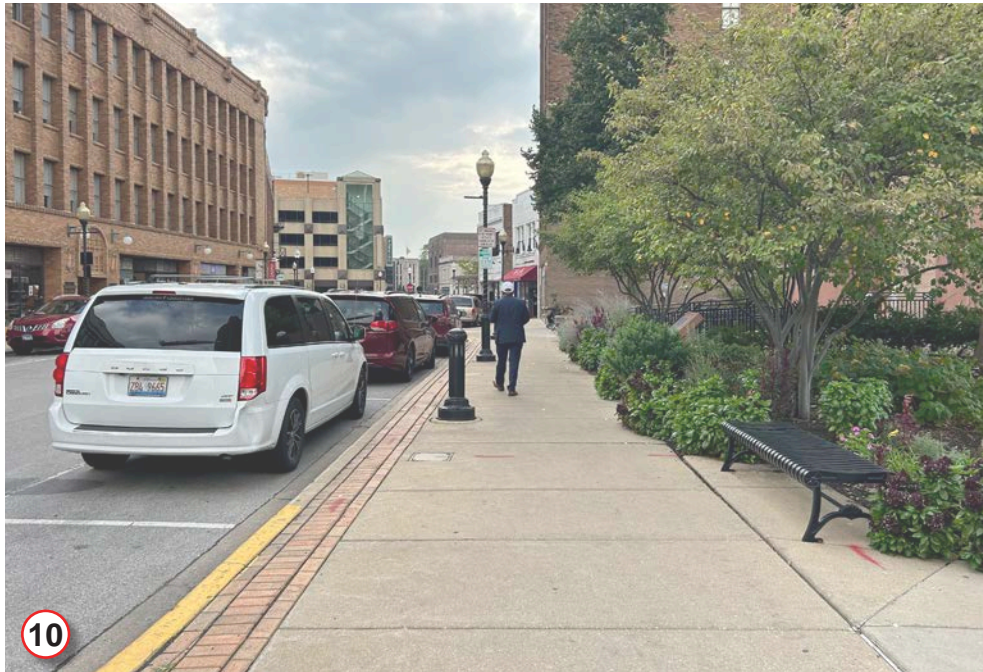
10 The existing streetscape and planting are well maintained and consistent with the downtown materials and aesthetic.

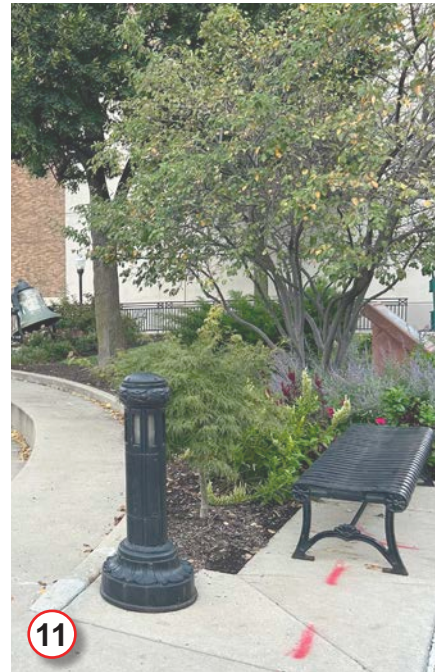
11 Existing lighting and furnishings are traditional in style and in fair condition.

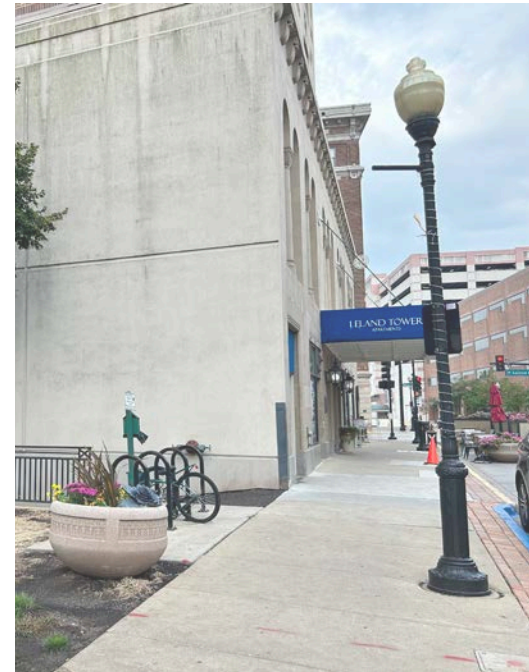
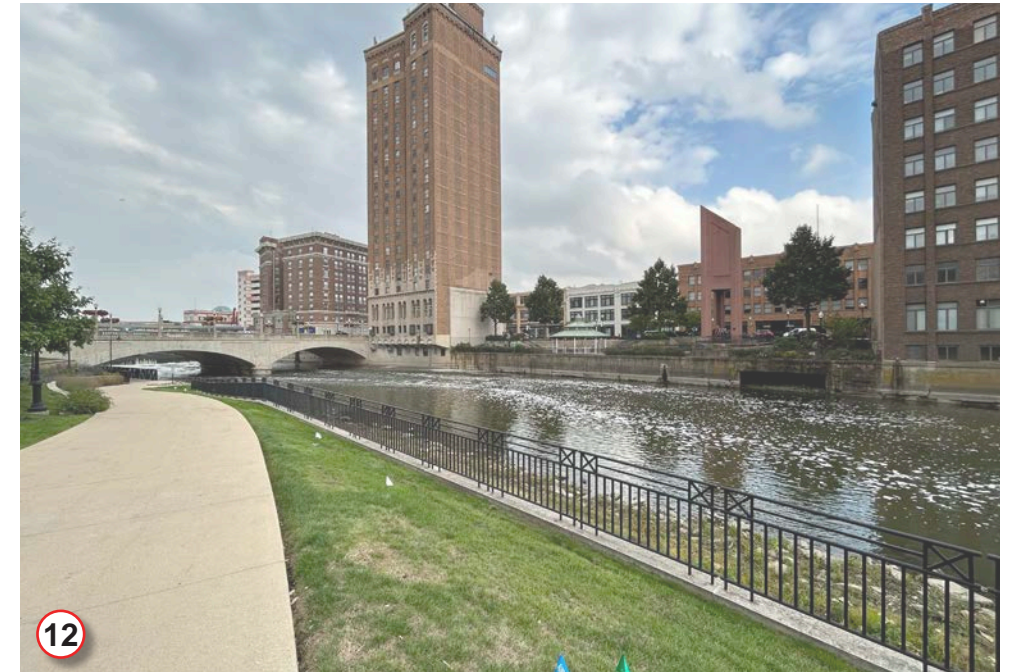
12 The adjacent buildings frame the space and provide opportunity for artistic or lighting elements.
