City of Aurora

2019 Bridge Condition Report

Rotary Plaza Pedestrian Walkway

Benesch Project No. 10483.03

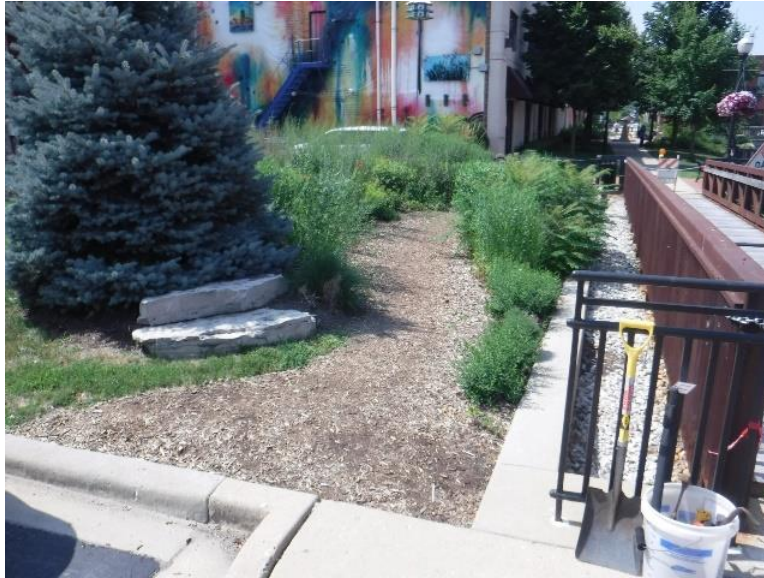
Photo A – Existing Detour East of Bridge

Since the closure of the existing pedestrian bridge, local foot traffic has created a detour just east of the structure, see Photo A. This option involves removing the existing superstructure and re-aligning the sidewalk to the existing detour, east of the current alignment. Moderate surface work in the adjacent area and additional pedestrian railing would be necessary. Additional work can be performed on the approaches to smooth out the alignment of the path and allow for a more natural route. The embankment below the existing structure would be left as-is since it is stabilized with riprap and well vegetated. The existing abutments can be left in place or removed.

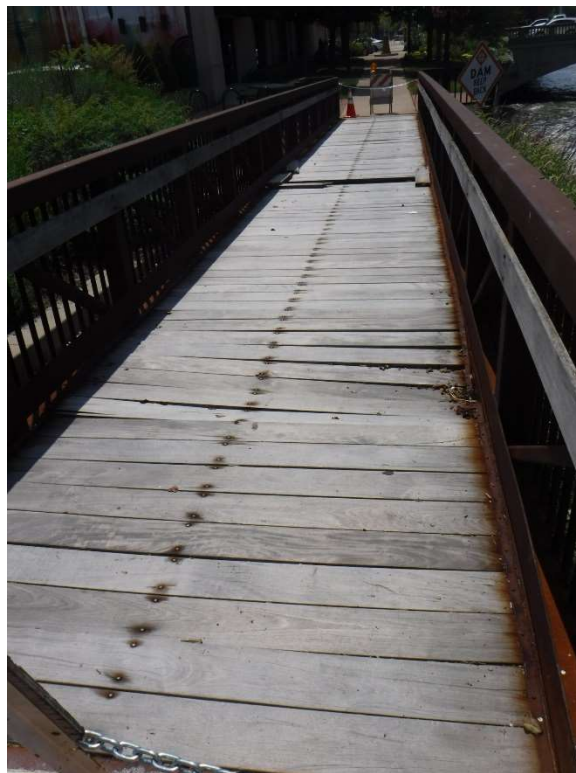
Photo 2 – Top of Deck, Looking South

Deck: Several of the planks throughout the deck area are loose and there are a few that are broken through. The welds along the plank hold downs are broken and there is moderate corrosion throughout the hold downs.

The first option to consider is to repair the existing structure. As noted in the previous section, the inspection of the existing structure found the deck and floor system to be beyond repair. It would be necessary to remove and replace the timber deck, plank holddowns, stringers, center nailer, diagonal bracing and floorbeams to return the existing structure to a functional condition. Additionally, the existing truss is designed to an outdated code and the bottom chord has moderate deterioration. In order to achieve a reasonable service life for the structure after the rehabilitation is complete, the bottom chord would require extensive repairs. Due to the significant member replacement and strengthening that would be required, liability issues repairing an existing bridge designed to an old code, and the environmental issues that you may have with the blasting and painting on site this option is not considered economical nor viable.

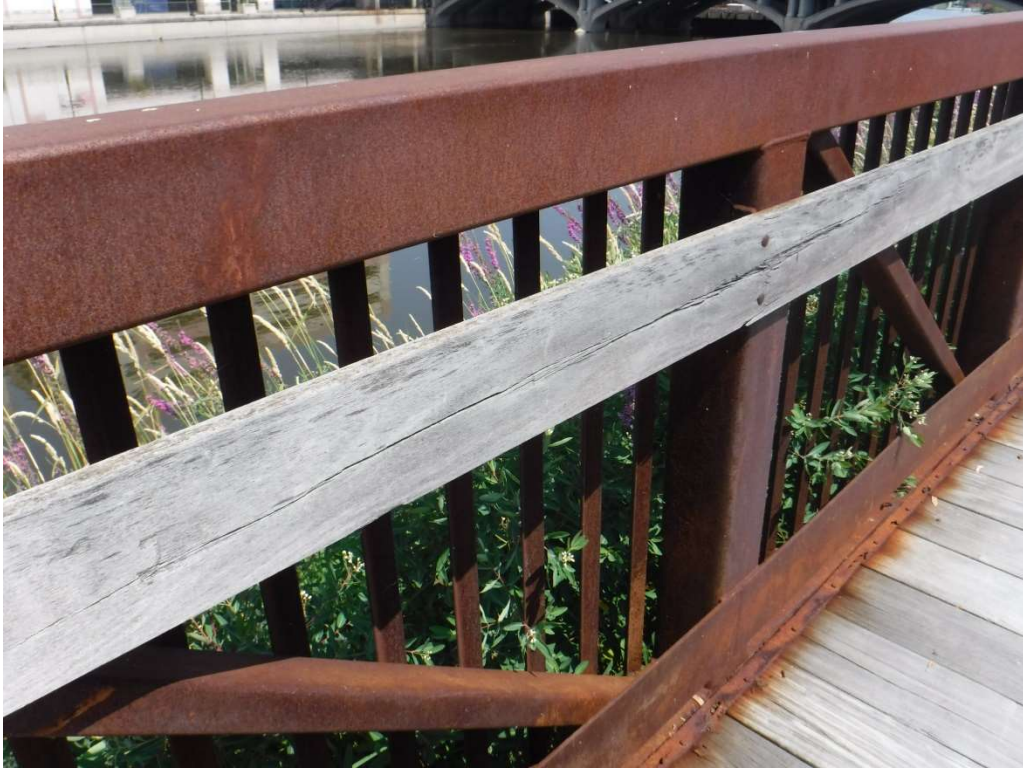
Photo 3 – Typical Truss above Deck and Rub Rail, Looking Northwest

Truss: The weathering steel protective coating show signs of degradation on the truss members above the deck. The diagonal and vertical members have minor section loss. The bottom chord has moderate section loss and moderate to heavy flaking on the bottom face and along the inside face between the plank hold down and the face of the chord. There is debris collecting between the railing pickets and the outside face of the bottom chord. The toe plate connection welds are intact. The rub rail bolted to the vertical members is heavily weathered and split in several areas.

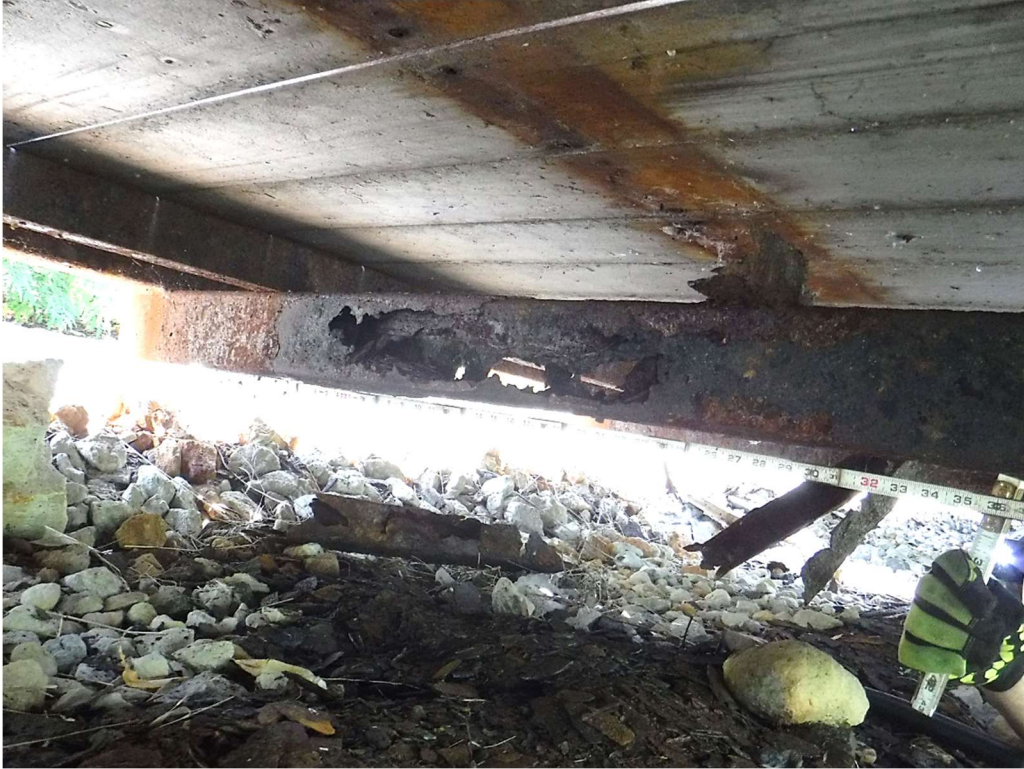
Photo 5 – Floorbeam 5, Looking Southeast

Floorbeams: The floorbeams typically have moderate to heavy corrosion with moderate to heavy flaking throughout the inside and outside faces. Ten of the thirteen floorbeams have corrosion holes on up to three faces of the member in a single cross section. The corrosion holes range from 1” to 24” along the length of the floor beam and up to the entire vertical face height.

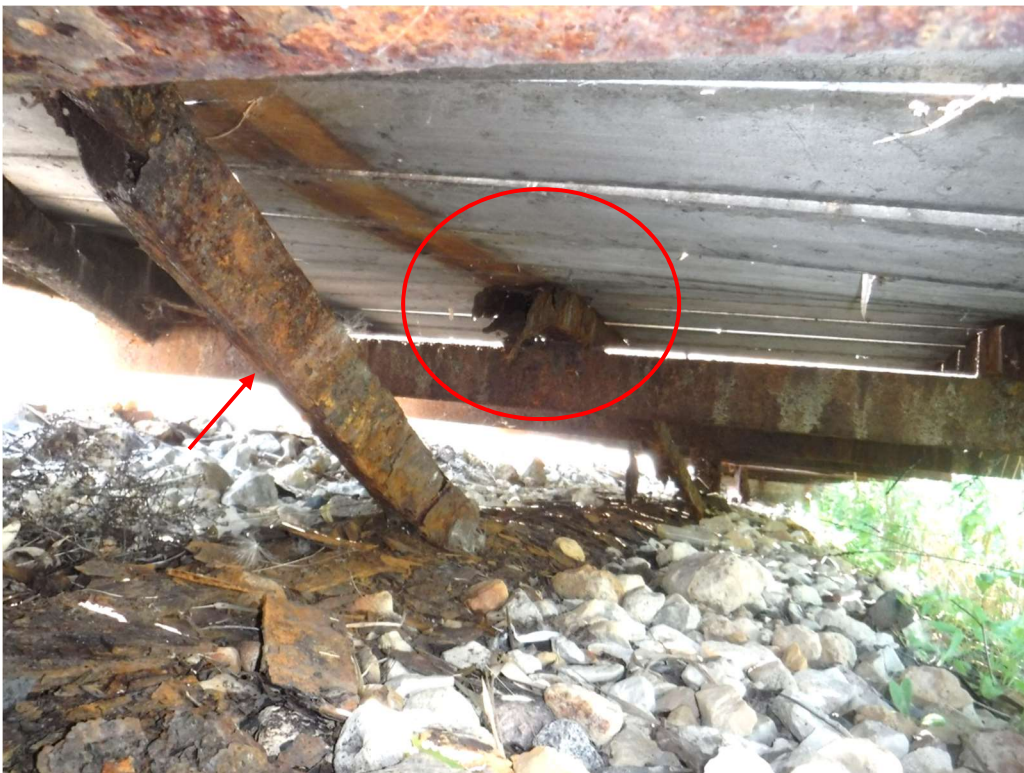
Photo 8 – Typical Center Nailer, Looking South

Stringers: The two stringers have moderate to heavy corrosion with moderate flaking, and the center nailer has failed through the majority of the bridge.

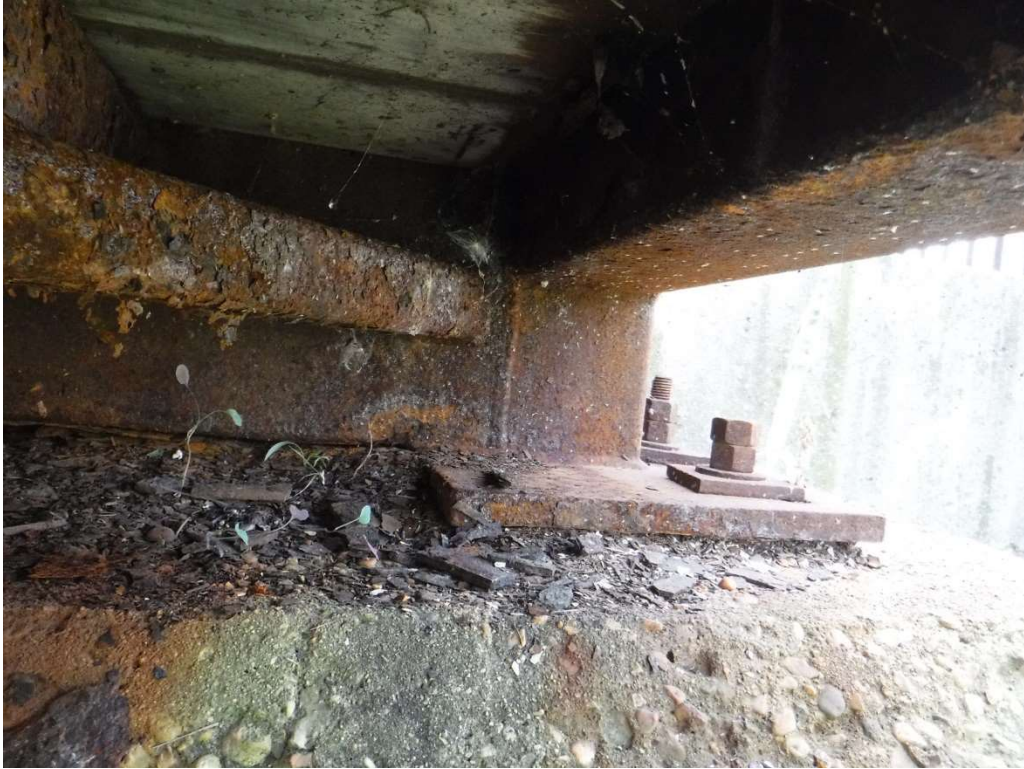
Photo 9 – Southwest Bearing

Bearings: The southeast bearing is buried and the other three bearings have minor debris surrounding them. There is minor corrosion and flaking on the bearing plates.

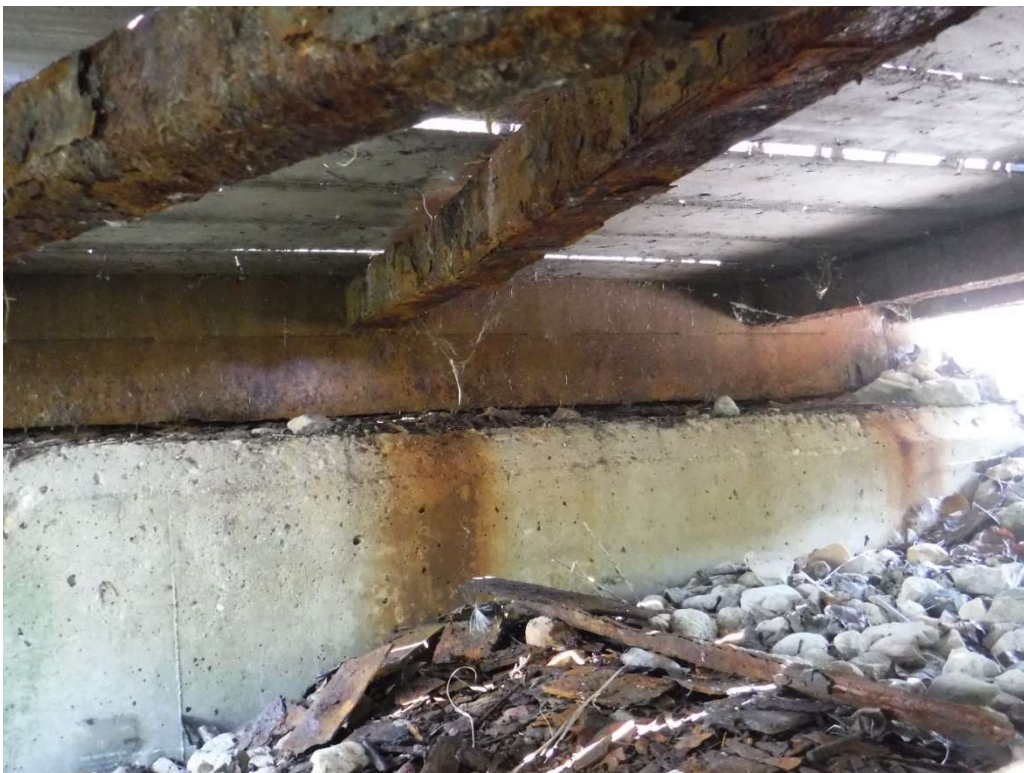
Photo 10 – North Abutment, Looking North

Abutments: The abutments have corrosion staining and minor to moderate debris build-up on the bearing seat. There is minor scour along the west end of the South Abutment along the embankment.
