Via E-mail: mkoos@chubb.com

March 6, 2019

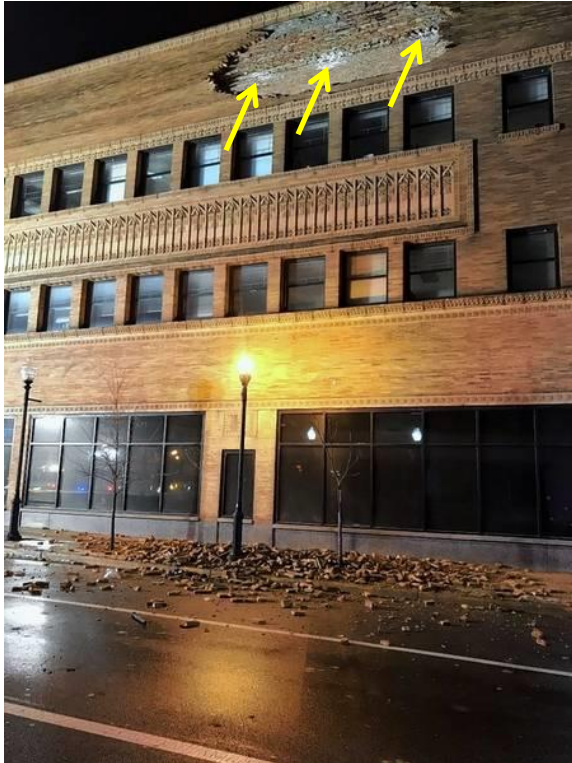
*Figure 5. Conditions on February 20, 2019 shortly after brick fell; note what appear to be efflorescence or frost spots on backup masonry (arrows)
(photo courtesy of Aurora Police Department as published in the Daily Herald:
<https://www.dailyherald.com/news/20190220/galena-boulevard-in-aurora-closed-after-partial-building-collapse>)*

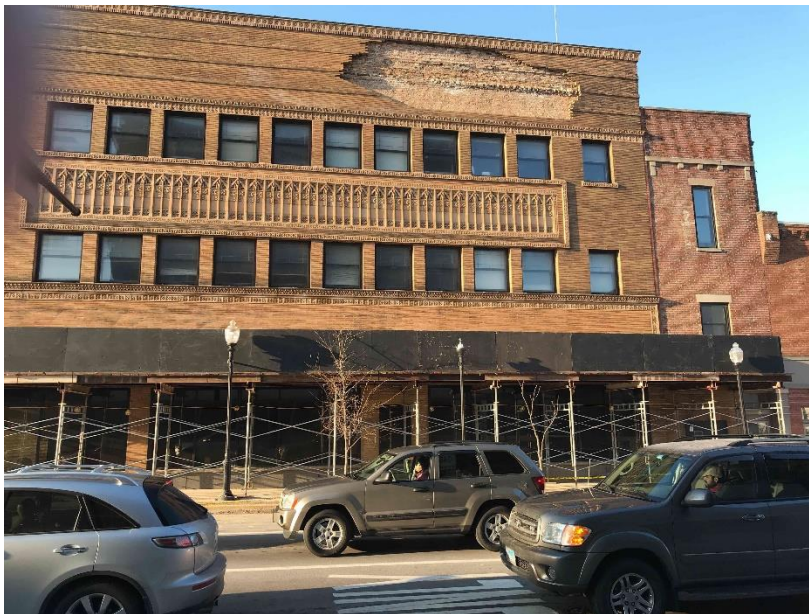
Figure 6. Conditions on February 22, 2019 after removal of additional brick masonry and erection of sidewalk canopy (photo courtesy of FHP)

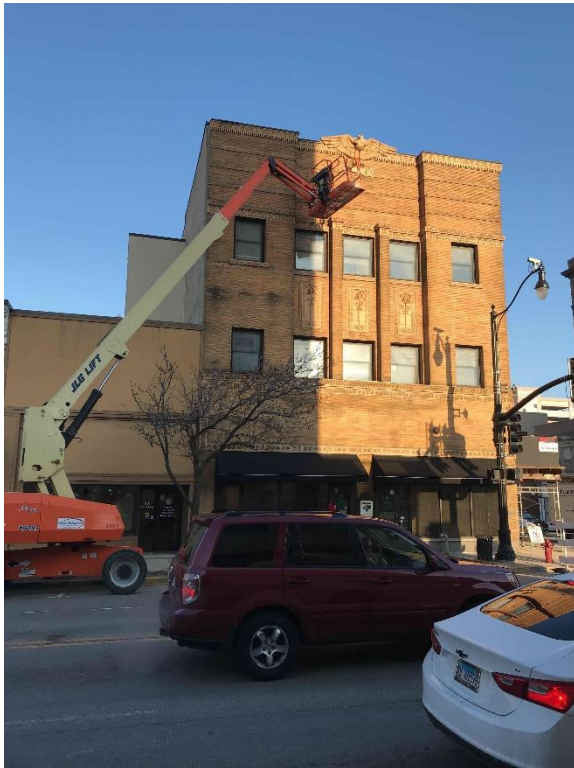
Figure 7. Inspection of east facade on February 22, 2019 (photo courtesy of FHP)

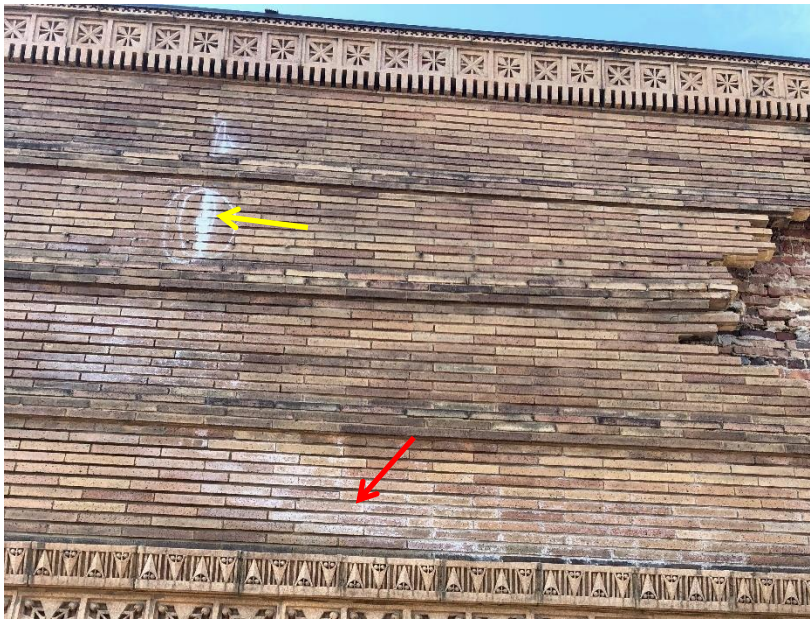
Figure 10. Extents of bulged face brick marked with white chalk by FHP (yellow arrow); also note frost or efflorescence on face brick (red arrow) at perimeter of bulged area (photo courtesy of FHP)

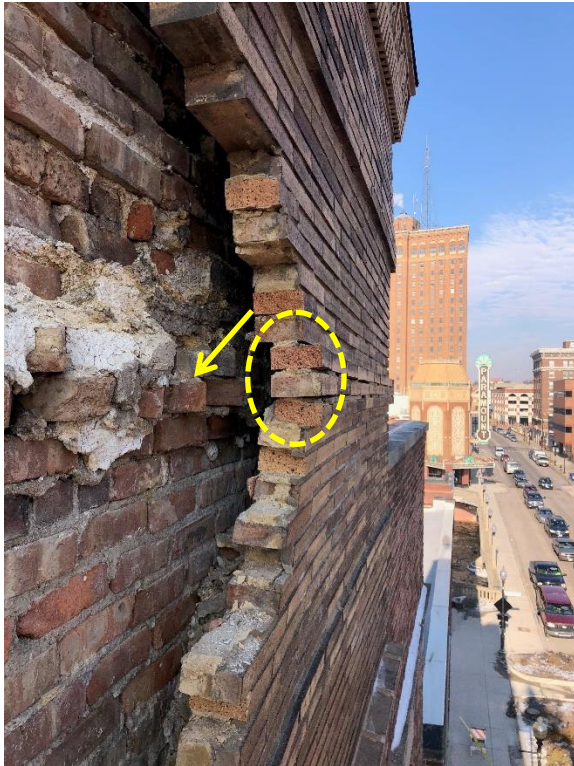
Figure 11. Bulged face brick; backup brick laid diagonally (arrow) corresponds roughly with roof line; the diagonal bricks may have served as blind headers to engage the adjacent projecting courses of face brick (circled) (photo courtesy of FHP)

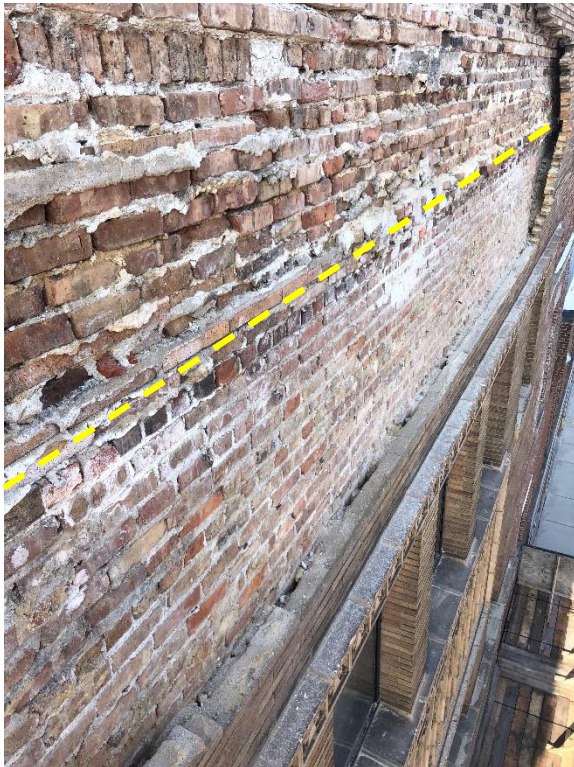
Figure 14. Irregularly spaced and corroded veneer ties visible below roof line (approximate location shown by dashed line), see Figure 15 for closer view (photo courtesy of FHP)

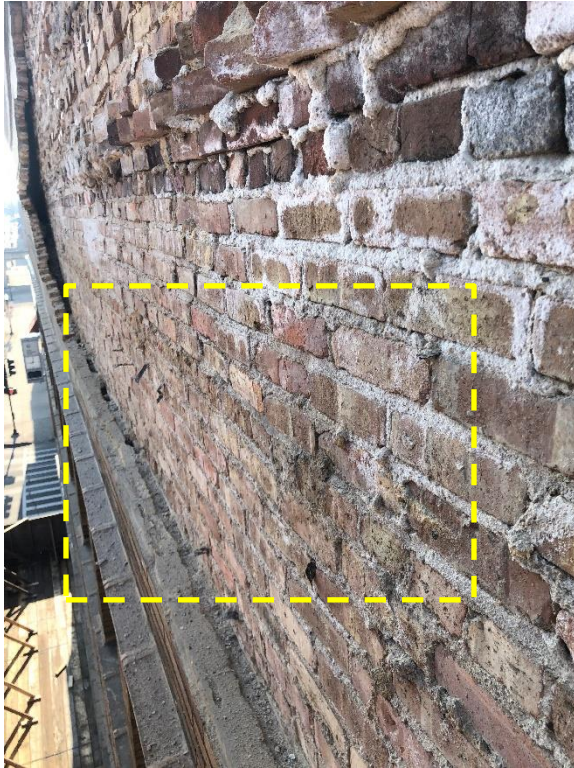
Figure 15. Irregularly spaced and corroded veneer ties below roof line, see Figure 16 for enlarged view of outlined area (photo courtesy of FHP)

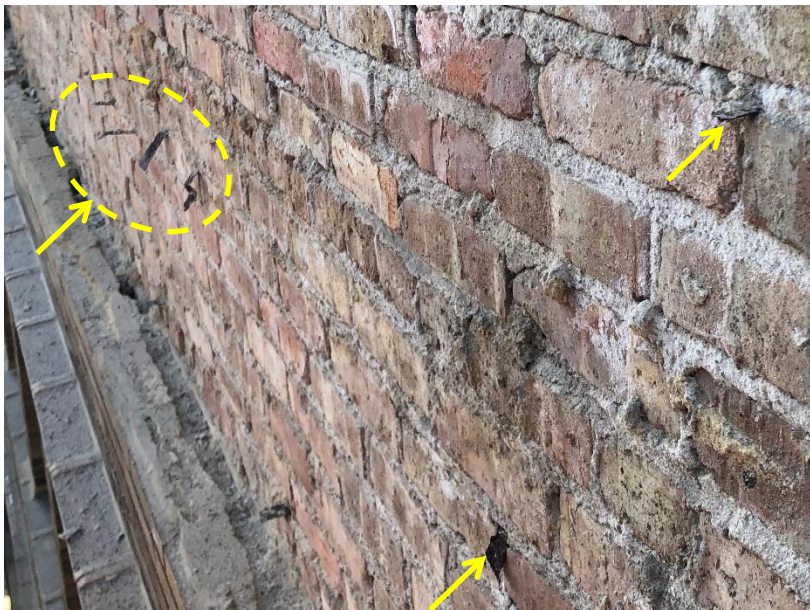
Figure 16. Irregularly spaced and corroded veneer ties below roof line (photo courtesy of FHP)

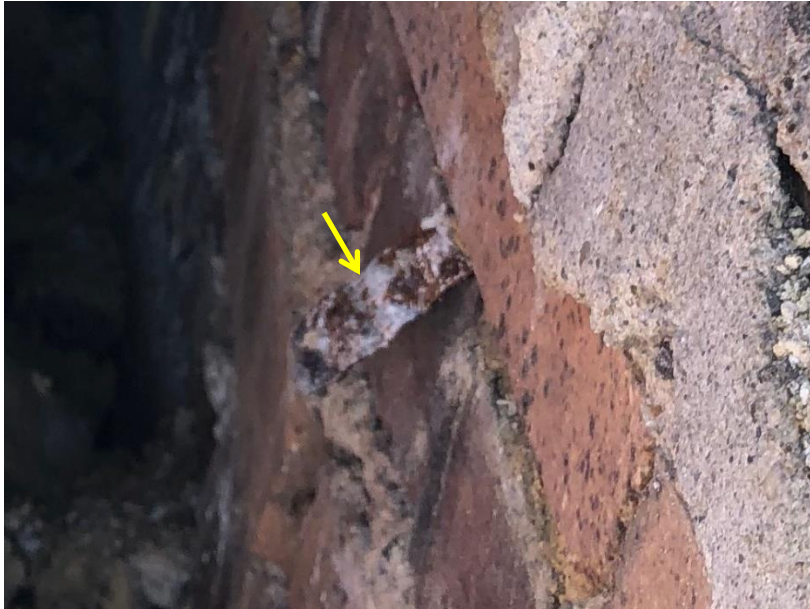
Figure 17. Close-up view of veneer tie with relatively minor corrosion but no engagement with face brick (photo courtesy of FHP)

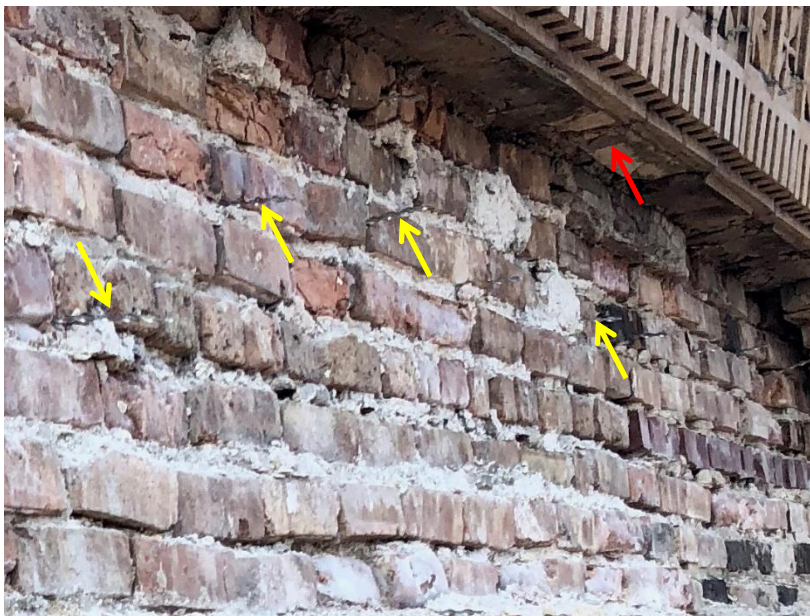
Figure 18. Previously installed supplemental helical anchors near top of failed area (yellow arrows); it is unclear whether the terra cotta units above (red arrow) are deep enough to bear on the backup brick masonry, or whether any shoring was installed prior to covering the area with the tarp (photo courtesy of FHP)

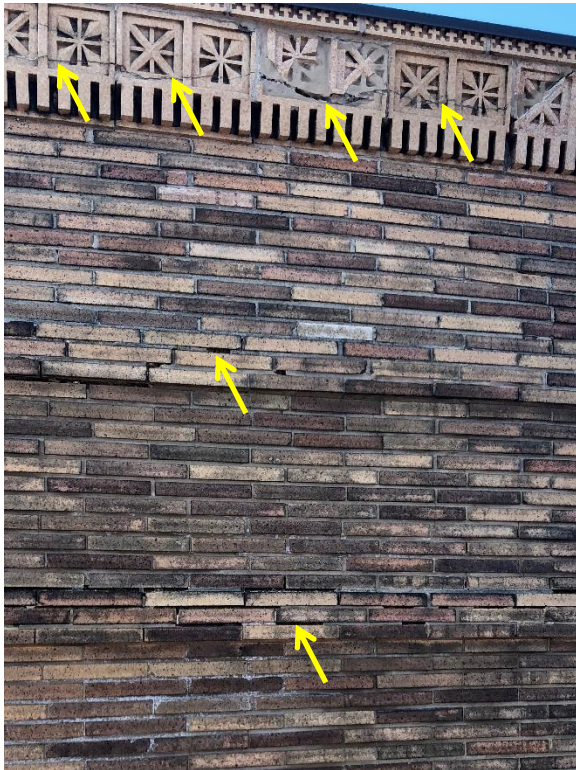
Figure 19. Open mortar joints in brick masonry and cracked terra cotta units (photo courtesy of FHP)

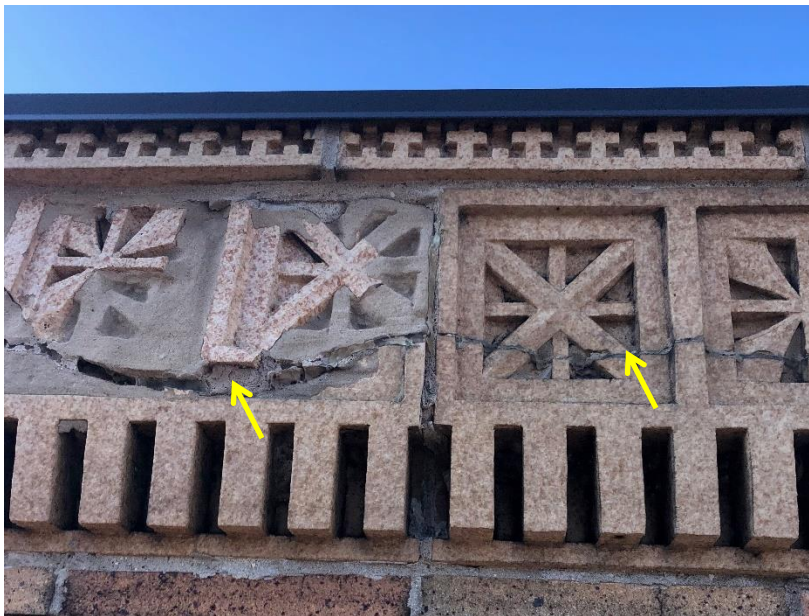
Figure 20. Cracked and previously repaired terra cotta units (photo courtesy of FHP)

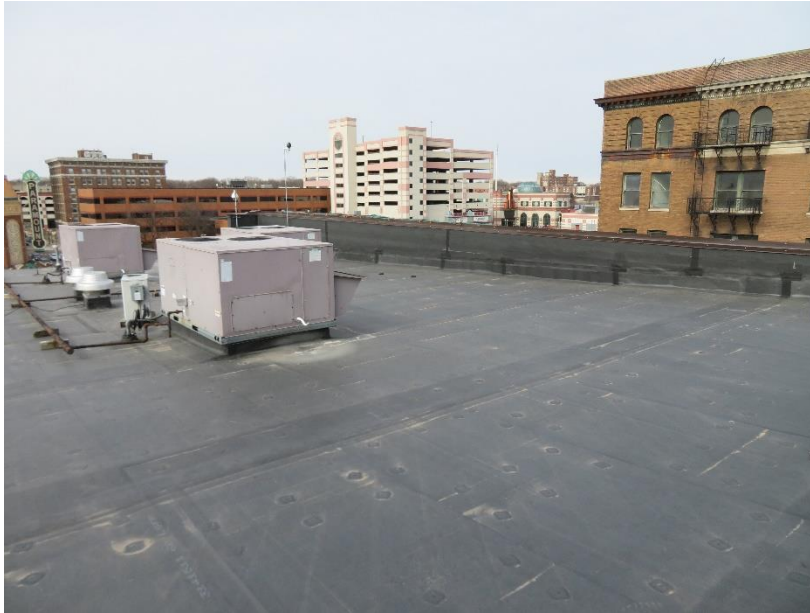
Figure 21. Overall photo of the roof looking northwest

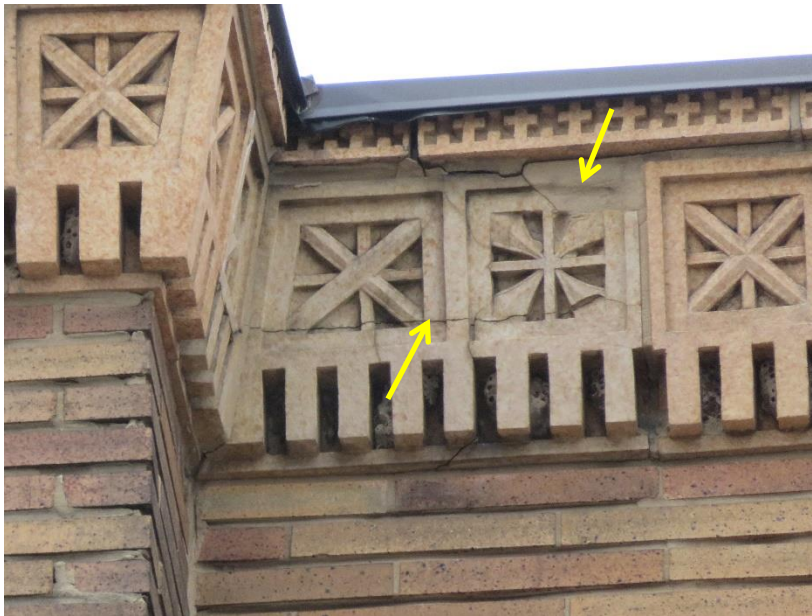
Figure 26. Cracked and previously patched terra cotta unit at parapet on east facade

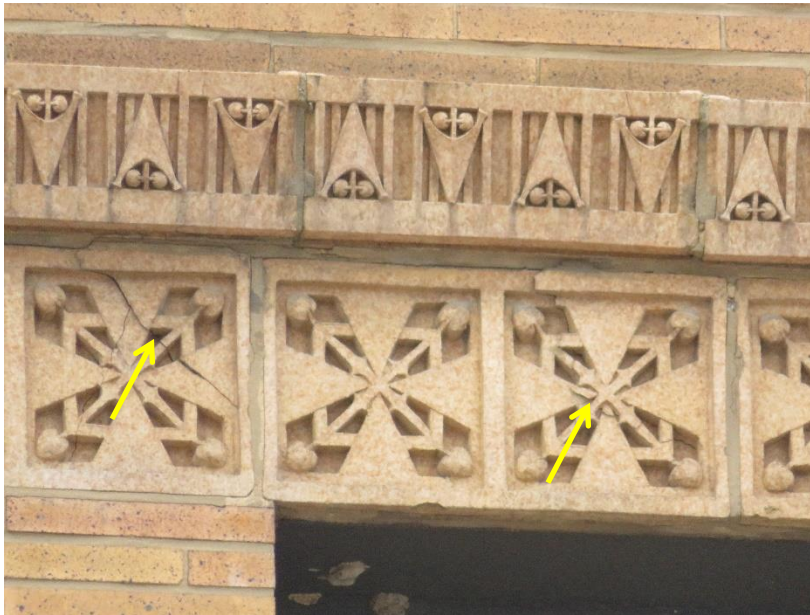
Figure 27. Cracked terra cotta units on east facade above third floor windows

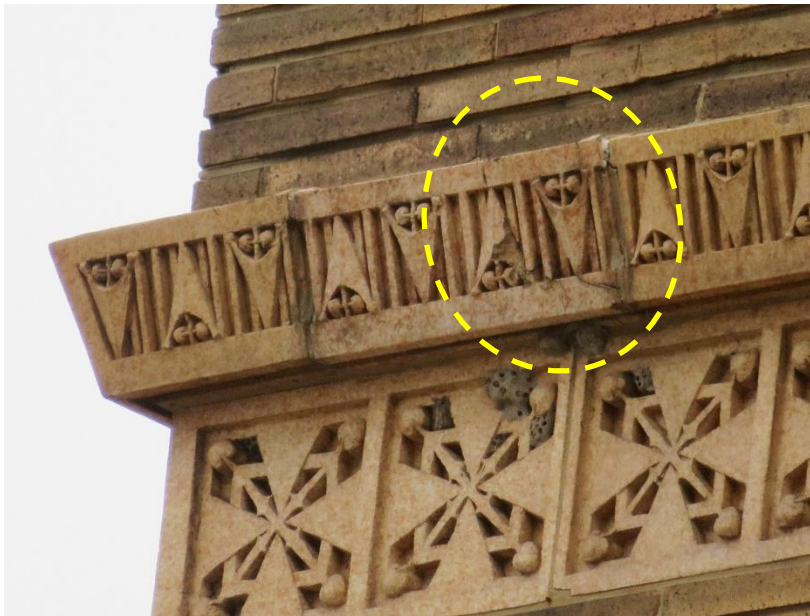
Figure 28. Cracked terra cotta unit on the north facade at the top course above the third floor windows

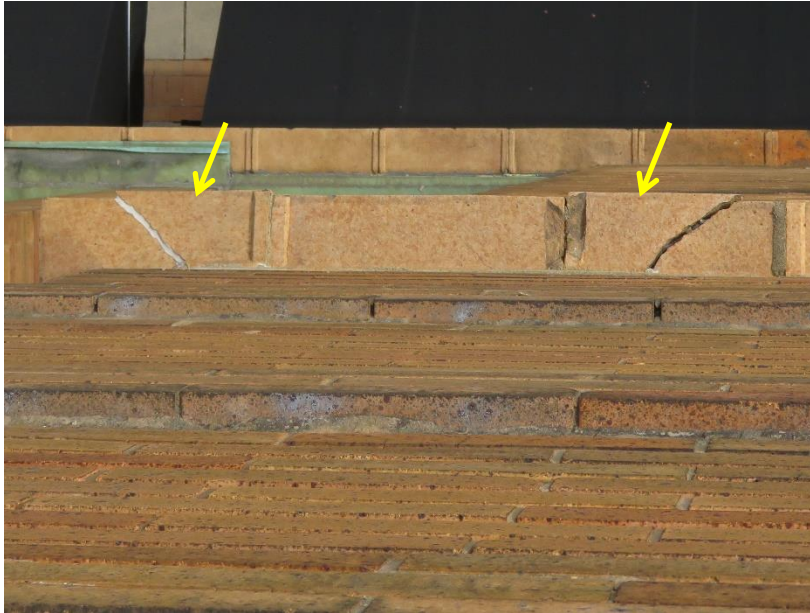
Figure 29. Cracked and displaced terra cotta units on the east facade at the top course above the third floor windows (viewed from the roof)

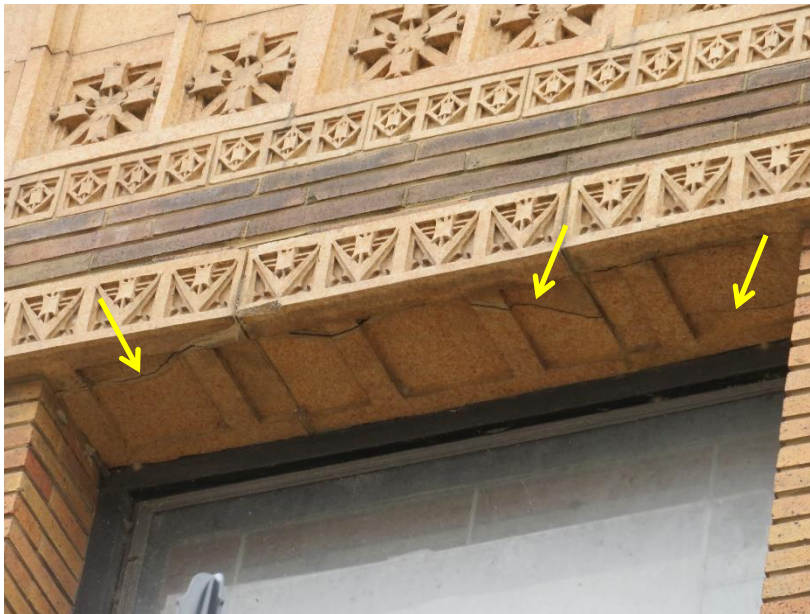
Figure 30. Cracked lintel units above the second floor windows on the north facade (condition typical at majority of second floor window lintel units on north facade)

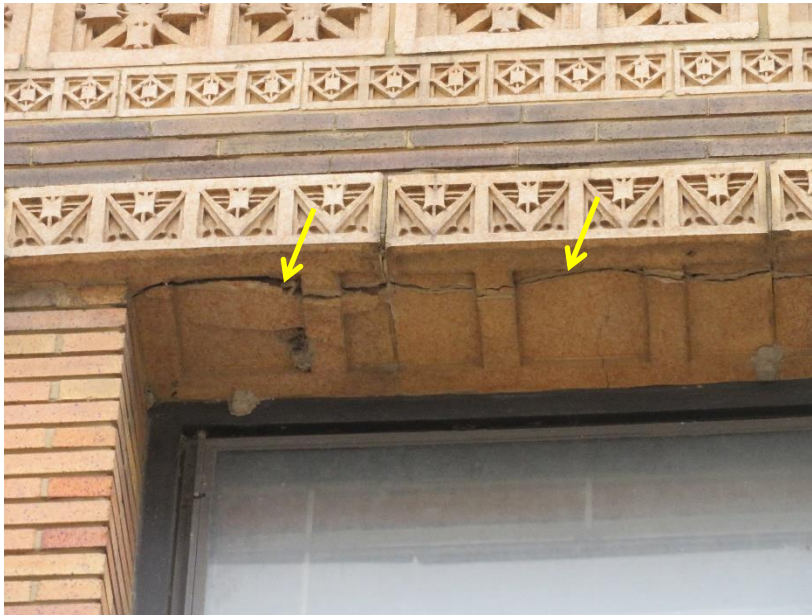
Figure 31. Cracked and spalled lintel units above the second floor windows on the north facade (condition typical at majority of second floor window lintel units on north facade)

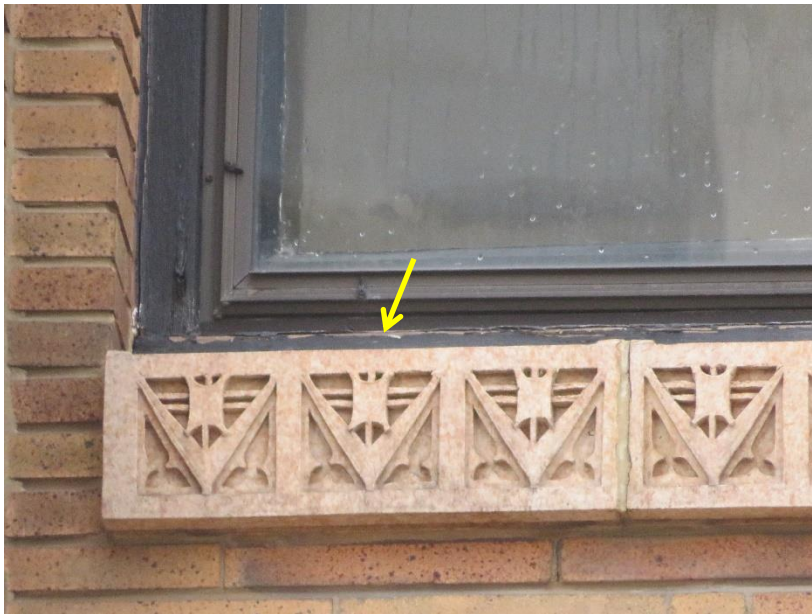
Figure 32. Peeling paint at wood window frame outside of metal storm window
