Re: Well 18

CITY OF AURORA
 WELL #18 PUMP INSPECTION REPORT

JOB NAME	Aurora	WELL	18	DATE	09/10/18
JOB NO.	50711	INSPECTED BY	J. Poppen, T. Healy, B. Balluff		
		BOWL ASSEMBLY	Byron Jackson 12 stage 13/12MQH		
		COLUMN ASSEMBLY	939' of 10" Sch 60 8RND		
		MOTOR	Byron Jackson 350 HP, 16", Type H

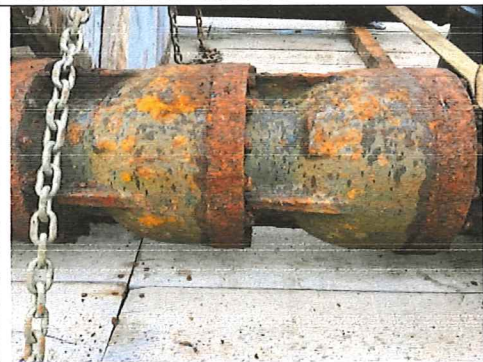
Bowl exterior pre sand blast

The bowl assembly exteriors have light erosion throughout. Throughout, the bowl assembly interior has moderate vein erosion and undercutting in the throat above the wear ring. The motor adapter bracket has localized heavy erosion. All erosion to the casting bodies are in locations of thick material construction.

Rebuild bowl with new custom wear rings, bushings, and impeller shaft. Ceramic coat bowl interior. Install stainless fittings.

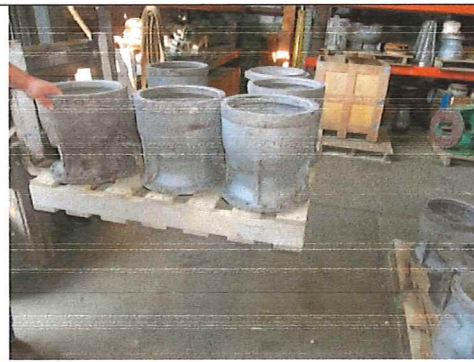
Bowl exteriors post sand blast

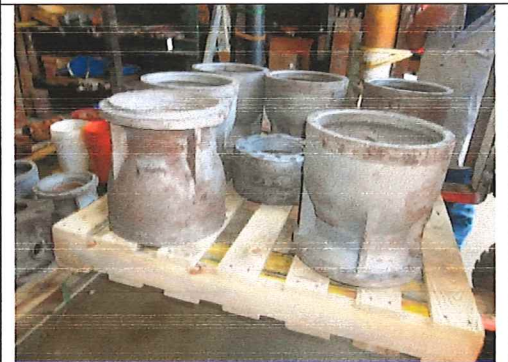
Bowl exteriors post sand blast

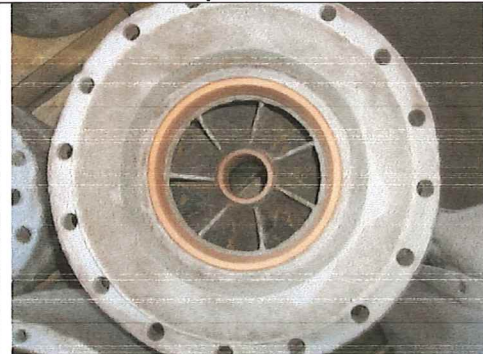
Wear ring and bushing clearance tolerances exceed acceptable

All bushing and wear ring clearance tolerances exceed specification. The impeller shaft has light wear in the bushing areas and heavy pitting in one localized area. The stainless screen is in good condition. The carbon fittings are in very poor condition.

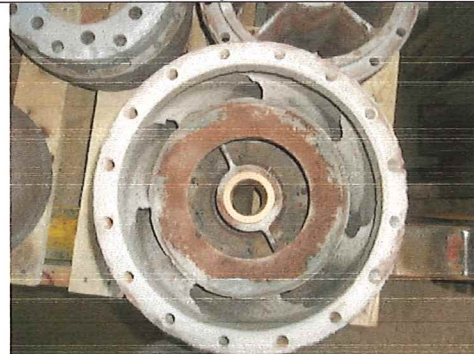
Moderate vein erosion (Typ.)

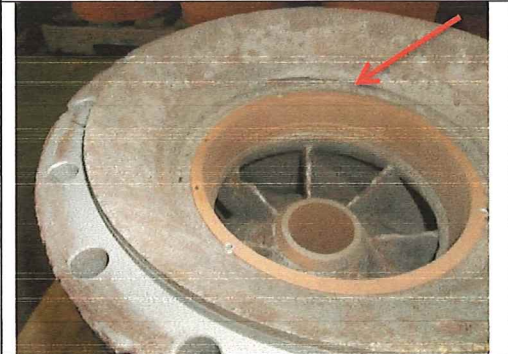
Undercutting above wear rings (Typ.)

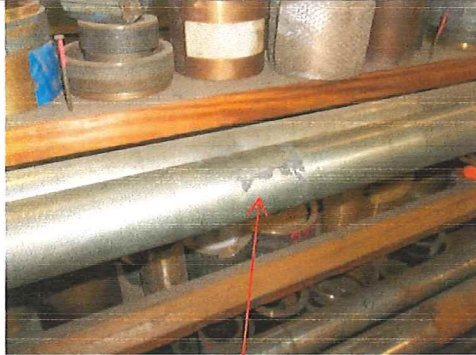
Impeller shaft is lightly worn in bushing areas and has one area of heavy pitting

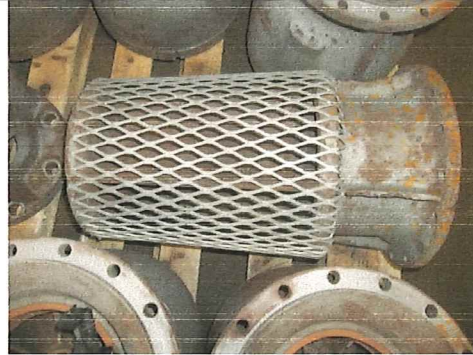
Stainless screen in good condition

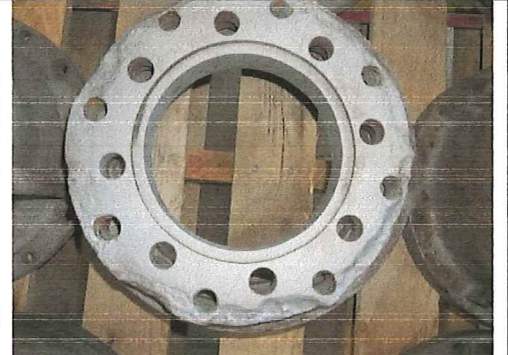
Motor adapter bracket erosion

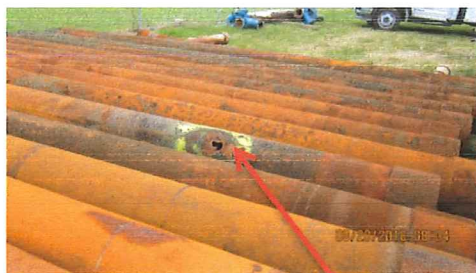
10", Sch 60 8RND T&C Line Pipe racked at Aurora Well 18 site. Large hole in 41st joint from top, four joints above bowl

The entire string of pipe has significant buildup of deposits on its interior, particularly below static water level. Large hole in the middle of the fourth joint above bowl and just below lower surge control valve which appears to be wedged in the closed position. Prior to pipe clean up, it appears that at least

Bring entire string to Layne yard for inspection sand blast.

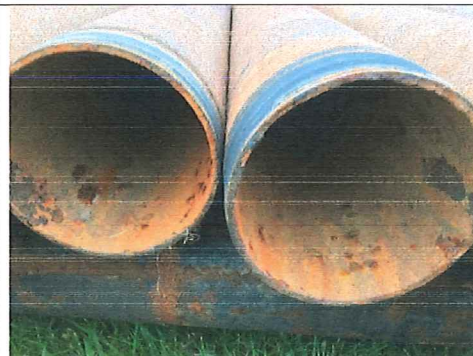
Significant deposition on pipe interiors.

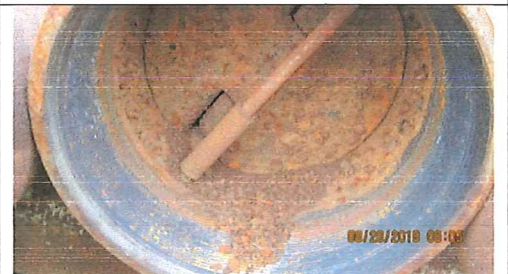
Lower surge control "locked" in closed position.
