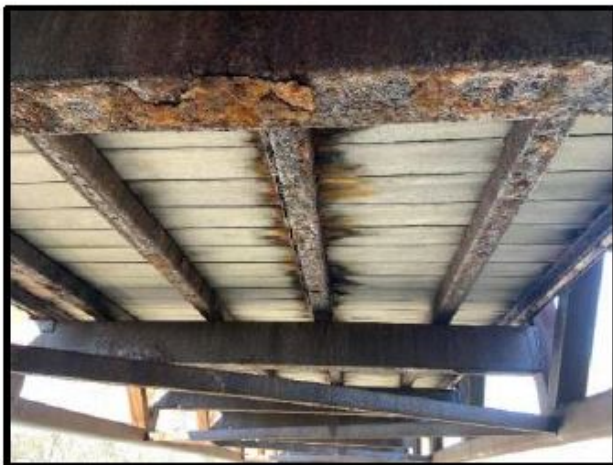
*Typical Steel Deterioration*

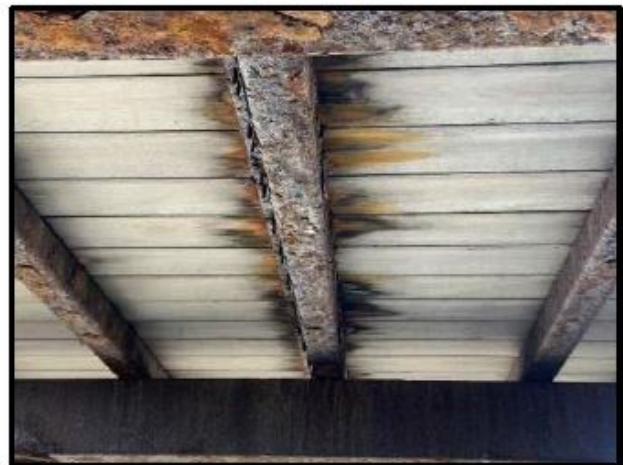
*Pack Rust and Section Loss in Stringer*

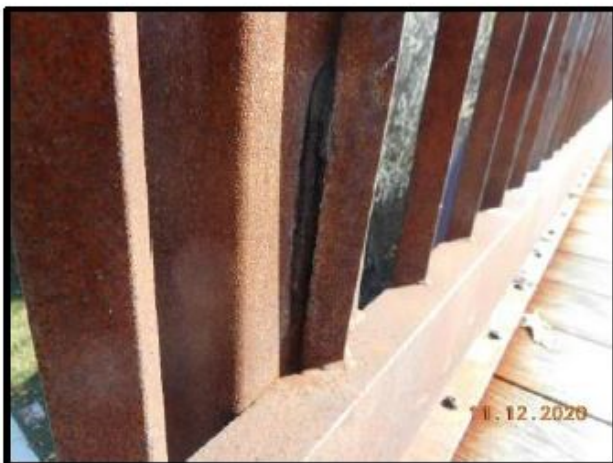
*Pack Rust at Weld Between Picket and Tube*
