Technical Memorandum

Riverwalk Promenade Inspection

October 28, 2016

City of Aurora

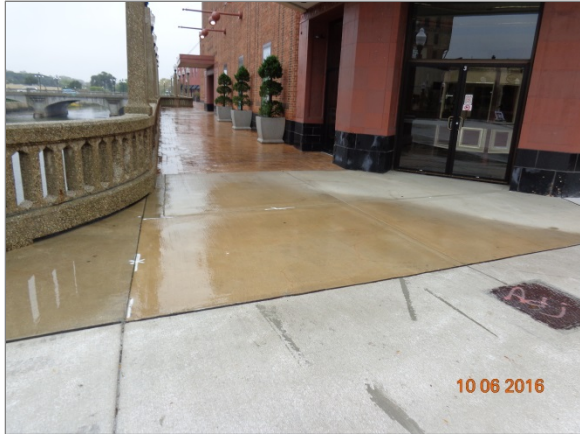
Riverwalk at Paramount Lobby

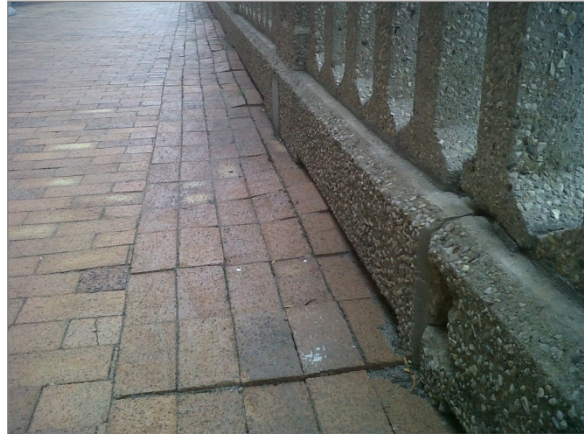
The top of the slab, neoprene joint and waterproof membrane are not visible due to the brick pavers. The brick paver surface is uneven which may cause water to pool. At the slab underside, transverse cracks with efflorescence, rust stains, and evidence of leakage were visible in the exterior cantilever and the interior back span. The worst of this slab deterioration occurs in the atypical spans near Galena Bridge.

Uneven Brick Pavers at Paramount

It appears the drainage layer under the pavers is holding water. This will lead to deterioration of any waterproofing that may be present between the slab and the drainage layer and will eventually cause the slab to deteriorate. Any water that is able to penetrate the joint between the building wall and the slab will lead to deterioration of the cantilevered steel beams at the location where they carry the highest shear and moment. If a renovation of the surface of the Riverwalk is planned, sampling and testing should be included in the process. We would also recommend a different type of pavement, flashing, and drainage system that will better protect the concrete slab and the steel beams by assuring rapid run off.

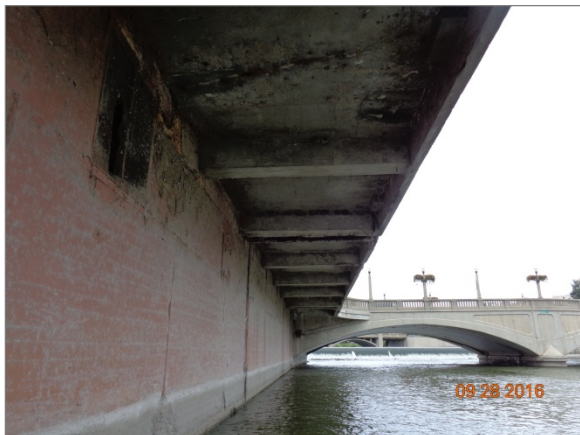
Cantilever Underside at Paramount Lobby

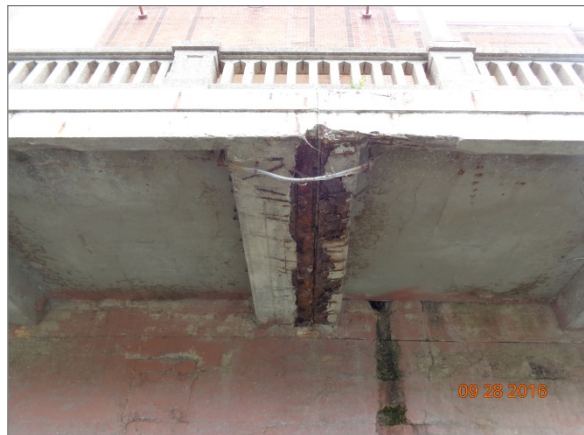
The deterioration below the expansion joint in slab is extensive. The concrete cover on the bottom of the encased beams is mostly gone exposing the beam bottom flange on either side of the joint. The bottom flanges have significant pack rust and section loss. The beam appears to have little of its initial capacity north of the joint. There was not significant cracking in the slab or notable deflection that would indicate the slab north of the joint is under duress.

Underside of Expansion Joint

We recommend performing structural steel repairs at the expansion joint as soon as possible. The beam north of the joint is of particular concern. Without physically removing the remaining concrete and steel pack rust, it is not possible to determine what capacity remains. Until repairs are made, no vehicles should be allowed on the Riverwalk. The slab north of the joint should be closely monitored for vertical movement that would indicate a significant loss of capacity and potential failure.

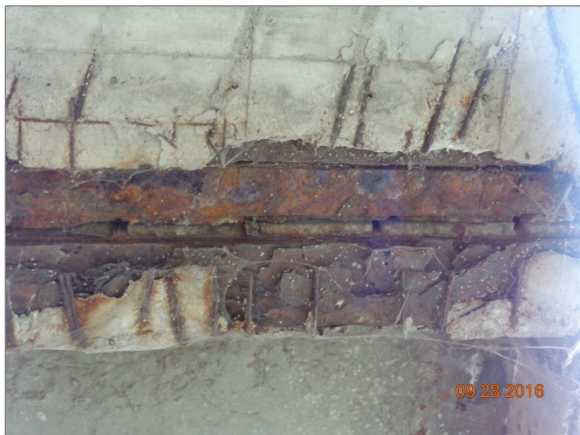
Steel Deterioration at Expansion Joint

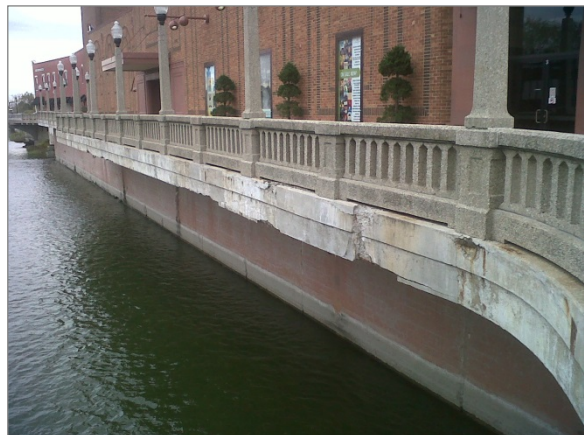
There are several locations of spalls in the concrete edge beam with exposed reinforcement. One pair of encased beams north of the expansion joint has lost a portion concrete cover, exposing the steel beams. Several other encased beams have cracks forming in the concrete.

Spalls on Fascia of Edge Beam

Other repairs include concrete patching in edge beams with exposed reinforcement, concrete patching and epoxy crack injection for river wall foundation, and brick and mortar repairs in the river wall.

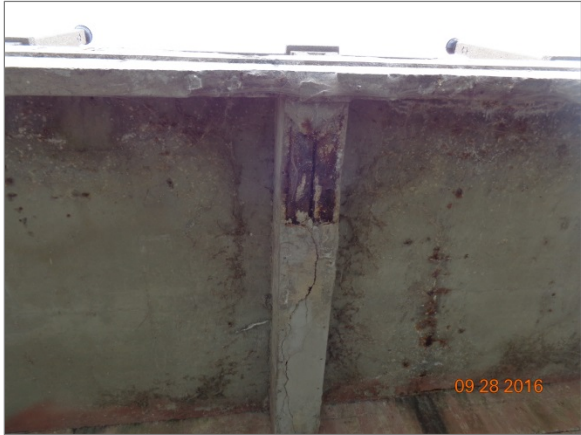
Exposed Beams North of Joint

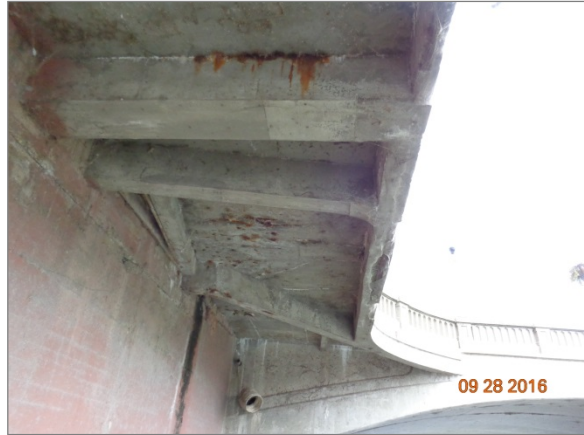
Underside near Galena Bridge

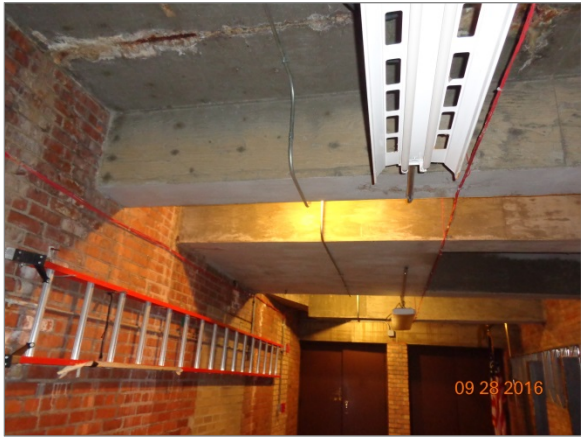
Back Span Underside at Paramount Auditorium

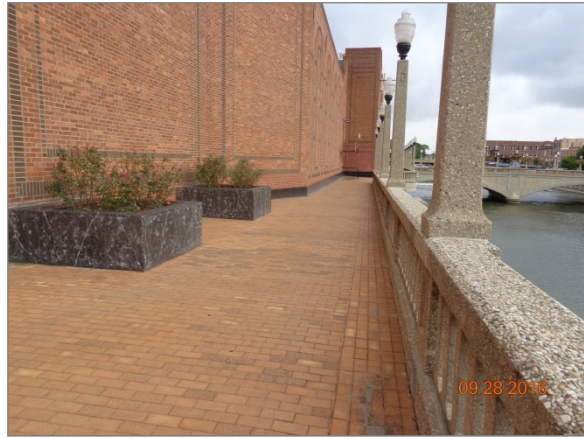
Riverwalk at Paramount Auditorium

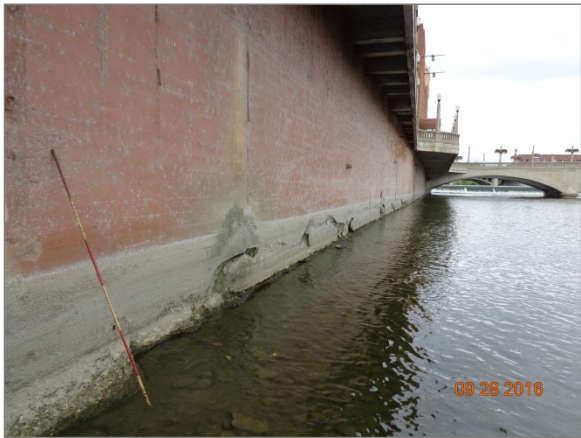
The river wall is in good to fair condition. The concrete base has wide spread spalls with reinforcement exposed in some cases. Spalls have been worsened by areas of poorly consolidated concrete and decades of abrasive action by the river. Some locations appear to have been patched or overlaid at some point, but portions of these repairs have failed. The bricks above the concrete are generally in good condition, but there are several locations where bricks are disintegrating or missing.

Paramount River Wall

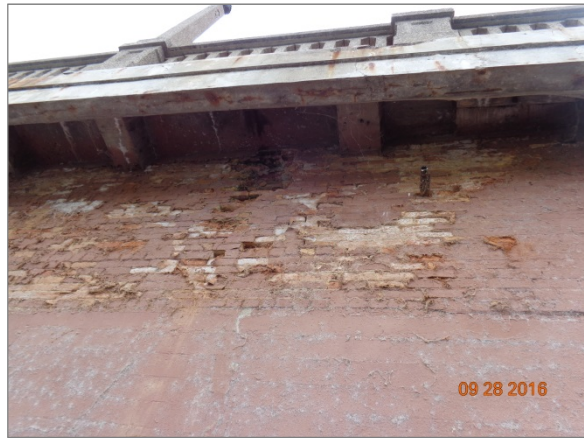
Cantilever Underside at Paramount Auditorium

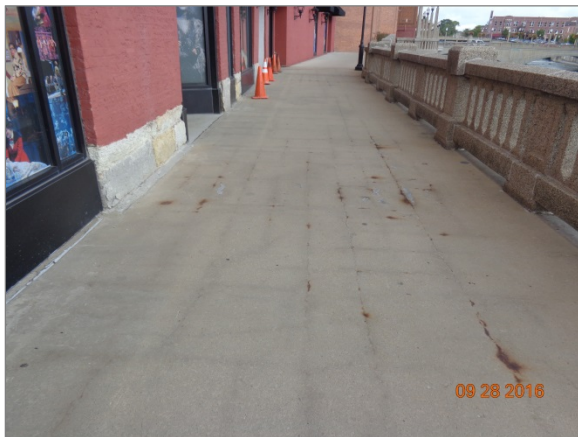
The Downer cantilever is in good to fair condition. Longitudinal and transverse cracks with rust stains show through the top of the slab at approximately 12" centers. This most is likely caused by a lack of

Downer Cantilever Topside

We recommend sealing the cracks in the top surface of pan joist slab and adding coving/sealant between the building and slab to help prevent further deterioration. We also recommend removing the delaminated concrete from the encased beams. Afterwards, any area of the steel beams that are exposed should be cleaned and painted. We also recommend concrete patching and epoxy crack injection for the slab on grade portions of river wall foundation.

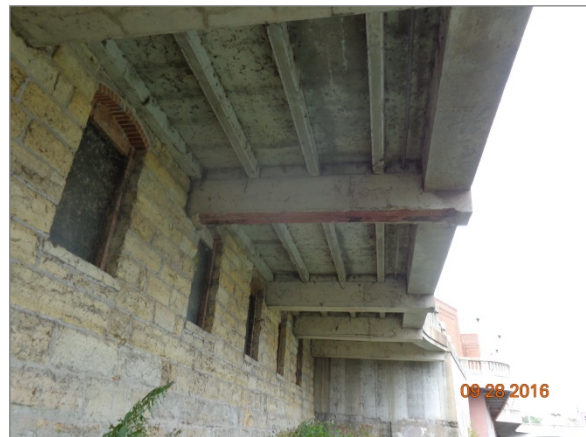
cover above the slab reinforcement. The caulked joint between the pan joist slab and the masonry building wall is in fair condition. There does not appear to be any flashing between the slab and wall. Transverse cracks also show at the underside with efflorescence and are typically at the pan joist span quarter points between the cantilever beams. The bottom cover has spalled off on several encased beams leaving the steel exposed. Only surface rust with initial section loss was observed. The remaining encased beams all have wide cracks near the bottom indicating the concrete is delaminated and will soon spall off as well. The stacked limestone is in good condition.

Downer Cantilever Underside

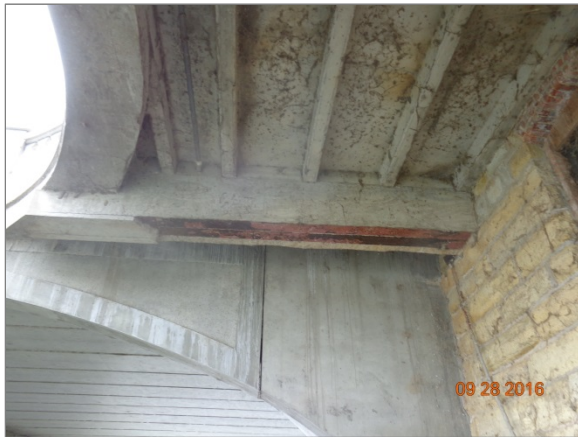
Downer Underside at Bridge

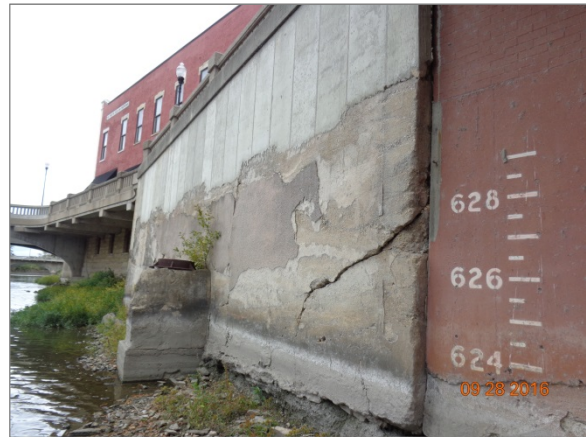
The Downer slab on grade was in good condition. The base of the wall has numerous spalls and abrasion near the waterline. There are also several wide vertical and diagonal cracks. No differential movement was observed. The newer top portion of the river wall was in good condition.

Slab on Grade River Wall
