Re: Well 28

CITY OF AURORA WELL #28 PUMP INSPECTION REPORT

JOB NAME	Aurora	WELL	28	DATE	01/13/2020
JOB NO.	982278	INSPECTED BY	J. Poppen, J. Kopp, M. Poppen, B. Balluff, J. Iverson		
		BOWL ASSEMBLY	Byron Jackson 13 stage 13MQ/12MQH all bronze construction		
		COLUMN ASSEMBLY	10" T&C schedule 60, 8RND thread, SRL		
		MOTOR	Byron Jackson 400 HP, 17", 2300V, type H

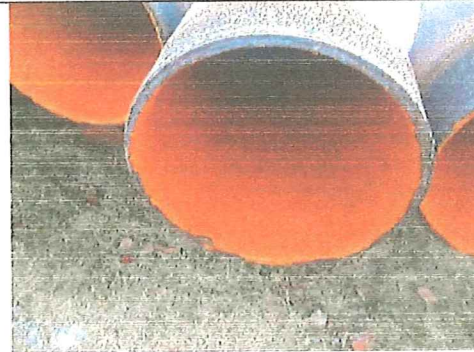
Heavy build up on pipe interior (typical of all).

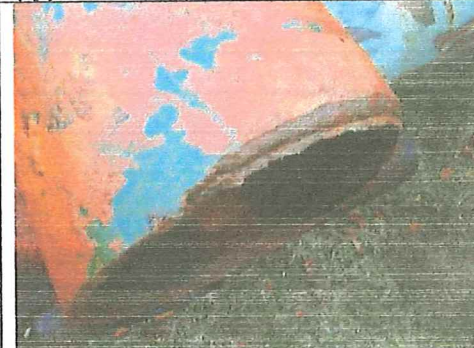
Eroded coupling above static water level. Typical of eleven couplings.
