THIS REPORT IS A FIELD STRUCTURAL SITE ANALYSIS OF THE EXISTING CONDITIONS OF THE NORTH ELEVATION UNDERLYING WYTHES OF MASONRY AFTER THE STONE VENEER REMOVAL. SITE ANALYSIS ALSO INCLUDED THE EXTG. CONDITIONS OF THE 2 X 12 ROOF RAFTER ASSEMBLY & RECOMMENDATIONS FOR REMEDIATION.

FIELD STRUCTURAL SITE ANALYSIS EVALUATION REPORT

SUBJECT PROPERTY: 35 N. BROADWAY, AURORA IL. 60505

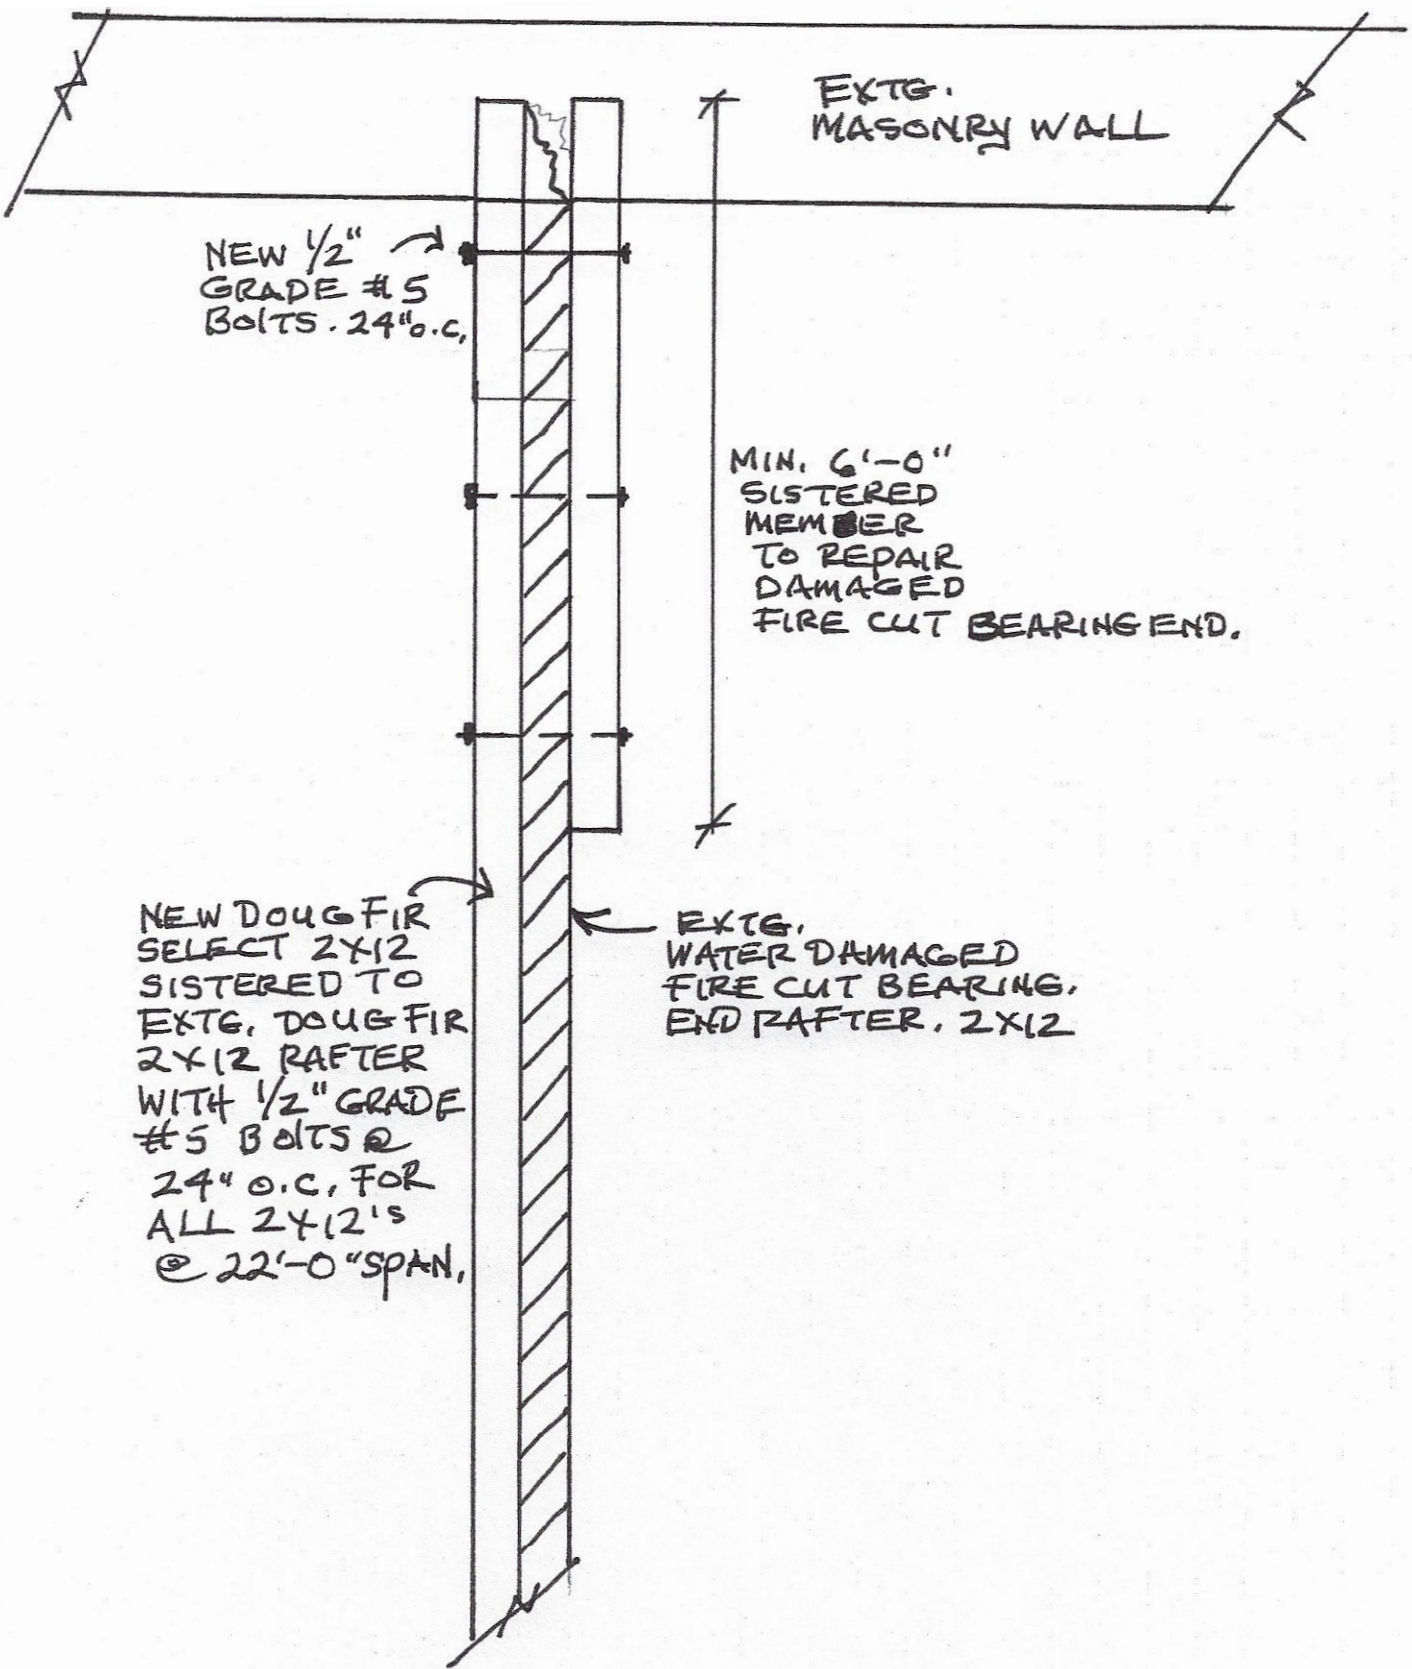
RAFTER TO BEARING WALL CONNECTION - NTS

EXTG. WATER DAMAGED FIRE CUT BEARING. END RAFTER, 2X12

MIN. 6'-0" SISTERED MEMBER TO REPAIR DAMAGED FIRE CUT BEARING END.

NEW DOUG FIR SELECT 2X12 SISTERED TO EXTG. DOUG FIR 2X12 RAFTER WITH 1/2" GRADE #5 BOLTS @ 24" o.c. FOR ALL 2X12'S @ 22'-0" SPAN.

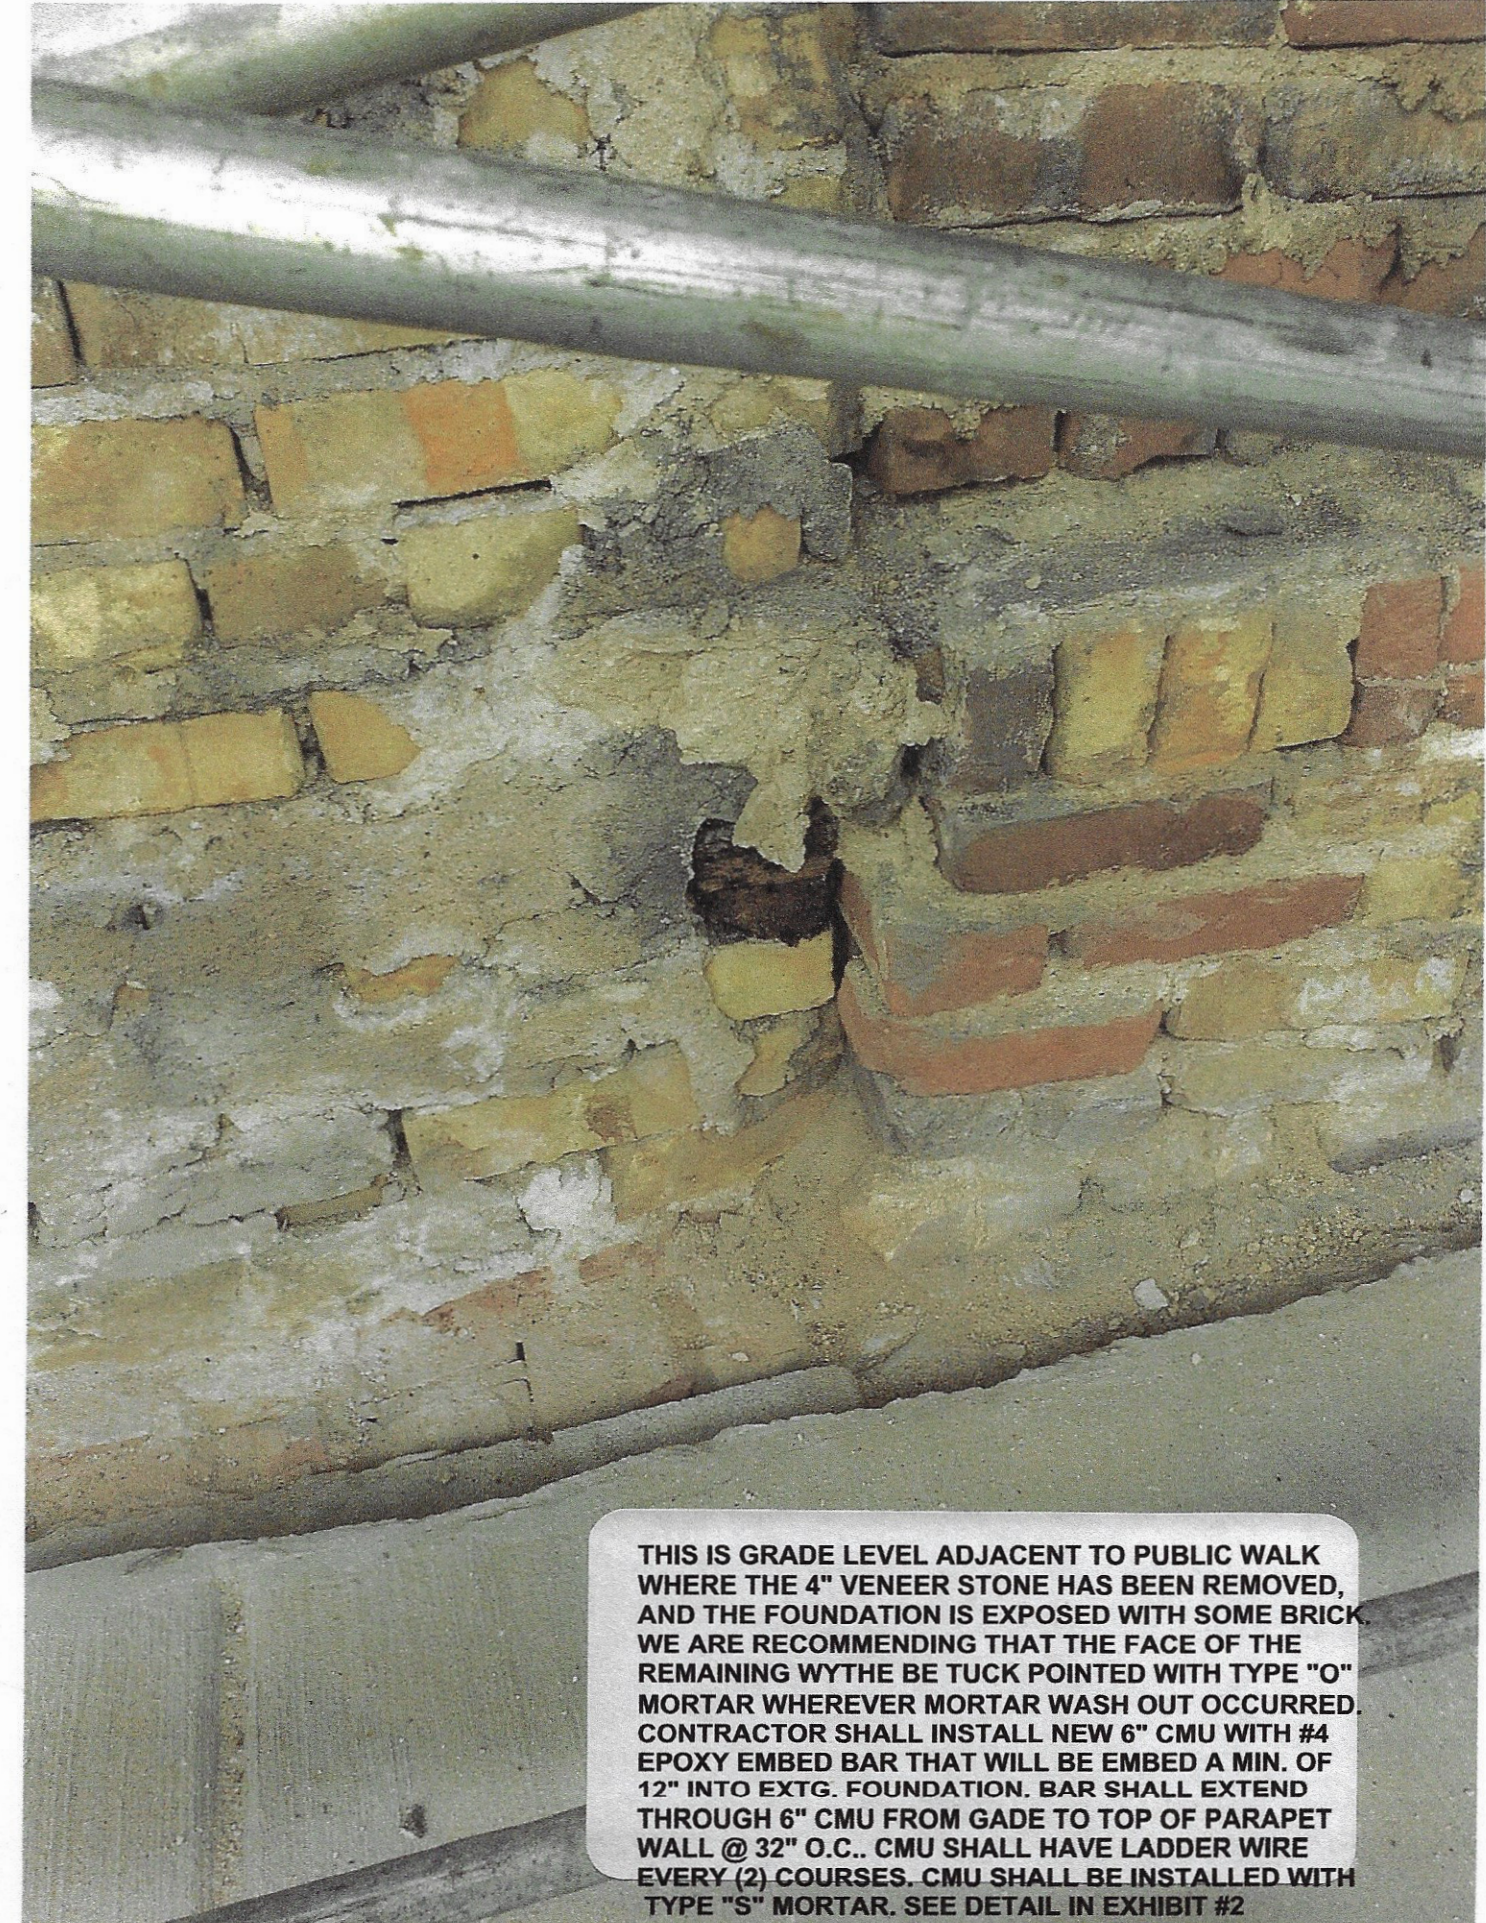
THIS IS GRADE LEVEL ADJACENT TO PUBLIC WALK WHERE THE 4" VENEER STONE HAS BEEN REMOVED, AND THE FOUNDATION IS EXPOSED WITH SOME BRICK. WE ARE RECOMMENDING THAT THE FACE OF THE REMAINING WYTHE BE TUCK POINTED WITH TYPE "O" MORTAR WHEREVER MORTAR WASH OUT OCCURRED. CONTRACTOR SHALL INSTALL NEW 6" CMU WITH #4 EPOXY EMBED BAR THAT WILL BE EMBED A MIN. OF 12" INTO EXTG. FOUNDATION. BAR SHALL EXTEND THROUGH 6" CMU FROM GADE TO TOP OF PARAPET WALL @ 32" O.C.. CMU SHALL HAVE LADDER WIRE EVERY (2) COURSES. CMU SHALL BE INSTALLED WITH TYPE "S" MORTAR. SEE DETAIL IN EXHIBIT #2

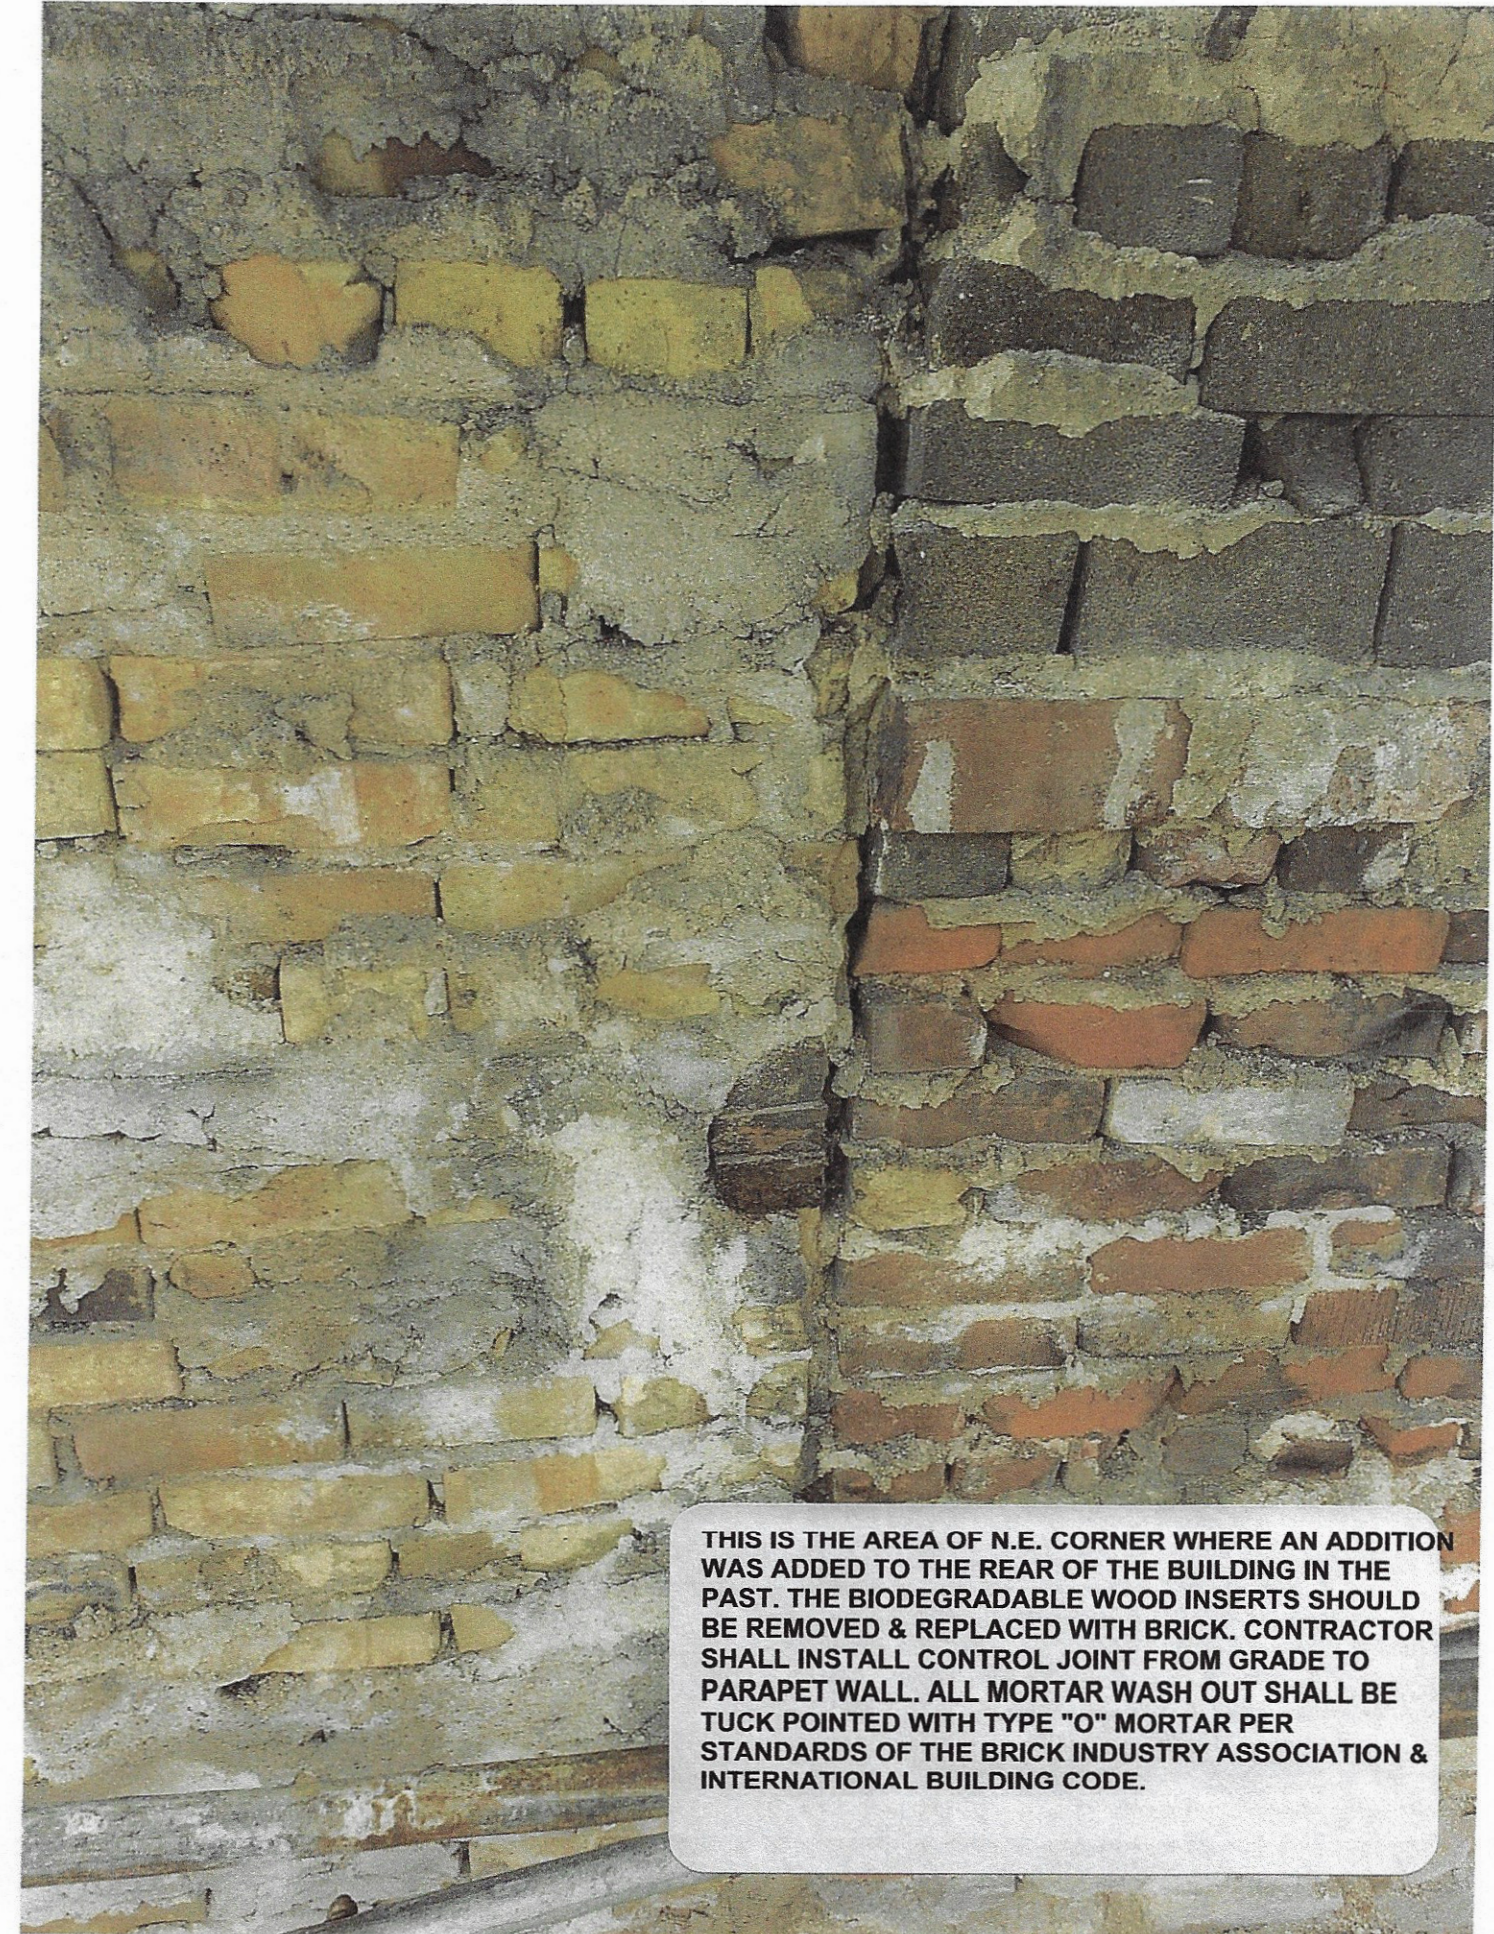
THIS IS THE AREA OF N.E. CORNER WHERE AN ADDITION WAS ADDED TO THE REAR OF THE BUILDING IN THE PAST. THE BIODEGRADABLE WOOD INSERTS SHOULD BE REMOVED & REPLACED WITH BRICK. CONTRACTOR SHALL INSTALL CONTROL JOINT FROM GRADE TO PARAPET WALL. ALL MORTAR WASH OUT SHALL BE TUCK POINTED WITH TYPE "O" MORTAR PER STANDARDS OF THE BRICK INDUSTRY ASSOCIATION & INTERNATIONAL BUILDING CODE.

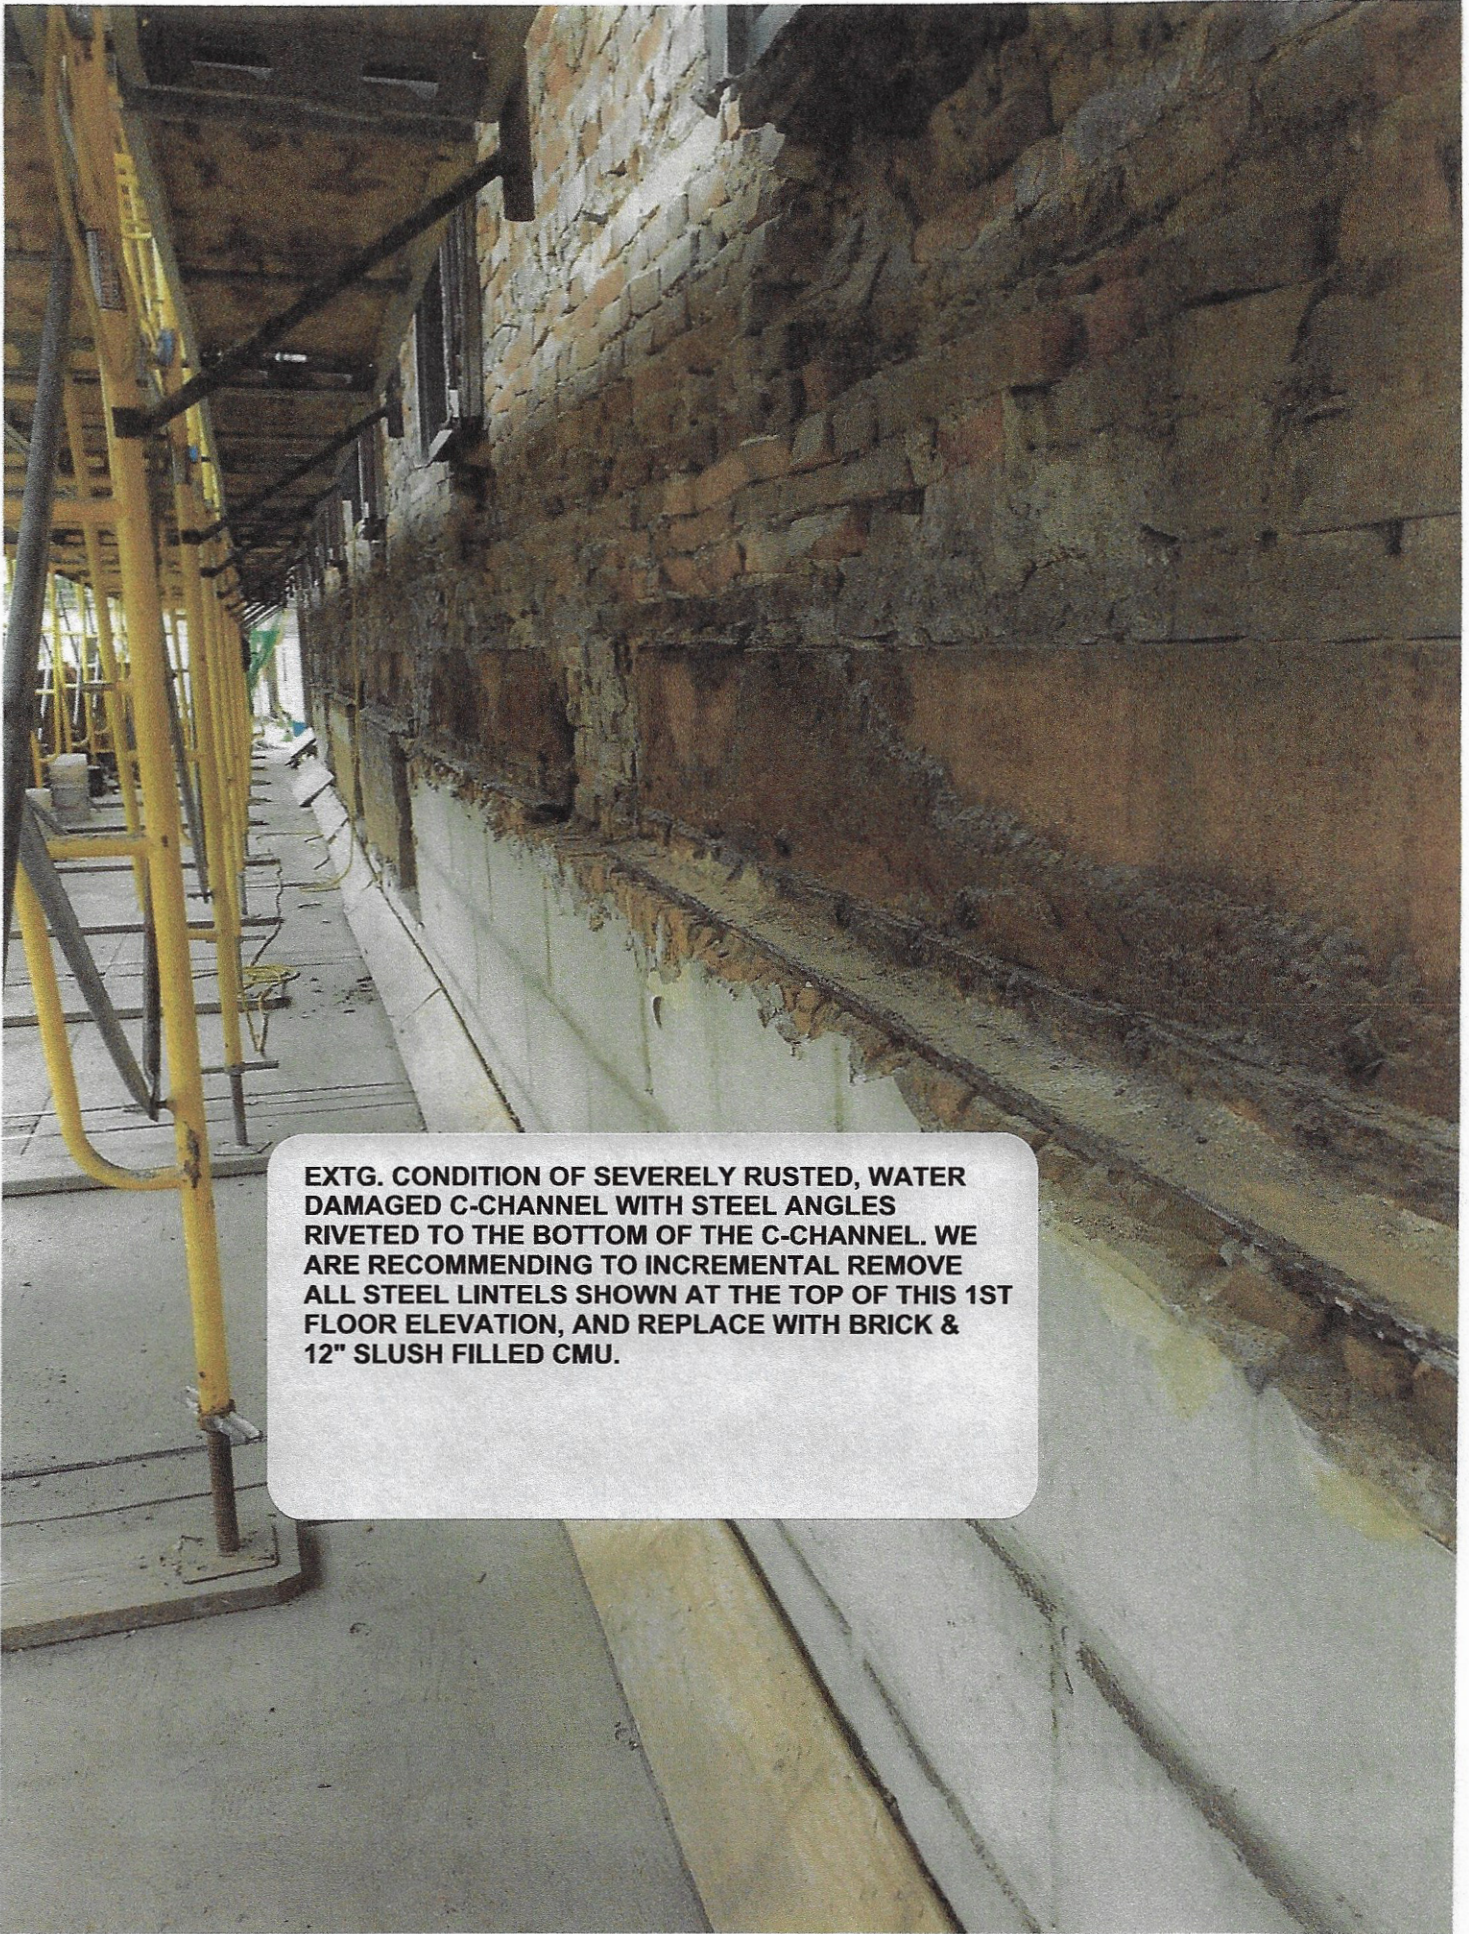
EXTG. CONDITION OF SEVERELY RUSTED, WATER DAMAGED C-CHANNEL WITH STEEL ANGLES RIVETED TO THE BOTTOM OF THE C-CHANNEL. WE ARE RECOMMENDING TO INCREMENTAL REMOVE ALL STEEL LINTELS SHOWN AT THE TOP OF THIS 1ST FLOOR ELEVATION, AND REPLACE WITH BRICK & 12" SLUSH FILLED CMU.

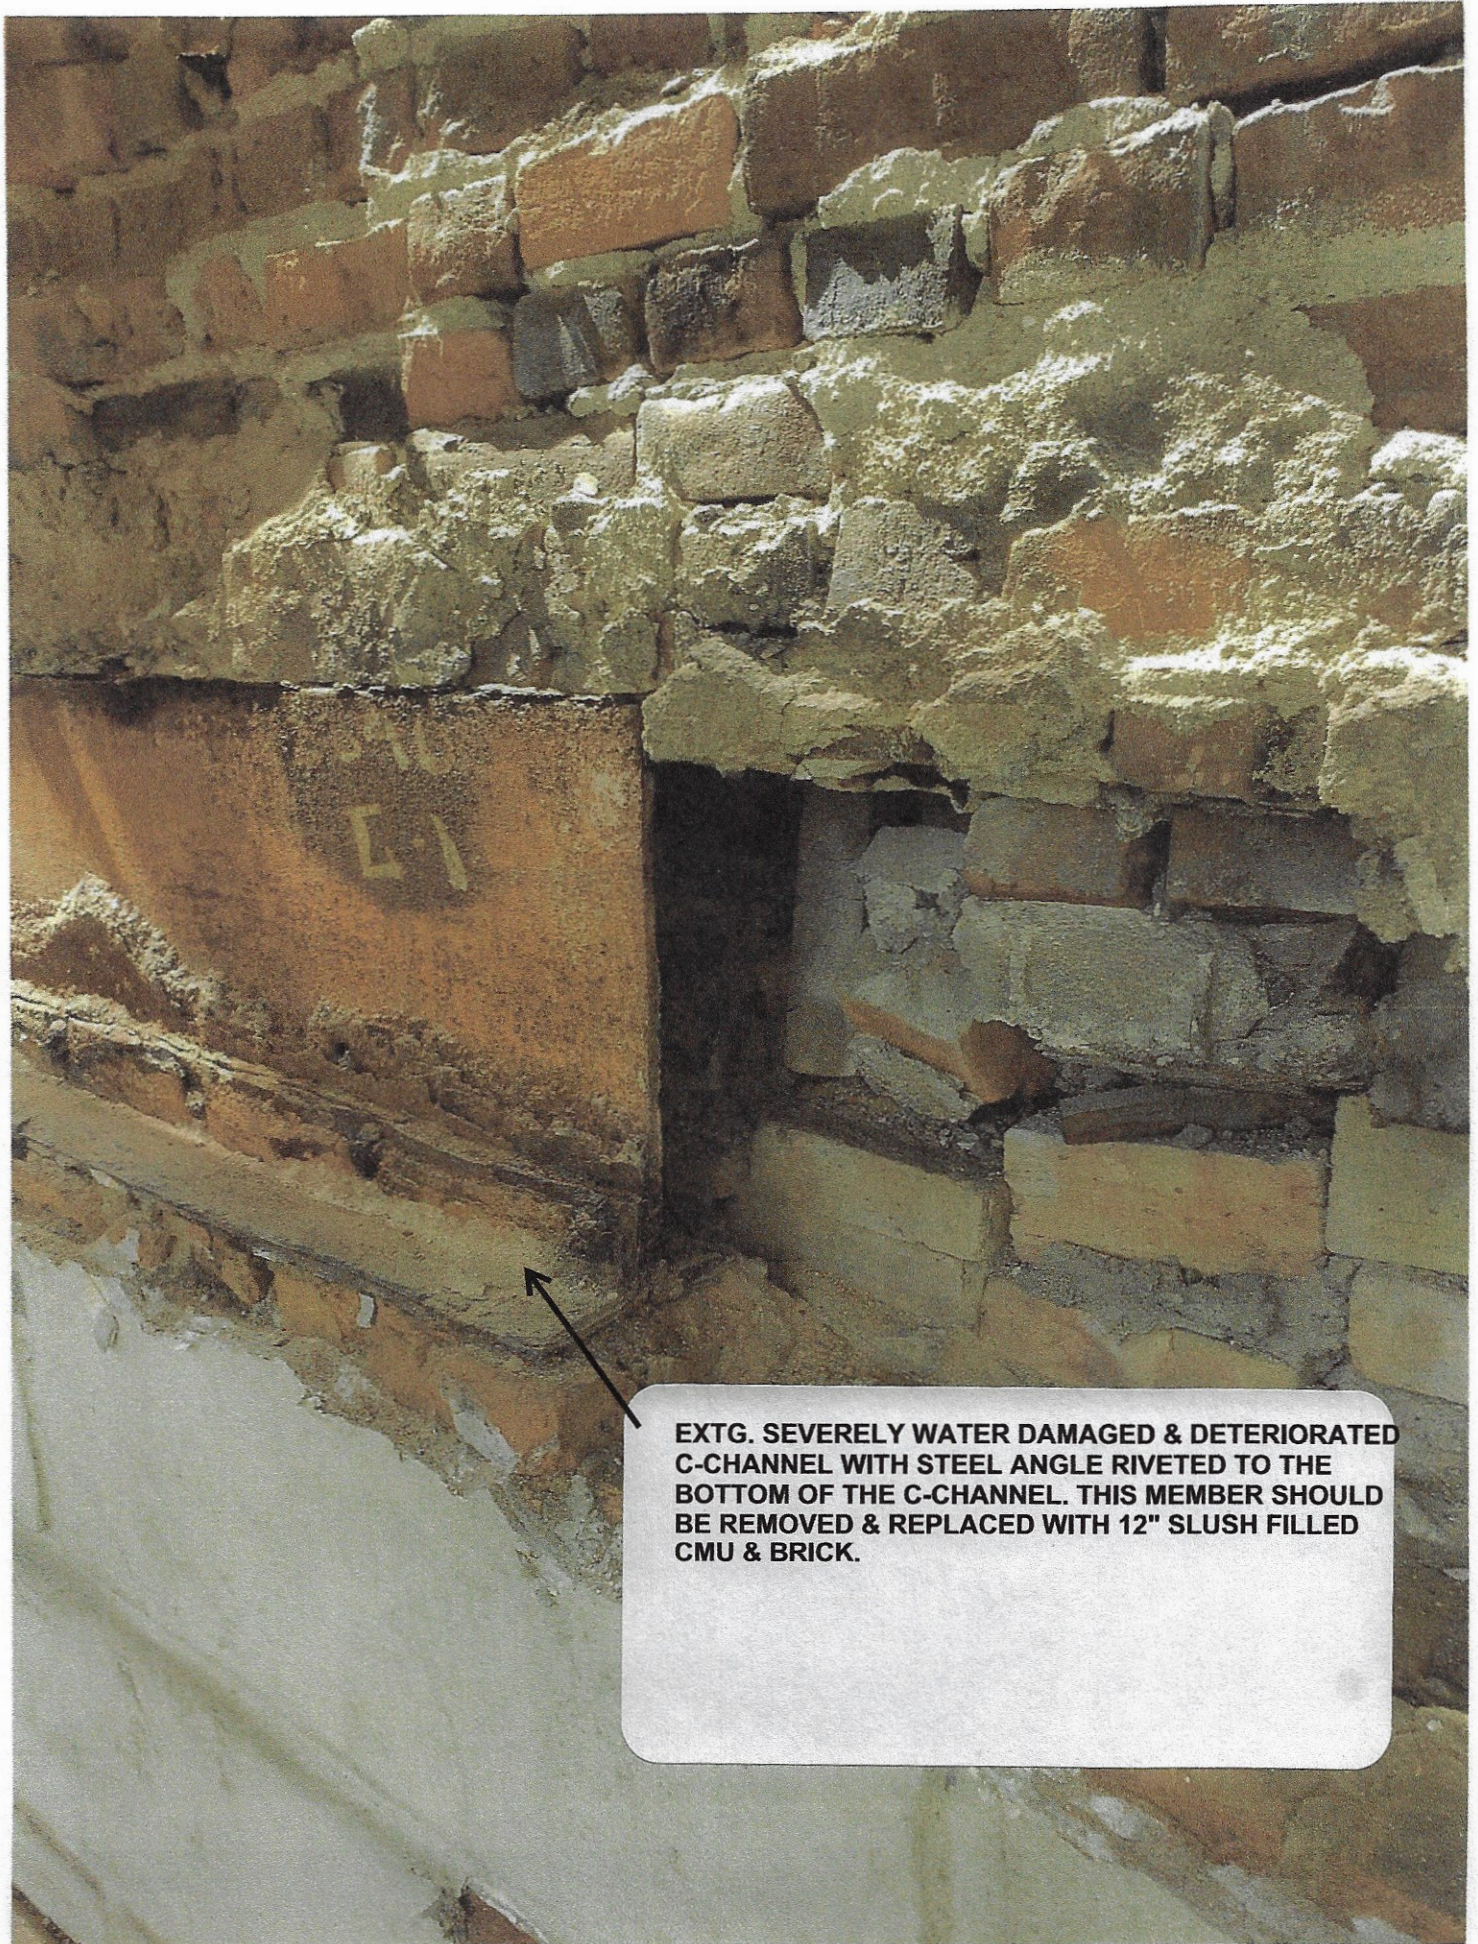
EXTG. STEEL C-CHANNEL SEVERELY WATER DAMAGED AND RUSTED. REMOVE & REPLACE WITH 12" CMU SLUSH FILLED & BRICK.

EXTG. SEVERELY WATER DAMAGED & DETERIORATED C-CHANNEL WITH STEEL ANGLE RIVETED TO THE BOTTOM OF THE C-CHANNEL. THIS MEMBER SHOULD BE REMOVED & REPLACED WITH 12" SLUSH FILLED CMU & BRICK.

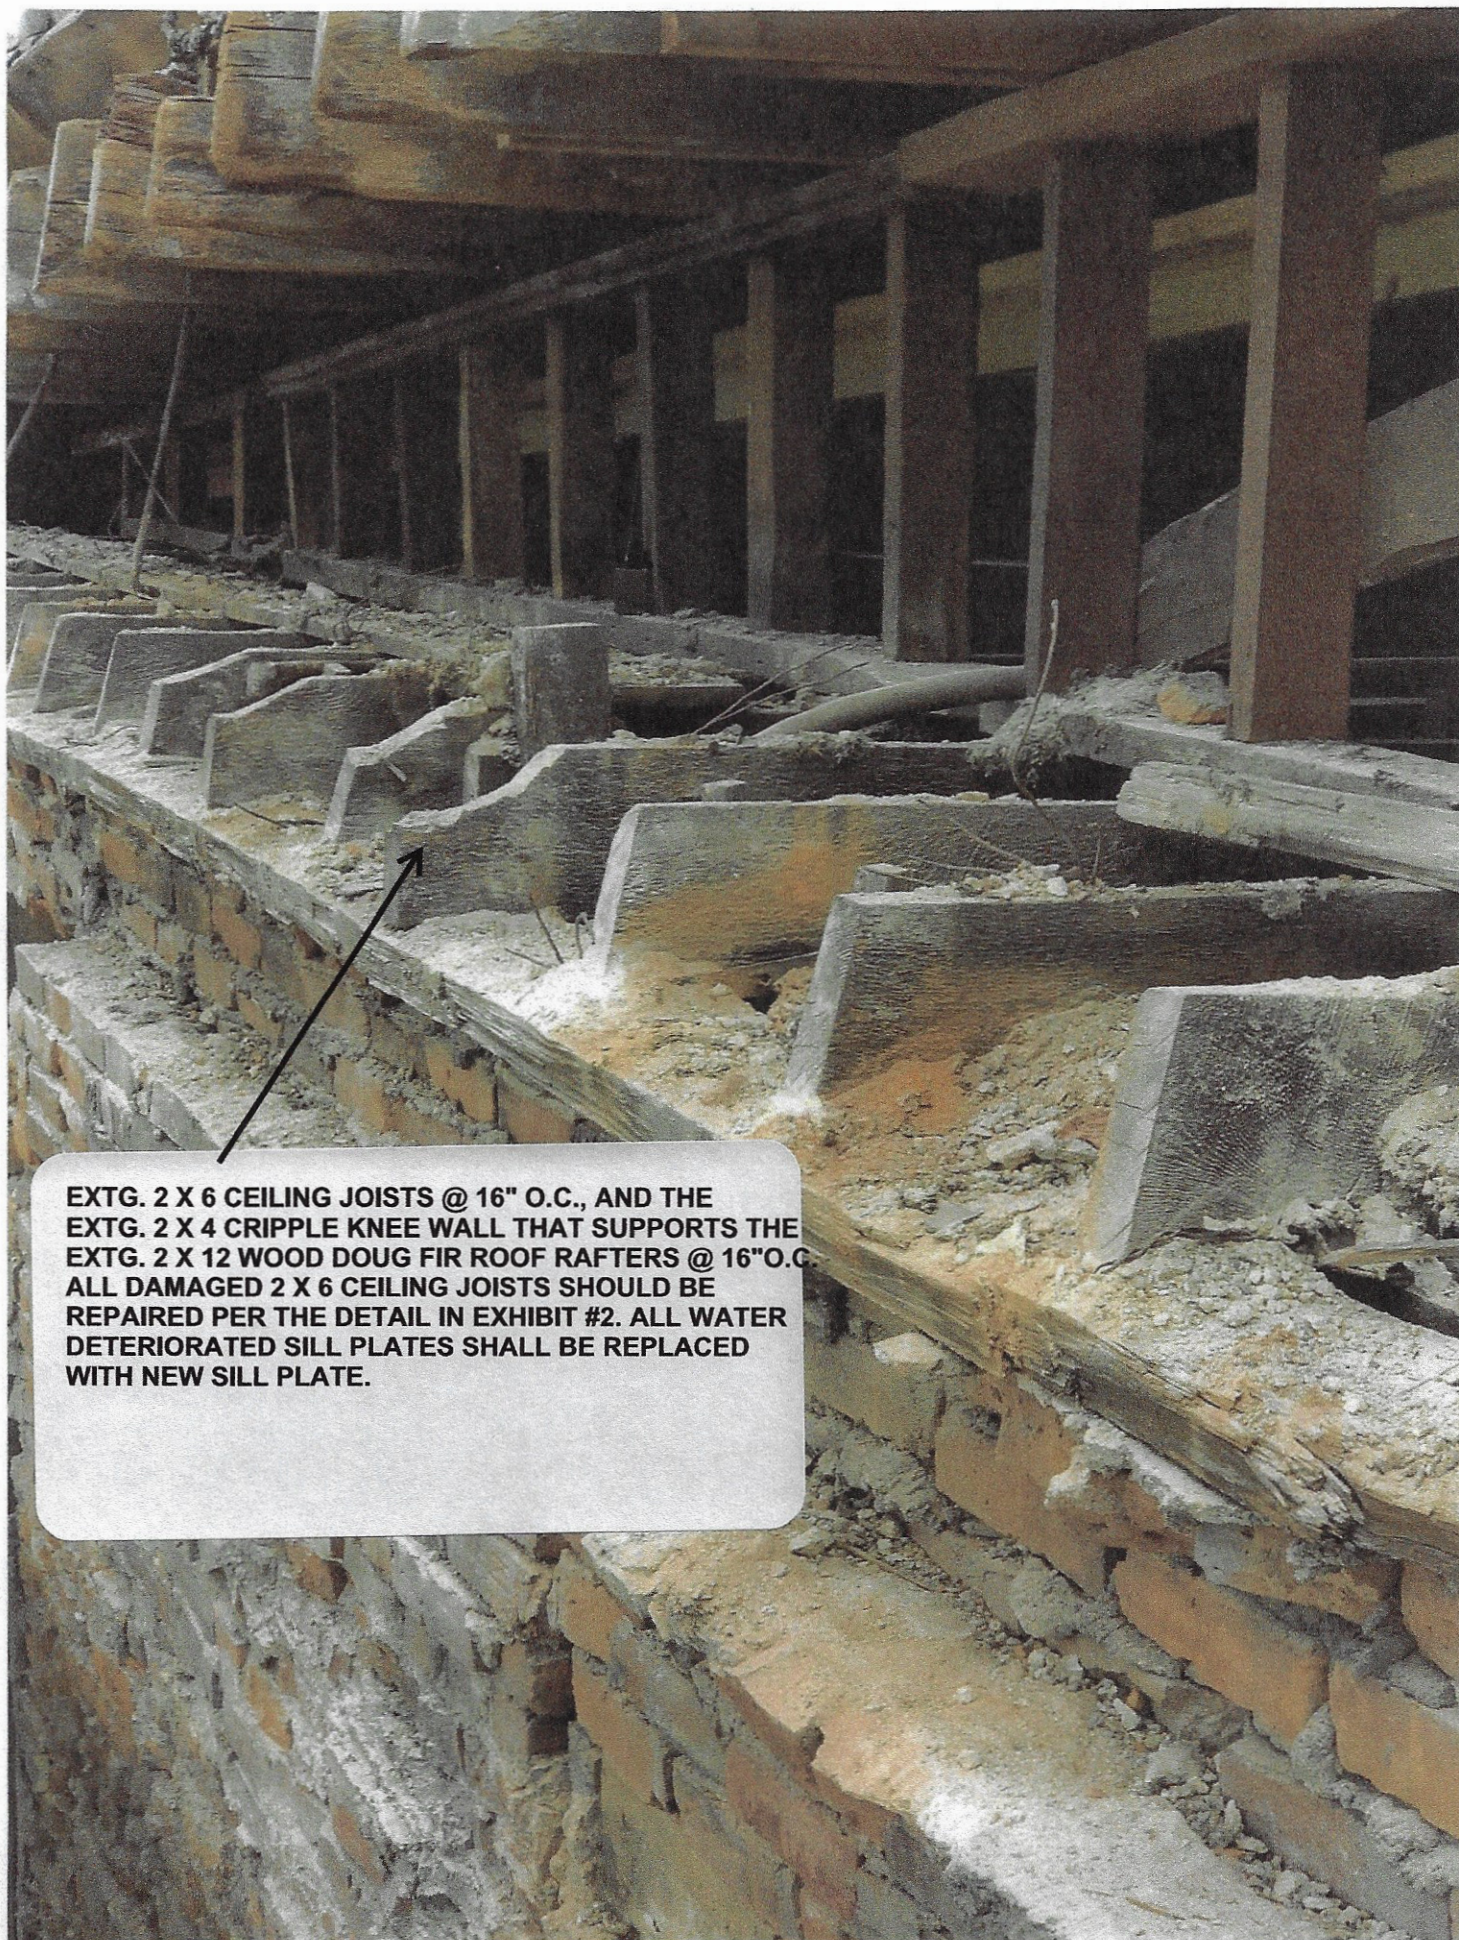
EXTG. 2 X 6 CEILING JOISTS @ 16" O.C.

EXTG. WOOD WINDOW LINTEL IN SEVERAL LOCATIONS. WE ARE RECOMMENDING THAT ANY WATER DAMAGED WOOD LINTEL SHOULD BE REPLACED WITH A NEW STEEL LINTEL. IT SHOULD BE REPLACED WITH A NEW W8 X 18 WITH A NEW 3/8" X 14" PLATE WELDED TO THE BOTTOM FLANGE OF THE W8 X 18. SEE CALCULATIONS IN EXHIBIT #1.

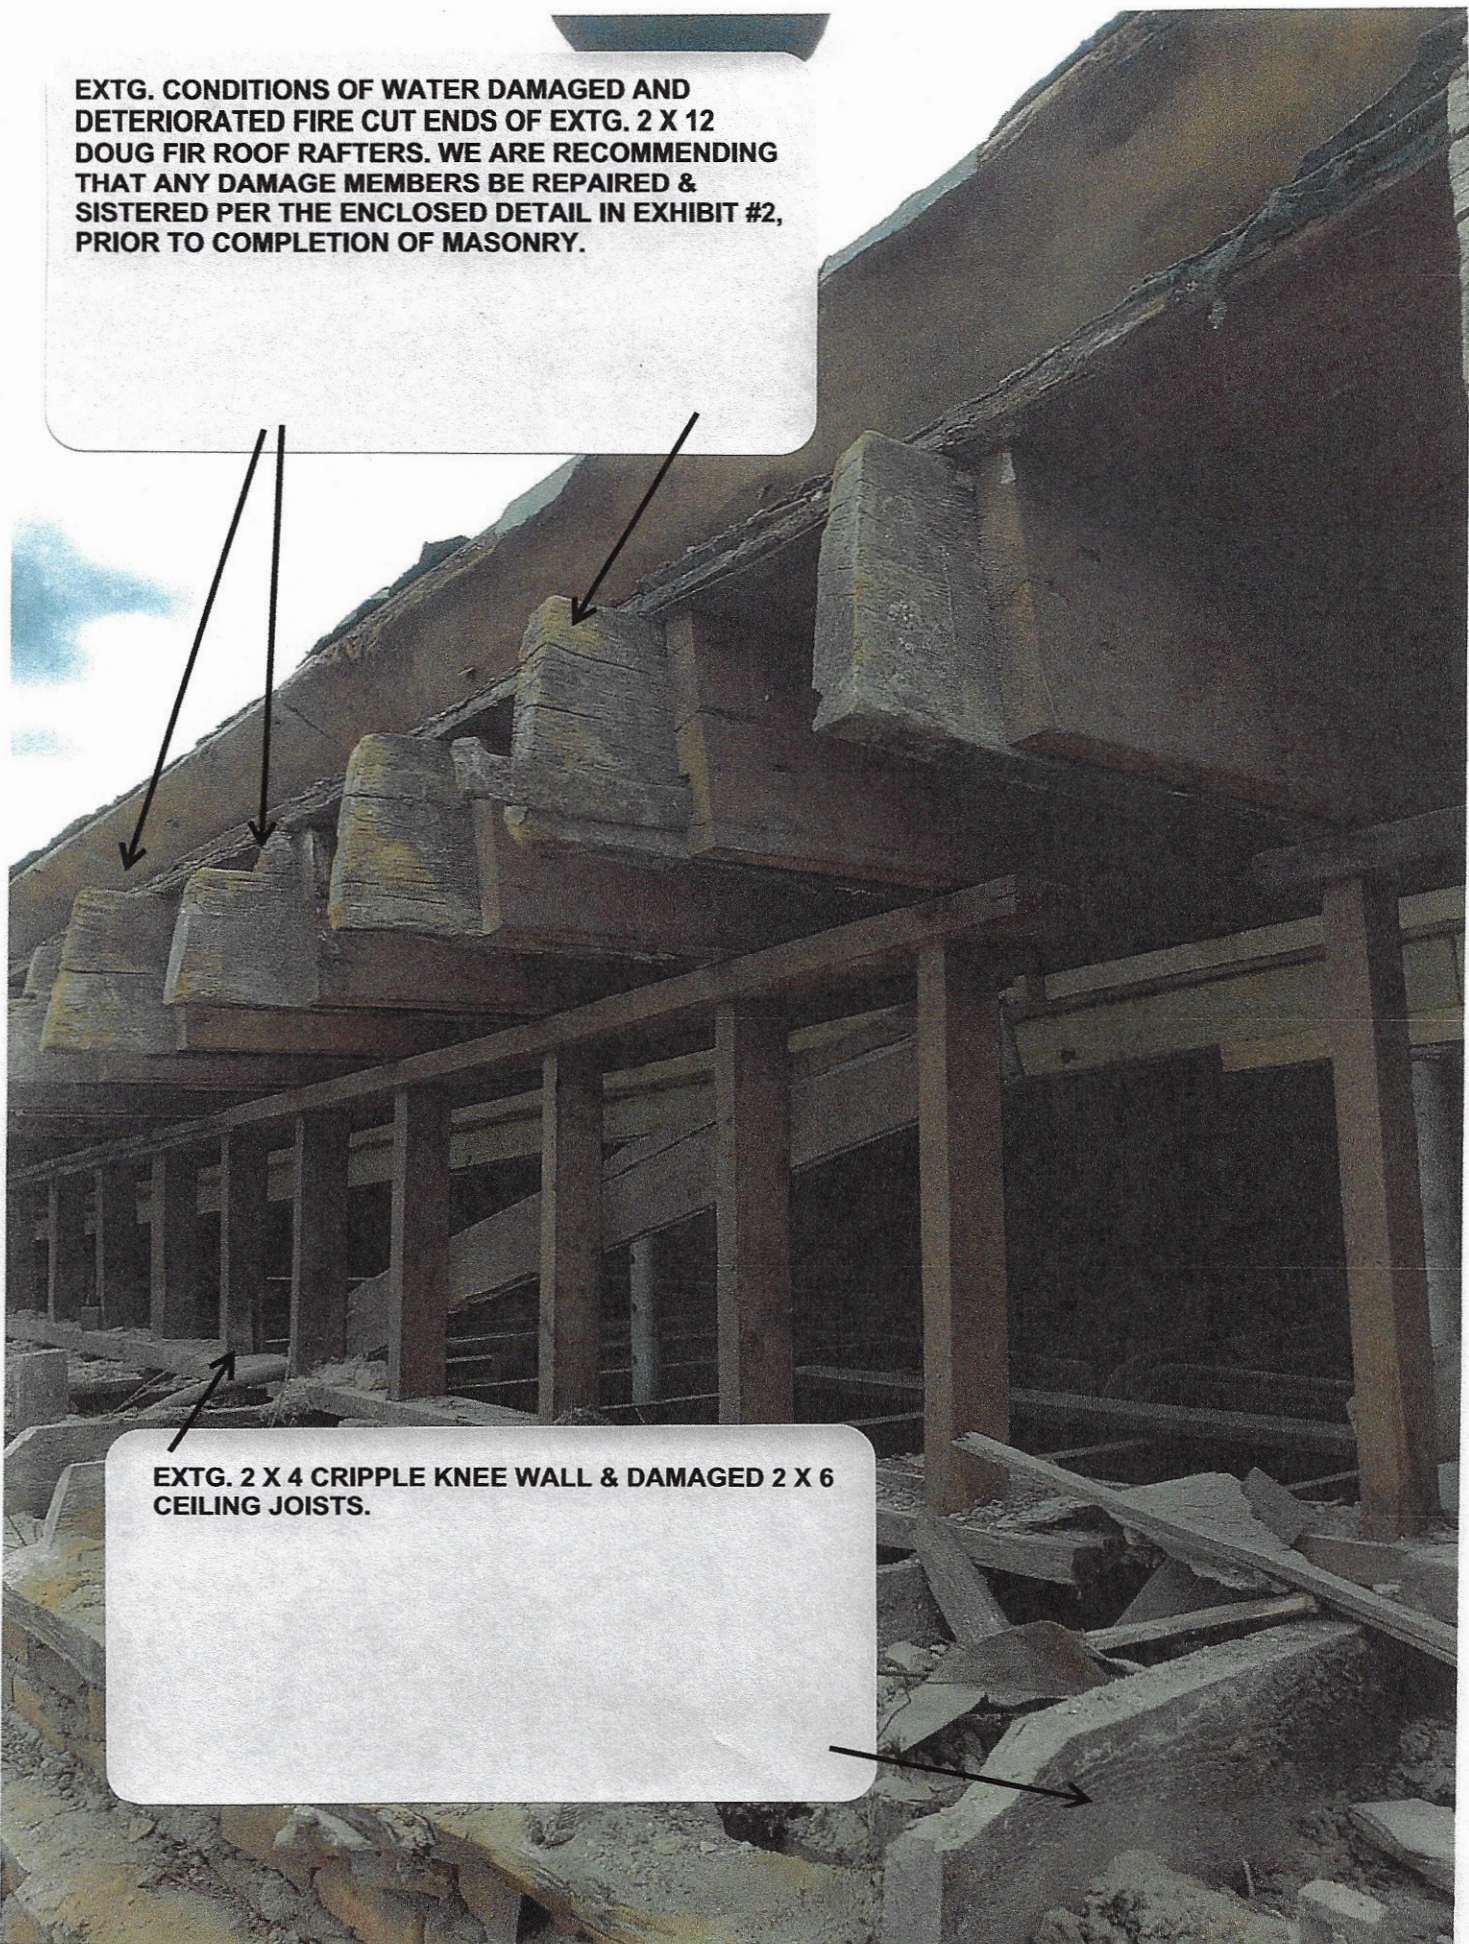
**EXTG. 2 X 6 CEILING JOISTS @ 16" O.C., AND THE
EXTG. 2 X 4 CRIPPLE KNEE WALL THAT SUPPORTS THE
EXTG. 2 X 12 WOOD DOUG FIR ROOF RAFTERS @ 16" O.C.
ALL DAMAGED 2 X 6 CEILING JOISTS SHOULD BE
REPAIRED PER THE DETAIL IN EXHIBIT #2. ALL WATER
DETERIORATED SILL PLATES SHALL BE REPLACED
WITH NEW SILL PLATE.**

EXTG. CONDITIONS OF WATER DAMAGED AND DETERIORATED FIRE CUT ENDS OF EXTG. 2 X 12 DOUG FIR ROOF RAFTERS. WE ARE RECOMMENDING THAT ANY DAMAGE MEMBERS BE REPAIRED & SISTERED PER THE ENCLOSED DETAIL IN EXHIBIT #2, PRIOR TO COMPLETION OF MASONRY.

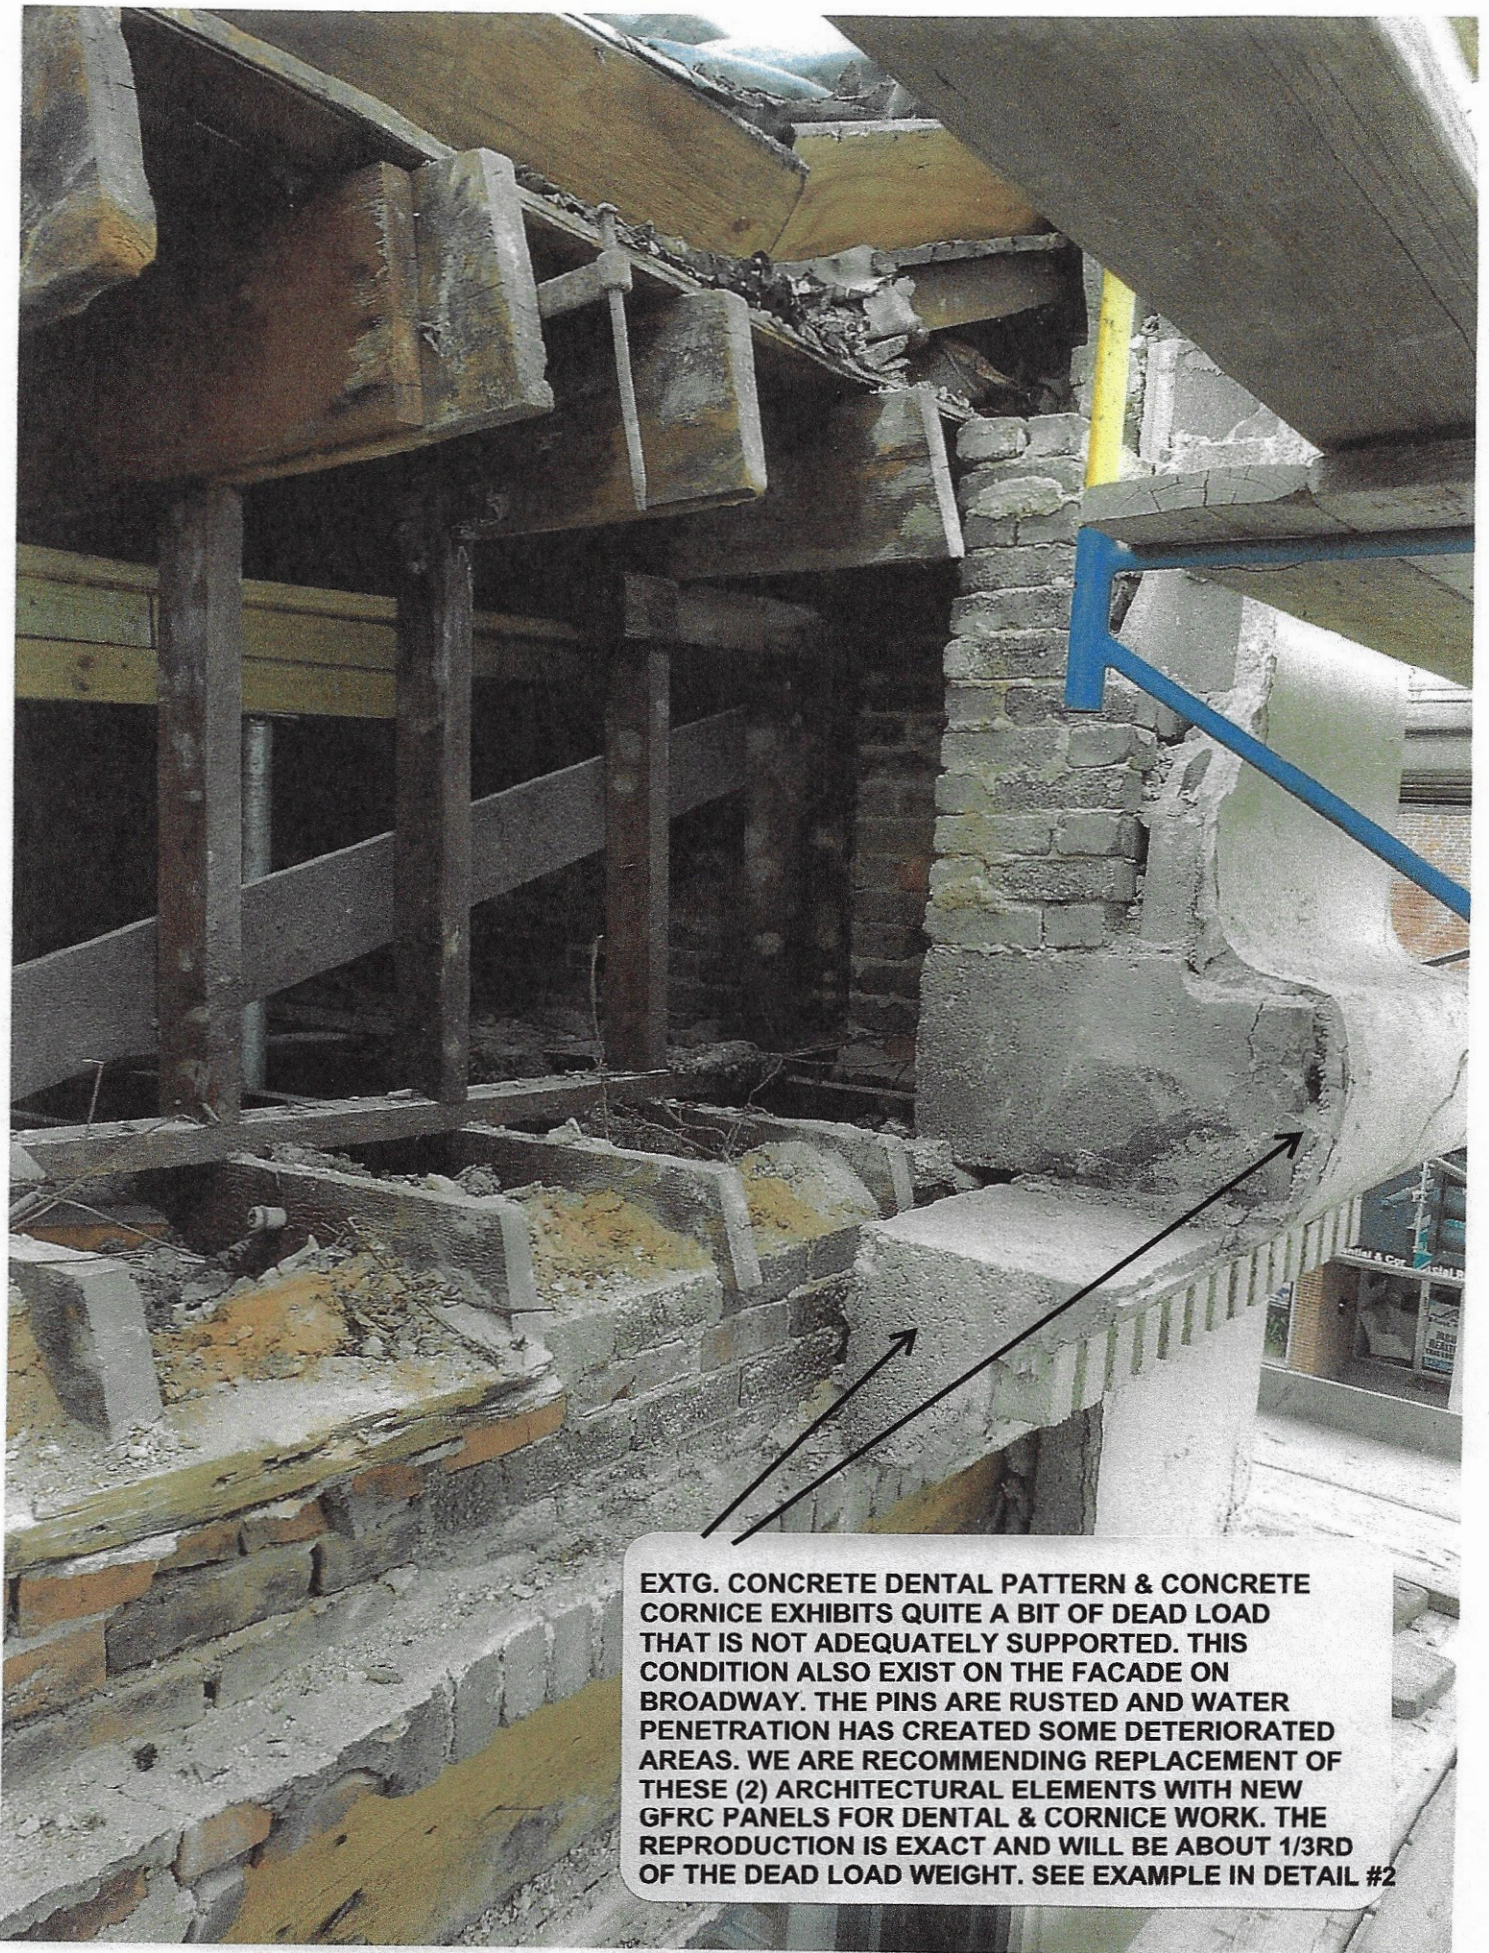
EXTG. 2 X 4 CRIPPLE KNEE WALL & DAMAGED 2 X 6 CEILING JOISTS.
