THIS REPORT IS A FIELD STRUCTURAL SITE ANALYSIS OF THE EXISTING CONDITIONS OF THE NORTH ELEVATION UNDERLYING WYTHES OF MASONRY AFTER THE STONE VENEER REMOVAL. SITE ANALYSIS ALSO INCLUDED THE EXTG. CONDITIONS OF THE 2 X 12 ROOF RAFTER ASSEMBLY & RECOMMENDATIONS FOR REMEDIATION.

FIELD STRUCTURAL SITE ANALYSIS EVALUATION REPORT

SUBJECT PROPERTY: 35 N. BROADWAY, AURORA IL. 60505

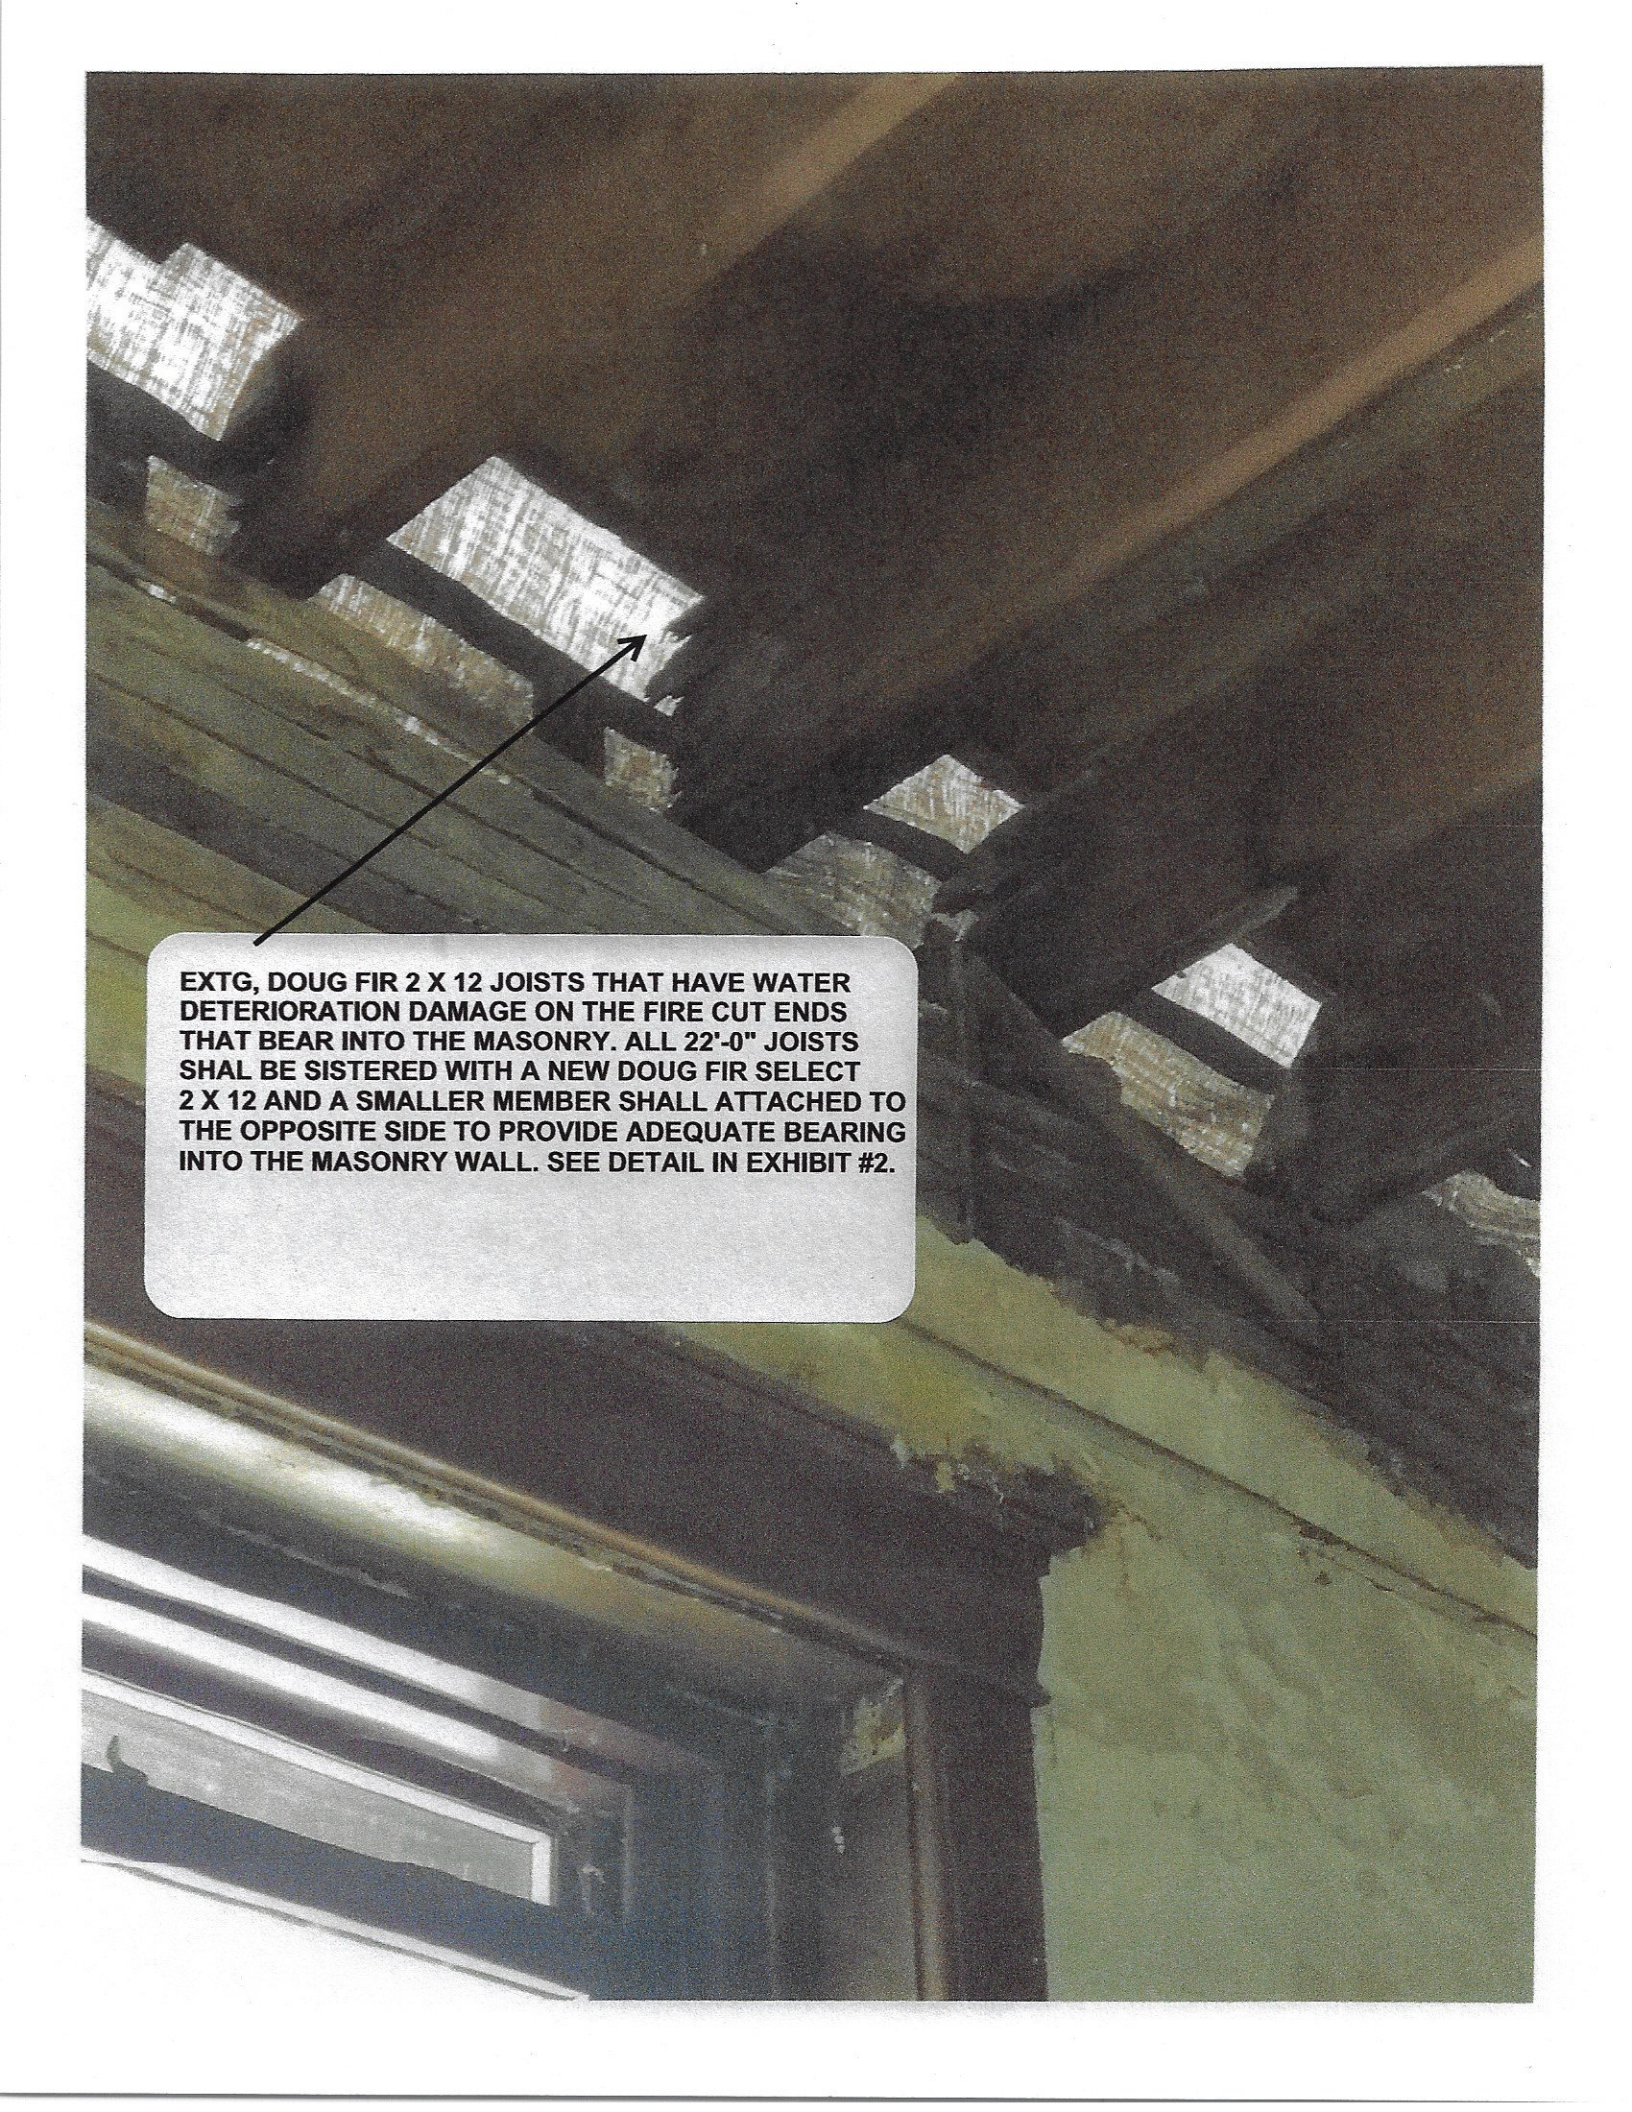
EXTG. CONCRETE DENTAL PATTERN & CONCRETE CORNICE EXHIBITS QUITE A BIT OF DEAD LOAD THAT IS NOT ADEQUATELY SUPPORTED. THIS CONDITION ALSO EXIST ON THE FACADE ON BROADWAY. THE PINS ARE RUSTED AND WATER PENETRATION HAS CREATED SOME DETERIORATED AREAS. WE ARE RECOMMENDING REPLACEMENT OF THESE (2) ARCHITECTURAL ELEMENTS WITH NEW GFRC PANELS FOR DENTAL & CORNICE WORK. THE REPRODUCTION IS EXACT AND WILL BE ABOUT 1/3RD OF THE DEAD LOAD WEIGHT. SEE EXAMPLE IN DETAIL #2

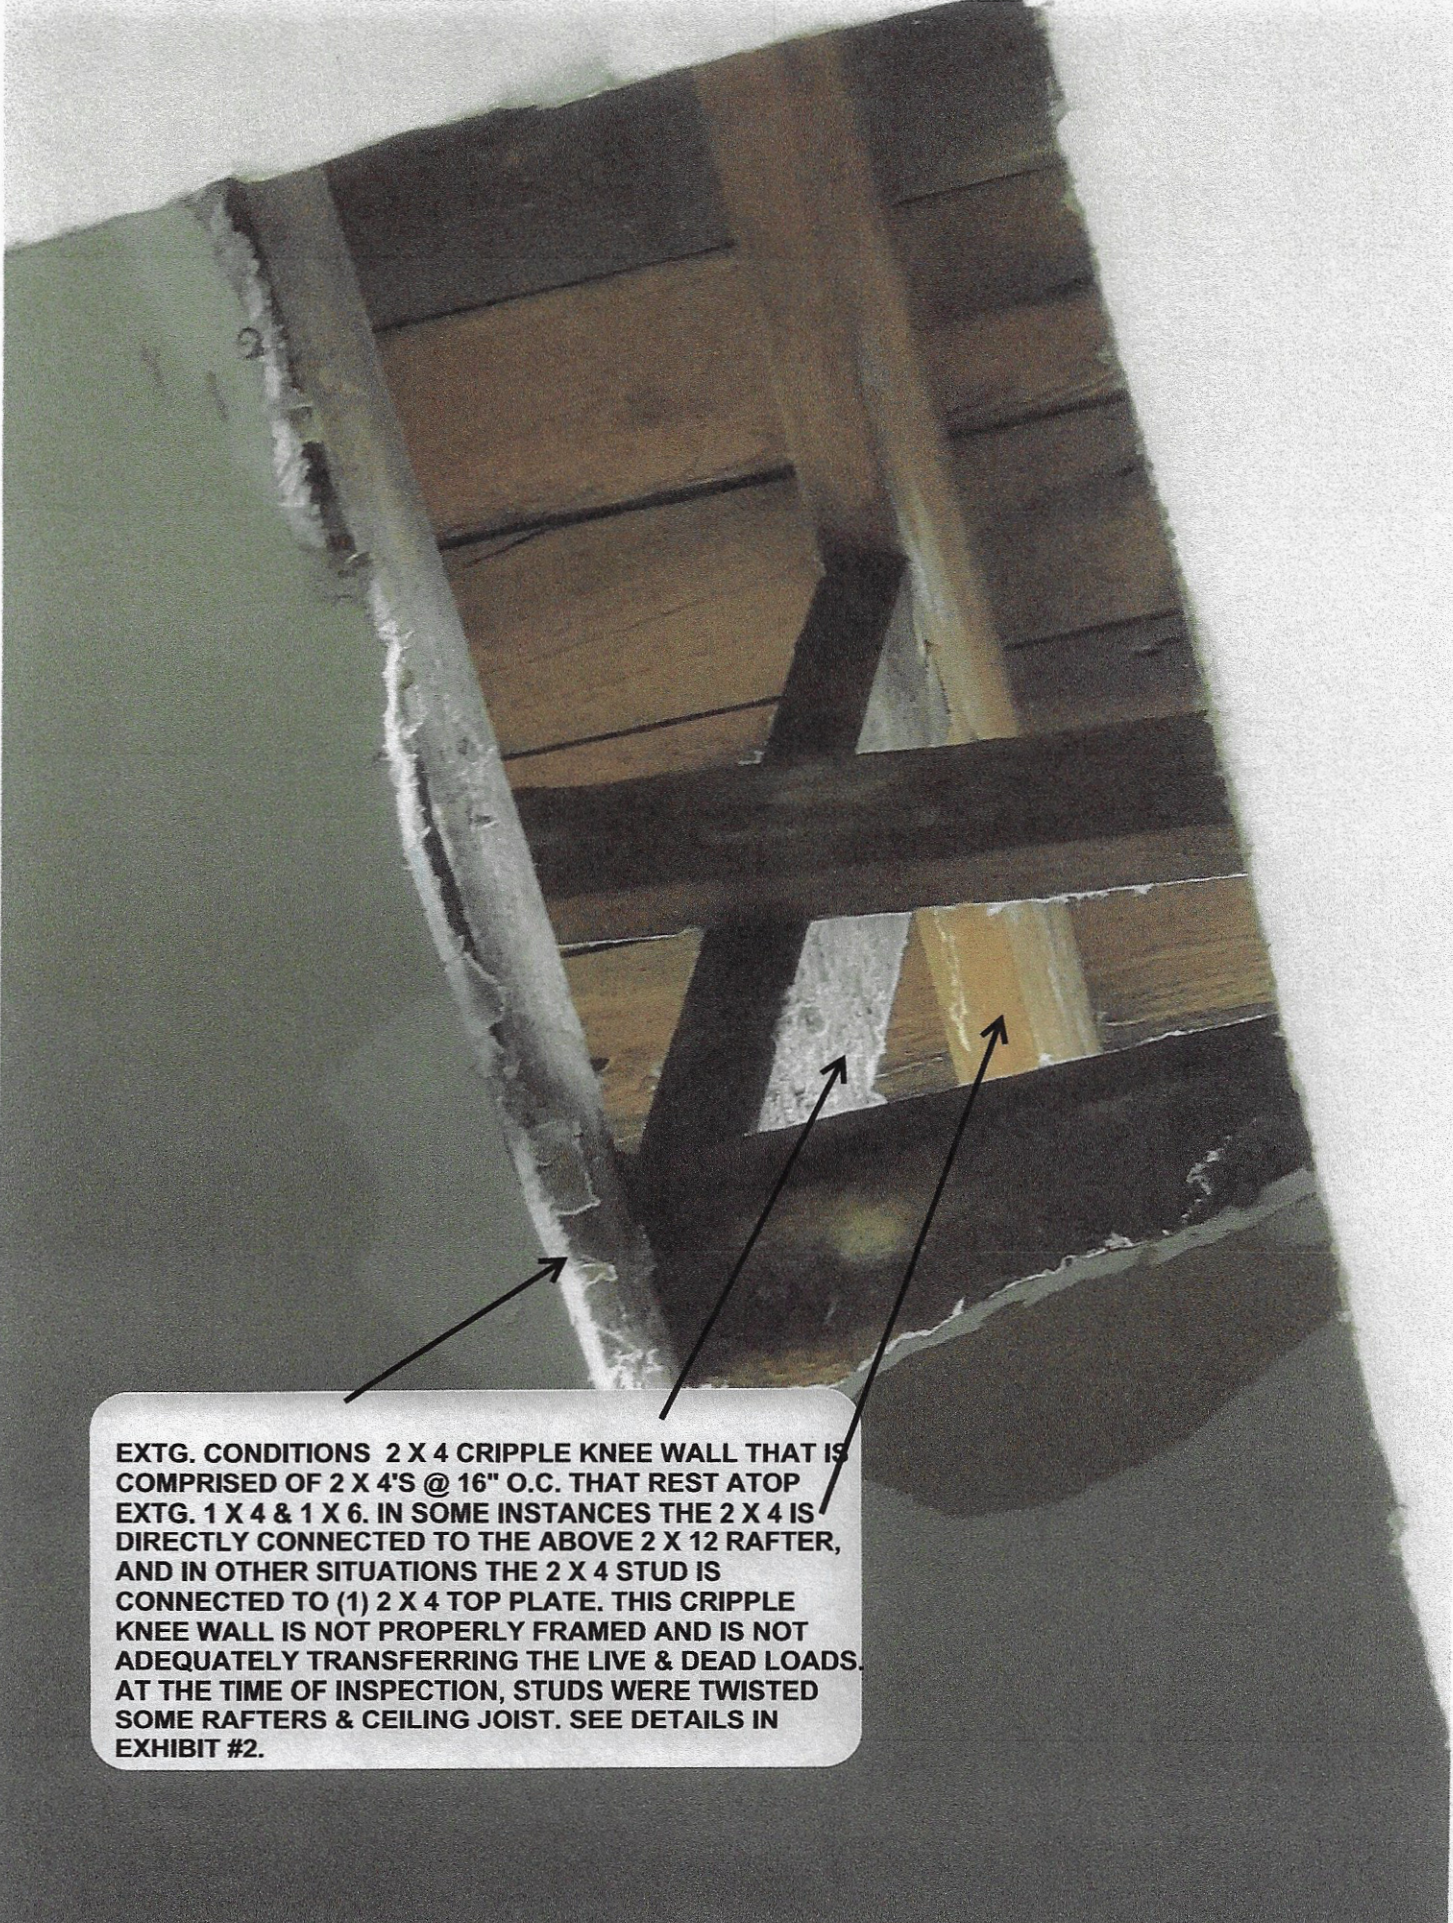
EXTG, DOUG FIR 2 X 12 JOISTS THAT HAVE WATER DETERIORATION DAMAGE ON THE FIRE CUT ENDS THAT BEAR INTO THE MASONRY. ALL 22'-0" JOISTS SHAL BE SISTERED WITH A NEW DOUG FIR SELECT 2 X 12 AND A SMALLER MEMBER SHALL ATTACHED TO THE OPPOSITE SIDE TO PROVIDE ADEQUATE BEARING INTO THE MASONRY WALL. SEE DETAIL IN EXHIBIT #2.

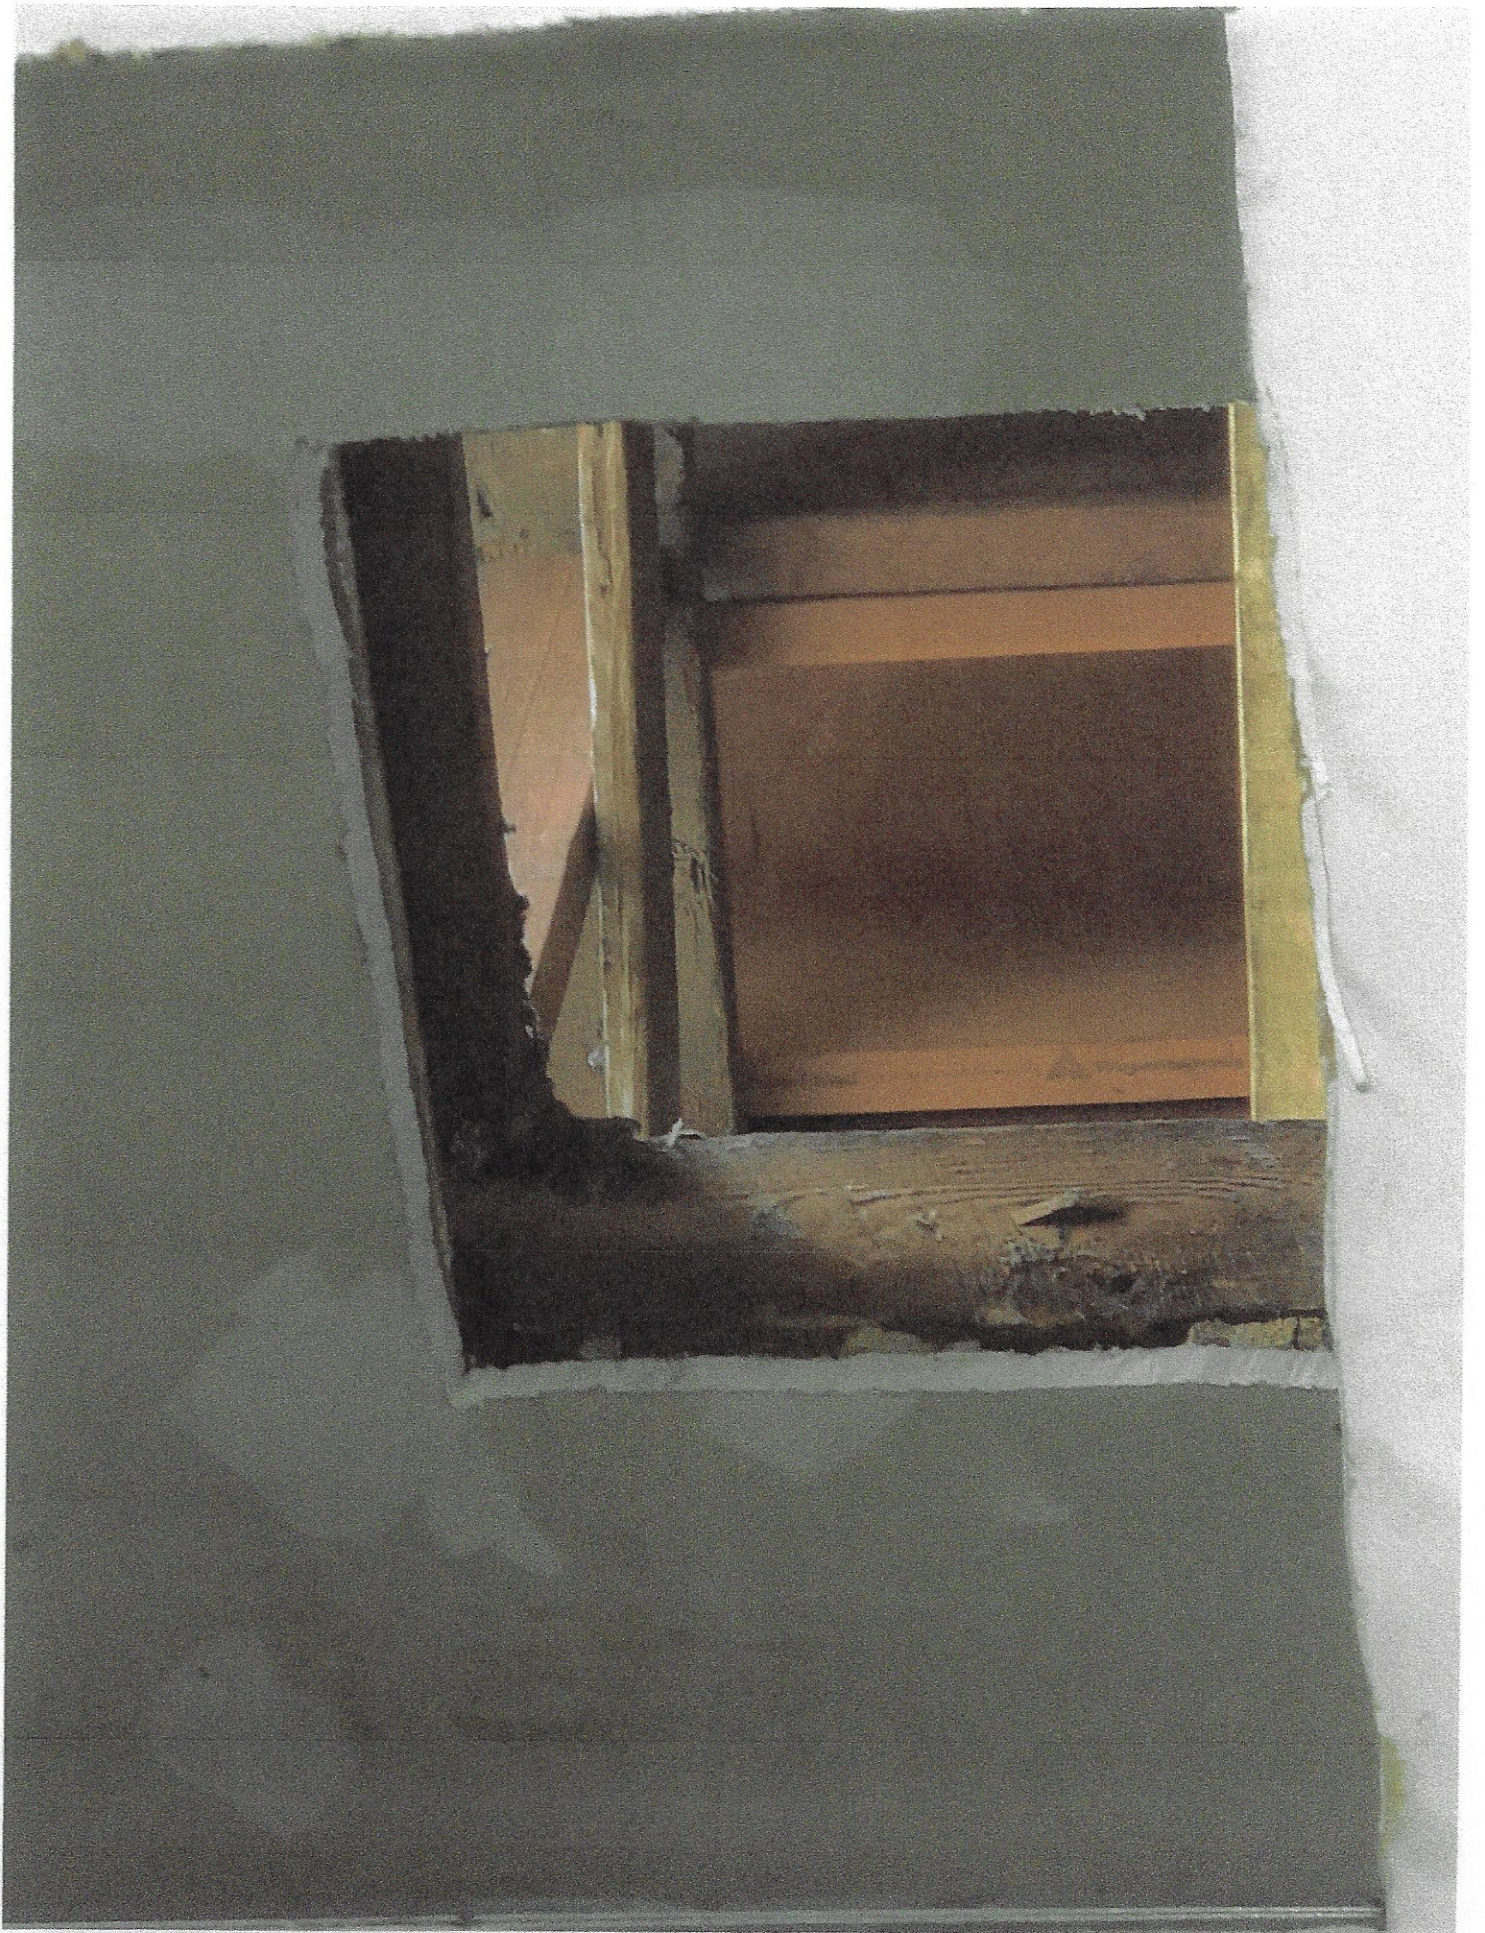
EXTG. CONDITIONS 2 X 4 CRIPPLE KNEE WALL THAT IS COMPRISED OF 2 X 4'S @ 16" O.C. THAT REST ATOP EXTG. 1 X 4 & 1 X 6. IN SOME INSTANCES THE 2 X 4 IS DIRECTLY CONNECTED TO THE ABOVE 2 X 12 RAFTER, AND IN OTHER SITUATIONS THE 2 X 4 STUD IS CONNECTED TO (1) 2 X 4 TOP PLATE. THIS CRIPPLE KNEE WALL IS NOT PROPERLY FRAMED AND IS NOT ADEQUATELY TRANSFERRING THE LIVE & DEAD LOADS. AT THE TIME OF INSPECTION, STUDS WERE TWISTED SOME RAFTERS & CEILING JOIST. SEE DETAILS IN EXHIBIT #2.
