Re: Well 26

CITY OF AURORA
WELL NO. 26 PUMP
INSPECTION REPORT

JOB NAME	AURORA	WELL NO.	26	DATE	4/21/2021
JOB NO.		INSPECTED BY	J. Kopp, B. Balluff, J. Geltz		
		BOWL ASSEMBLY	Byron Jackson 10 stage 12EJH		
		COLUMN ASSEMBLY	750' of 8" T&C Line Pipe, Sched 60		
		MOTOR	Byron Jackson 250 HP, 14", 2300V, Type M

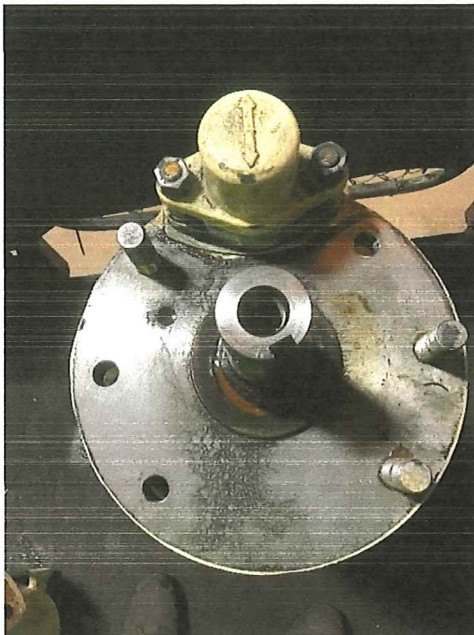
Shaft projection meets specification. Rotation in CW direction OK. Locked shaft in CCW rotation.

The motor/cable assembly megged dead short at the well head prior to pump removal. The motor megs dead short on its own. Shaft projection meets specification. Rotation is stiff but acceptable in clock-wise direction. Rotation is locked in counter-clockwise rotation. Stator can, lower can, and o-ring joint all in good condition. Balance tube in good condition. Reference attached Byron Jackson Motor Inspection – Type M report.

Replace motor with a factory exchange.

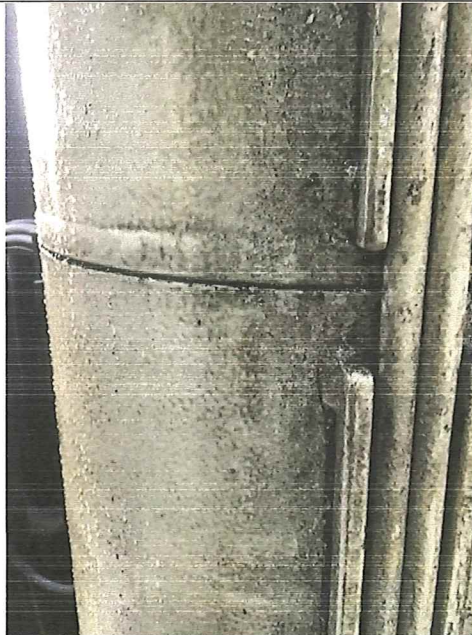
O-ring joint and lower can in good condition.

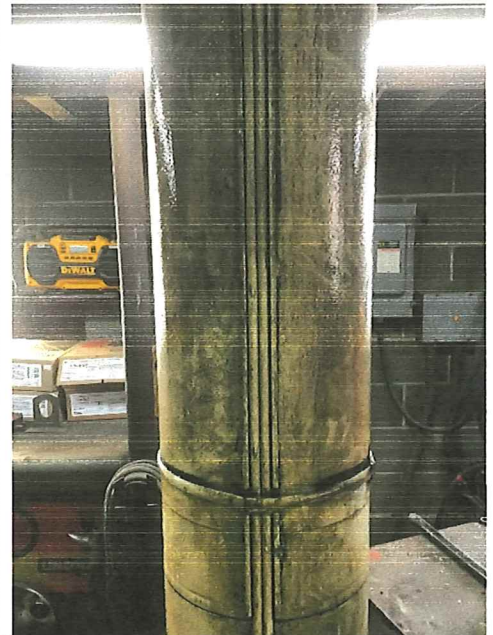
Stator can in good condition.

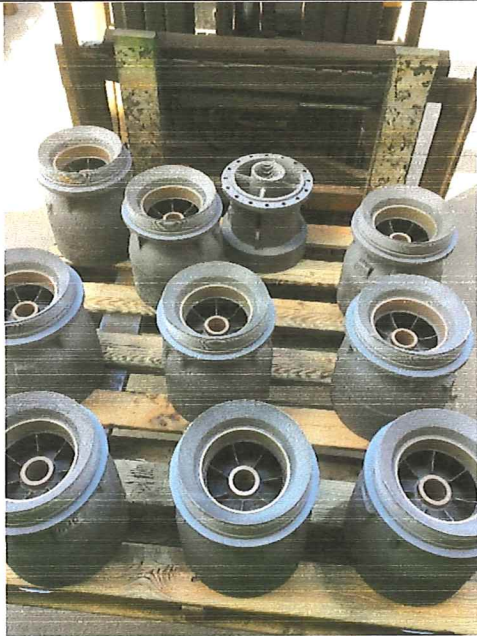
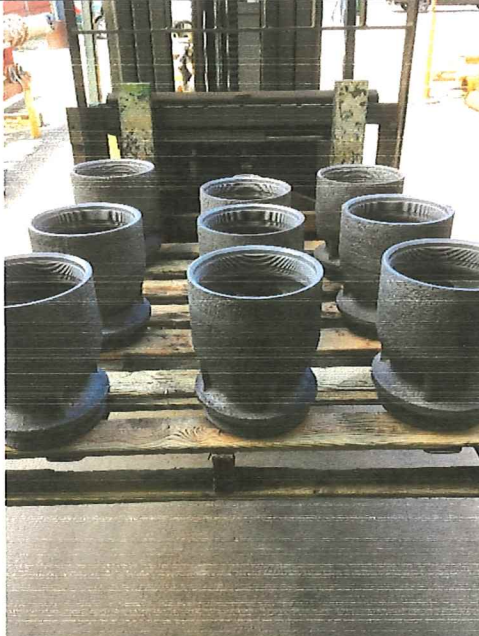
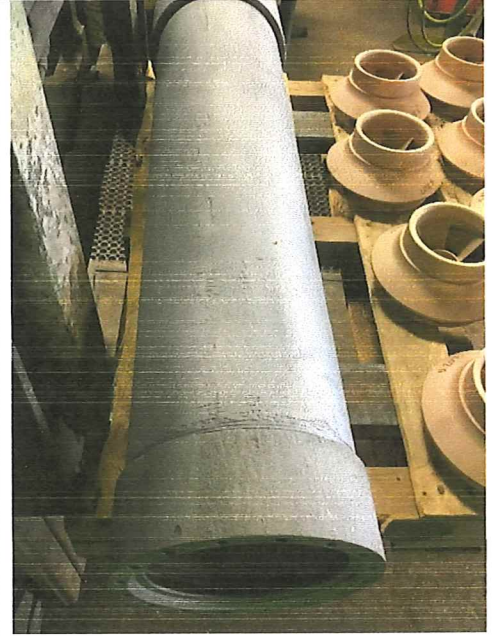
All castings have moderate exterior erosion.

Discharge includes a 3' pup.

Polish impeller shaft. Apply steel epoxy coating to interior pits. Apply ceramic coating to accessible interior.

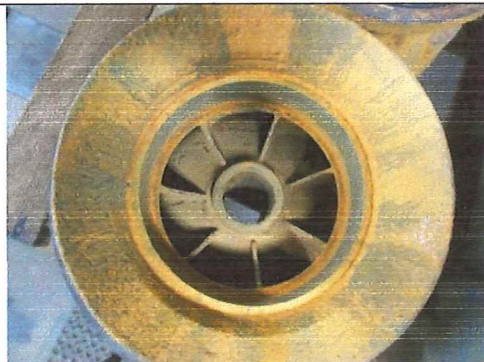
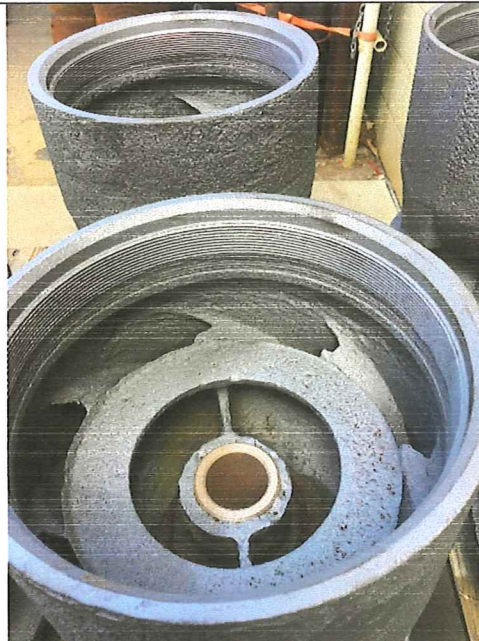
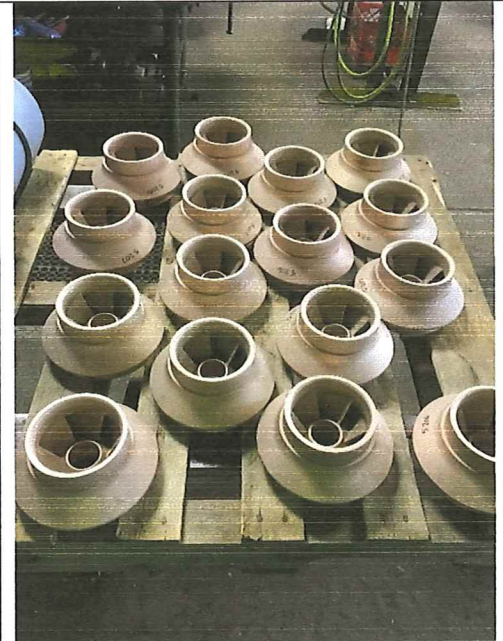
Wear ring and bushing clearances meet acceptable tolerances.

All castings have moderate vein deterioration and random deep interior pits.

All impellers in good condition.

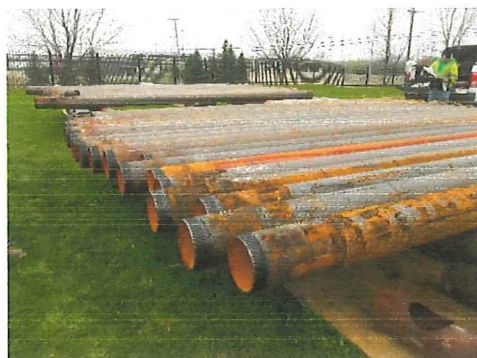
String of 8" Line Pipe racked on site.

This 8" T&C schedule 60 Line Pipe string was new in 2018. It has been installed and removed twice since that time. Overall, the pipe is in good condition with no pitting in the pipe bodies. The male threads and coupling threads were inspected using an API calibrated thread gauge. Several couplings and male threads did not pass the gauge specification. Reference attached Pipe Tally Sheet and Recommendations.

Cut & thread 3 male ends. Chase 7 male ends. Replace 6 couplings – plan a contingency for cut and thread the 6 exposed ends when these coupings are removed.

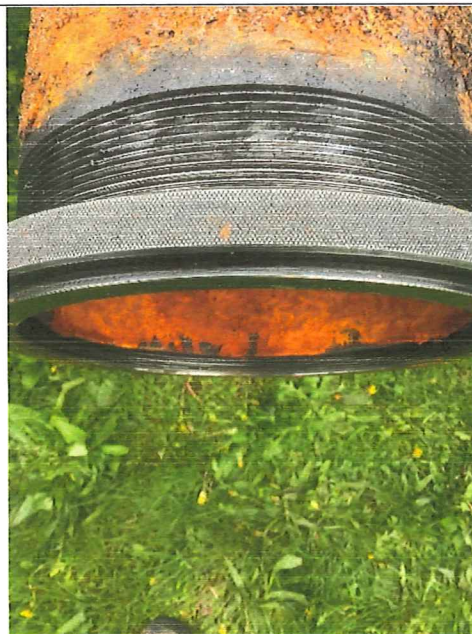
All male pipe threads were tested with an API calibrated thread guage.

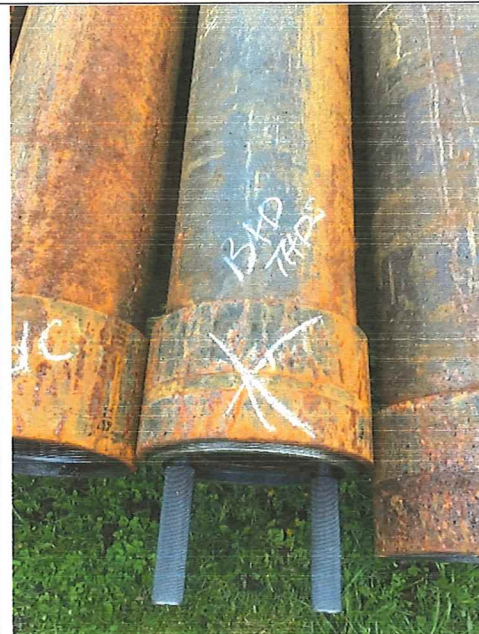
All couplings were tested with an API calibrated thread gauge.
