### TOPOGRAPHIC SURVEY

VACANT LAND - SOUTHEAST OF U.S. 30 AND WOLF'S CROSSING ROAD, AURORA, ILLINOIS

# AN ALTA/NSPS LAND TITLE SURVEY PERFORMED BY MANHARD CONSULTING DATED SHOWN ON THIS SURVEY.

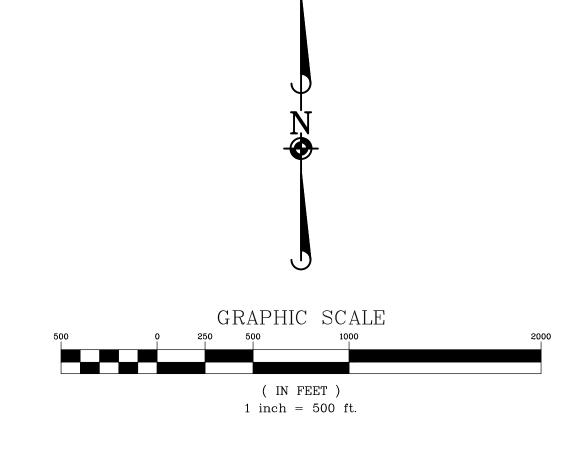
COORDINATES AND BEARINGS ARE BASED UPON THE ILLINOIS STATE PLAN COORDINATE SYSTEM, EAST ZONE (NAD 83), ADJUSTED TO GROUND VALUES AS ESTABLISHED BY A REAL-TIME KINEMATIC (RTK) GLOBAL NAVIGATION SATELLITE SYSTEM (GNSS) UTILIZING THE TRIMBLE VRS NOW NETWORK.

23,260,545 SQUARE FEET (533.989 ACRES)
