Proposal Response (Appendix A) to  
City of Aurora Request for Proposal 21-02

Request for Professional Services to Clean and Restore  
Murals at the Grand Army of the Republic Memorial Hall  
With Recognition of Addendum #1, and Historic Structure Report

Murals located at  
Grand Army of the Republic Memorial Hall  
23 E Downer Place  
Aurora, IL 60507

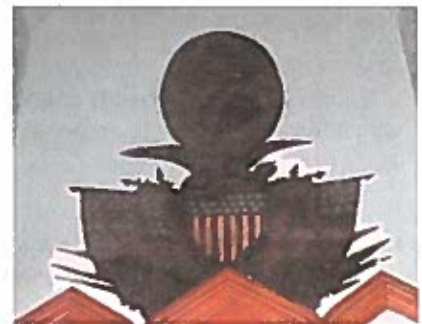
#### North Wall – George Washington 25.9 sq ft

"In the north alcove, over the entrance, appears a portrait of Washington, surrounded by half furled national flags resting upon central shield. In the foreground is the American eagle, with quiver and arrow in his talons, standing upon a pile of muskets and cannon of the Revolutionary period."

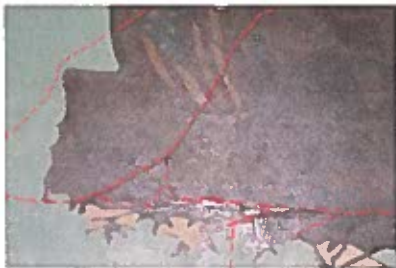
Fig.1 Open cracks

- Cracks with displaced plaster surfaces are especially evident at the south niche, and extend both horizontally and vertically across the wall surface of the niche and through the mural (fig. 1)
- The north niche exhibits evidence of map cracking throughout the mural surface, and variations in the plaster surface near the ceiling/wall intersection
- The east mural exhibits vertical hairline cracking
- Additional conditions including, but not limited to interlayer plaster separation, broken plaster keys, and active structural cracking may be present, but could not be verified during the site visit

Repairs and consolidation should occur only after stabilization of any underlying structural conditions have been rectified if found. It is assumed that all structural problems were addressed during the recent building renovations. Prior to treating any voids or damage to plaster, mock-ups of repair methods will be prepared first off-site, then in-situ on the existing plasters in order to determine the most appropriate method for the GAR Memorial Hall. Mock-up testing may include both commercially available products and custom formulas, with the goal of re-supporting existing plaster layers while minimizing impacts to the mural surfaces. It should be noted that the visible cracks may remain if repairing the cracks will result in visible or material disruptions of the murals or surrounding plaster walls.

Once the appropriate repair material and method is identified, its application will be tailored to the specific material requirements. However, the application is generally expected to include either plaster anchors, grout, or a combination thereof. Special care will be taken to avoid areas of visible and suspected murals. In the case of anchors, small, drilled holes (less than 1/8") in the plaster surface and through the lath. In the case of grout, the holes will be cleared of loose plaster and dust through careful cleaning with HEPA filtered vacuums. Then, the formulated grout will be injected through these holes to fill voids and create new plaster keys into the lath. The holes will be patched level with the surrounding wall surface and inpainted after curing to match the surrounding wall color.

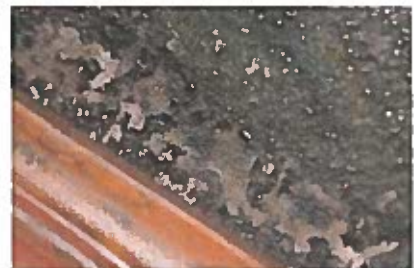
Fig.3 Flaking paint layer

Paint layer (binding medium likely oil) is flaking along the bottom edge of the North Mural (fig.3)

**Consolidation and Varnish Removal** Varnish removal from the areas of the flaking paint layer will be performed simultaneously with consolidation (several consolidants will be tested in situ, e.g. 2.5% Klucel E in isopropanol and distilled water).
