PHASE II ENVIRONMENTAL INVESTIGATION

115 West Indian Trail
Aurora, IL 60506

Project #0601548

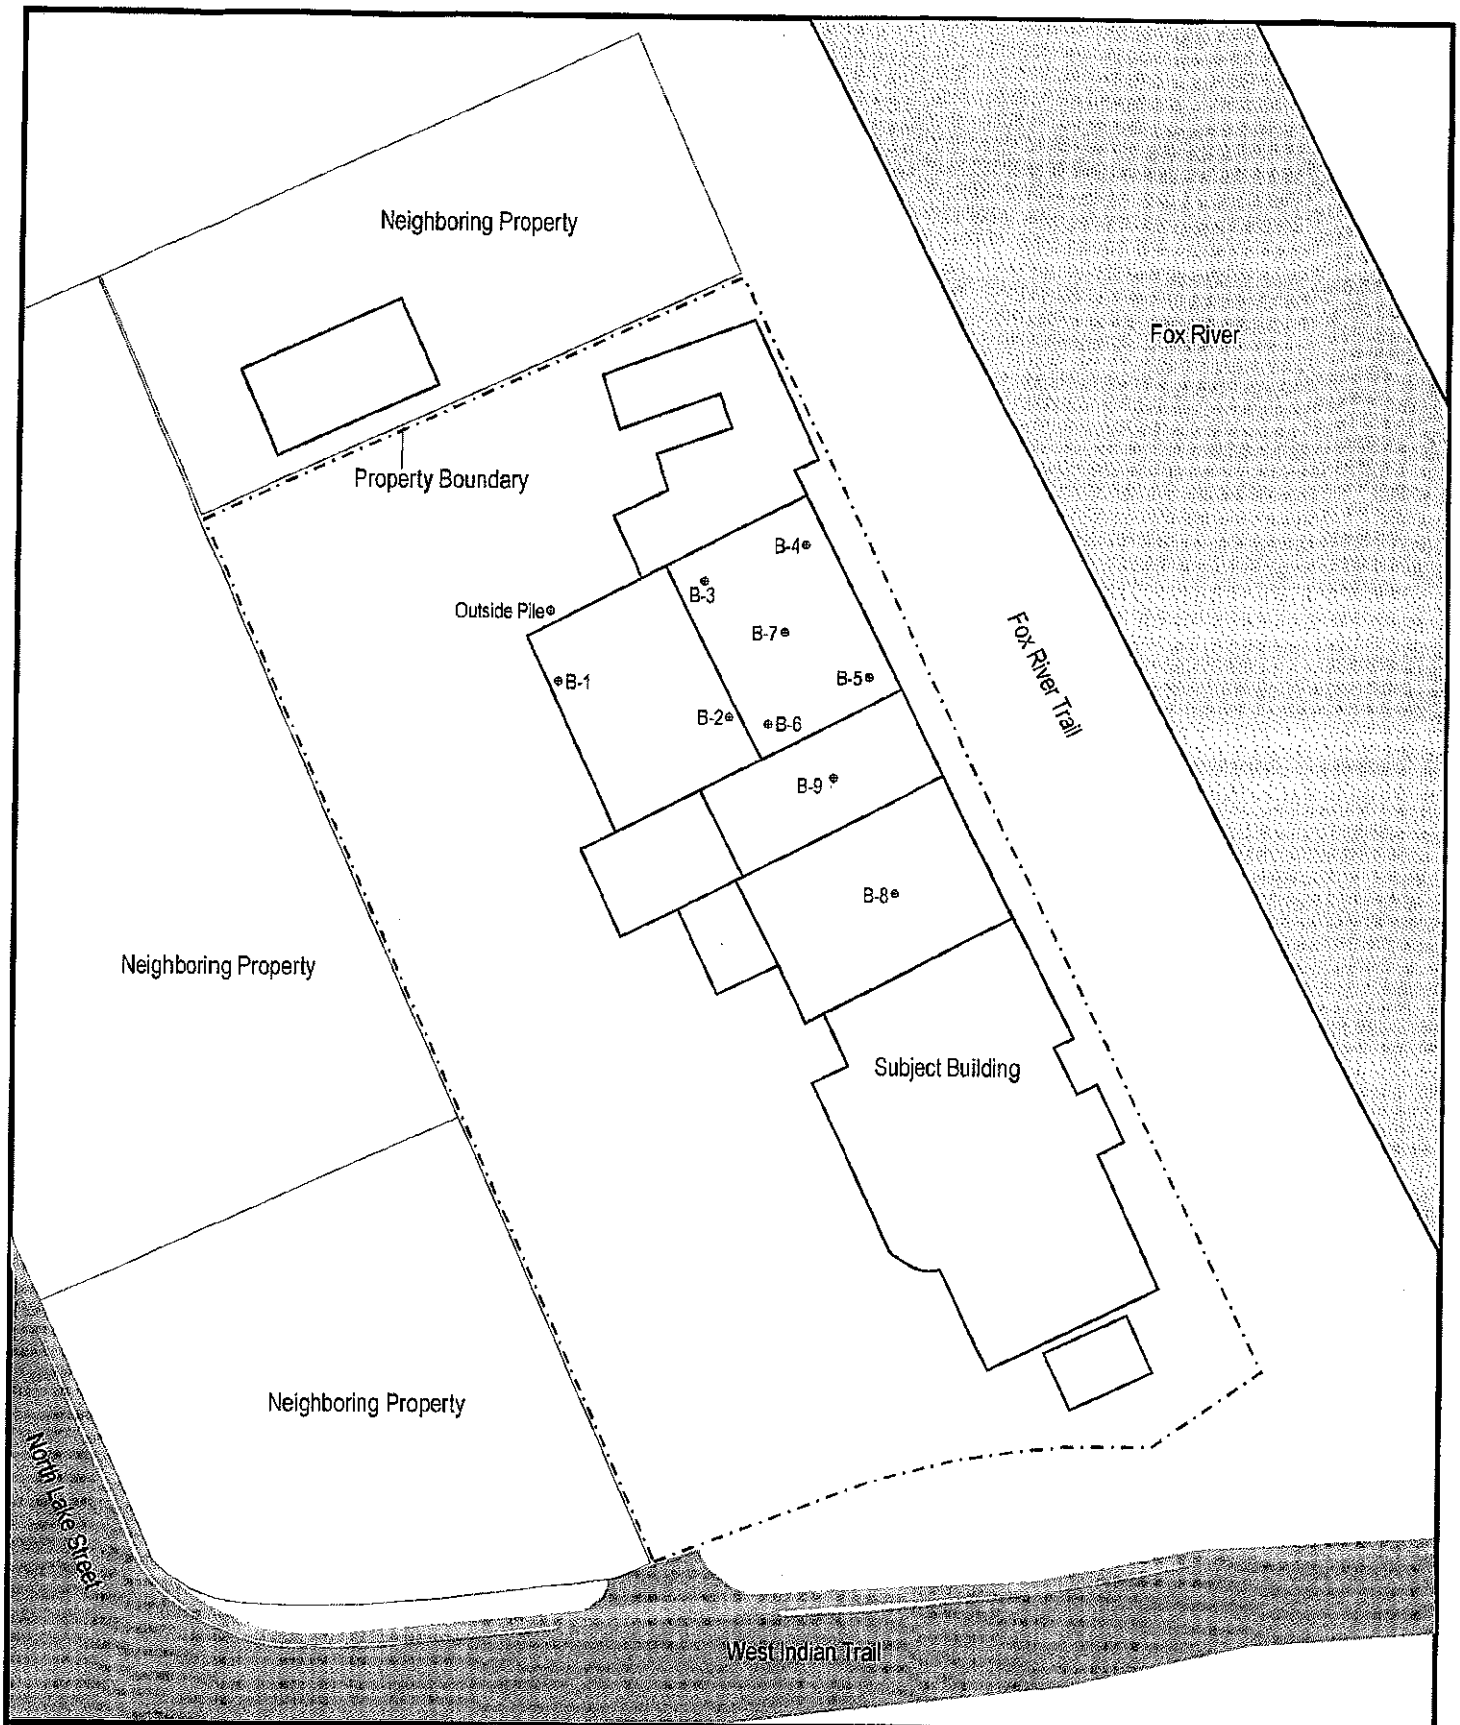
Soil Boring Location Map
Client: City of Aurora Dev. Services
Site location: 115 W. Indian Trail, Aurora

A total of nine (9) soil borings were advanced into the subsurface soils at the subject property on July 2, 2015. Groundwater sample collection was attempted but unsuccessful due to site geology. See Soil Boring Location Map in Appendix A for boring locations. Field screening of samples collected from the borings, including the use of a Photoionization Detector (PID), revealed no contamination in representative soil samples.

Nine (9) soil borings were advanced into the subsurface soils at the subject property on July 2, 2015. See Soil Boring Location Map in Appendix A for boring locations. Soil borings were advanced to the following depths Below Surface Grade (BSG): B-1 (3'), B-2 (3'), B-3 (3'), B-4 (4'), B-5 (3'), B-6 (1'), B-7 (7'), B-8 (4'), and B-9 (4'). Groundwater sample collection was attempted but unsuccessful due to site geology.

Gabriel recommends additional soil borings and analysis to further delineate the contamination on site.
