# *AURORA WEST DAM AND CANOE CHUTE INSPECTION REPORT*

December 30, 2025  
City of Aurora,  
Kane County,  
Illinois

Purchase Order:  
311184  
RS&H No.:  
1056-0079-000

Prepared by RS&H, Inc. at the  
direction of The City of Aurora, Illinois

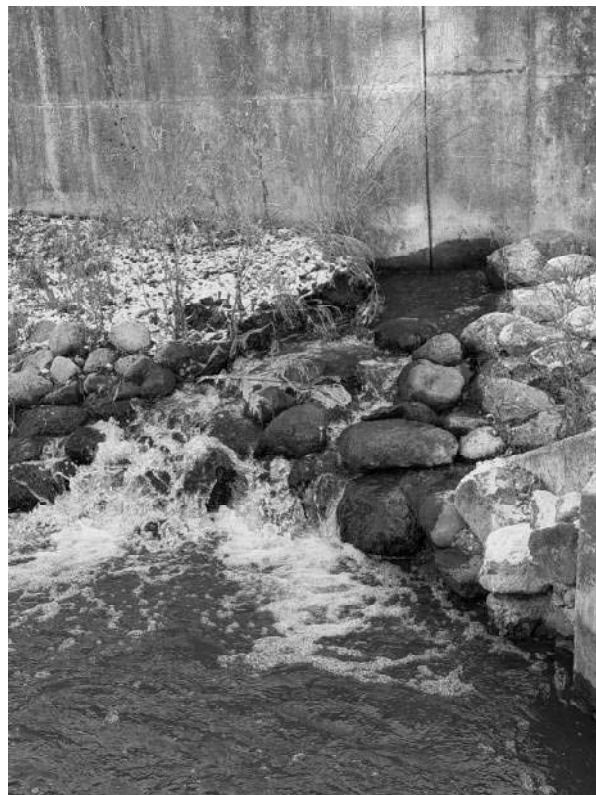
DS4 was observed to have active water flowing into the Canoe Chute from the Fox River on the upstream side. The water was coming into the Canoe Chute at a high volume and velocity from a void at the base of the wall (see Photo **DS4-2**). Seepage and erosion were also observed on the downstream side. Cracking was observed along the west sidewalk and wall. See Photos **DS4-1** to **DS4-6**.

***PHOTOGRAPH DS4-2: FLOW THROUGH CANOE CHUTE EAST WALL UPSTREAM OF DS4***

1. The construction joint and void at the Canoe Chute East Wall should be sealed and filled, respectively. This location was observed with active water flow from the Fox River into the Canoe Chute. The wall is supported by steel-encased concrete caissons keyed into the bedrock and the condition is not yet a bearing concern for the wall. The repair is recommended to eliminate this active flow of water and additional erosion concerns.

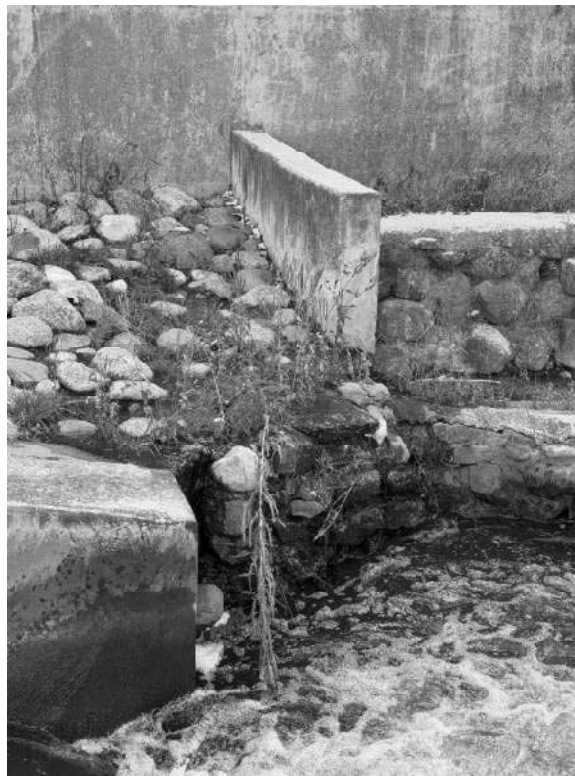
***PHOTOGRAPH DS4-4: DS4 DOWNSTREAM EROSION***

2. The drop structures were observed to have erosion and scour mostly along the concrete flares which included undercutting and riprap pop outs. It is recommended that void areas be filled with grout, and that riprap be reset along the concrete flares, in areas of undercutting, and along the pool walls. At the time of the inspections, pockets of branch and stone debris were noted, and these should be removed during regular Canoe Chute maintenance to keep continuous flow and prevent additional buildup in the chute. The West Dam also had two tree trunks trapped against the dam crest that should be removed.

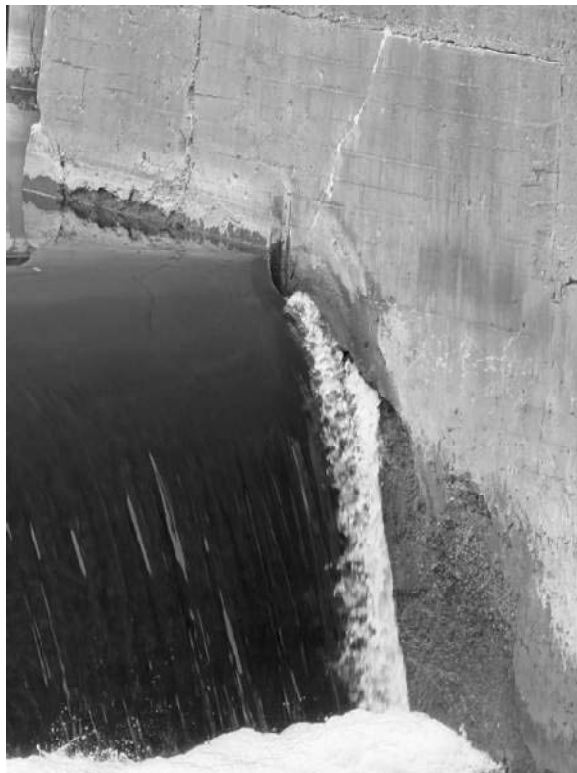
***PHOTOGRAPH WD-5: WEST DAM FOX RIVER EAST WALL SCALING DETAIL***

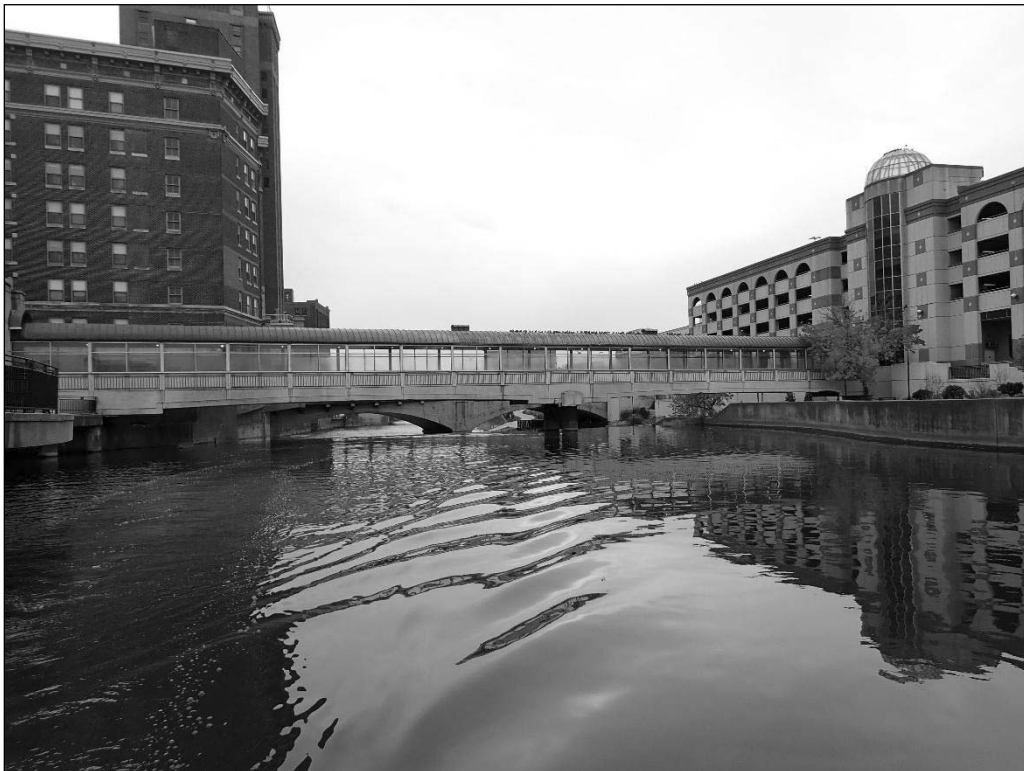
Photograph 2. Overall View of the Aurora Dam, Looking Southwest.

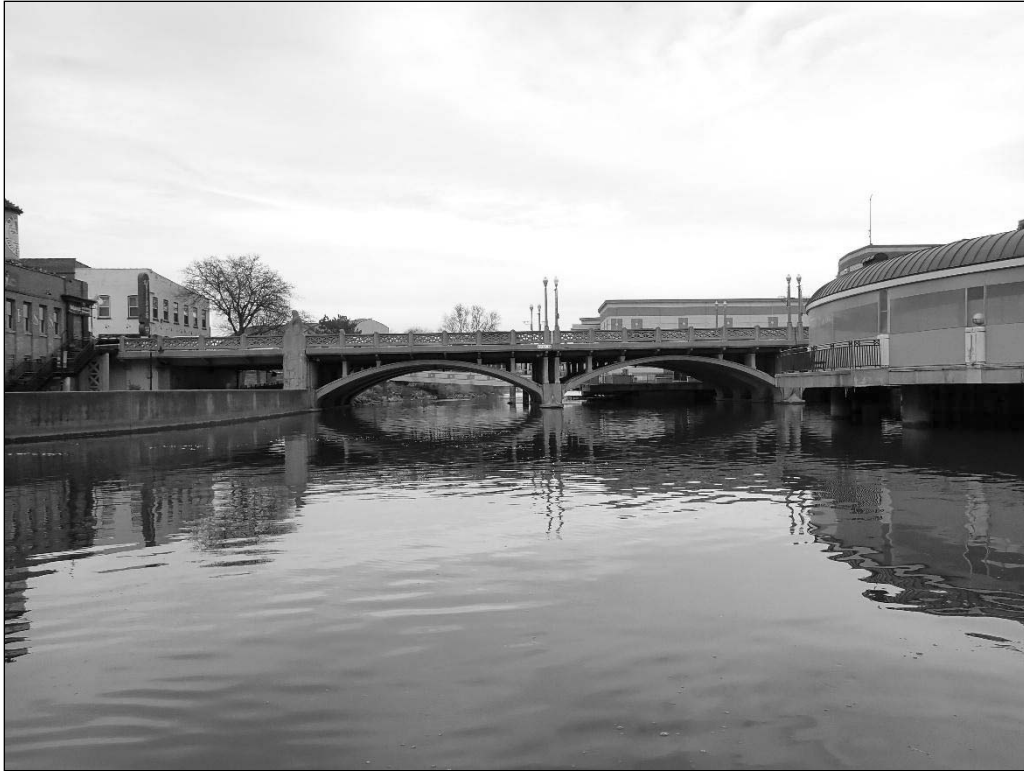
Photograph 3. View of the Upstream Channel, Looking North.

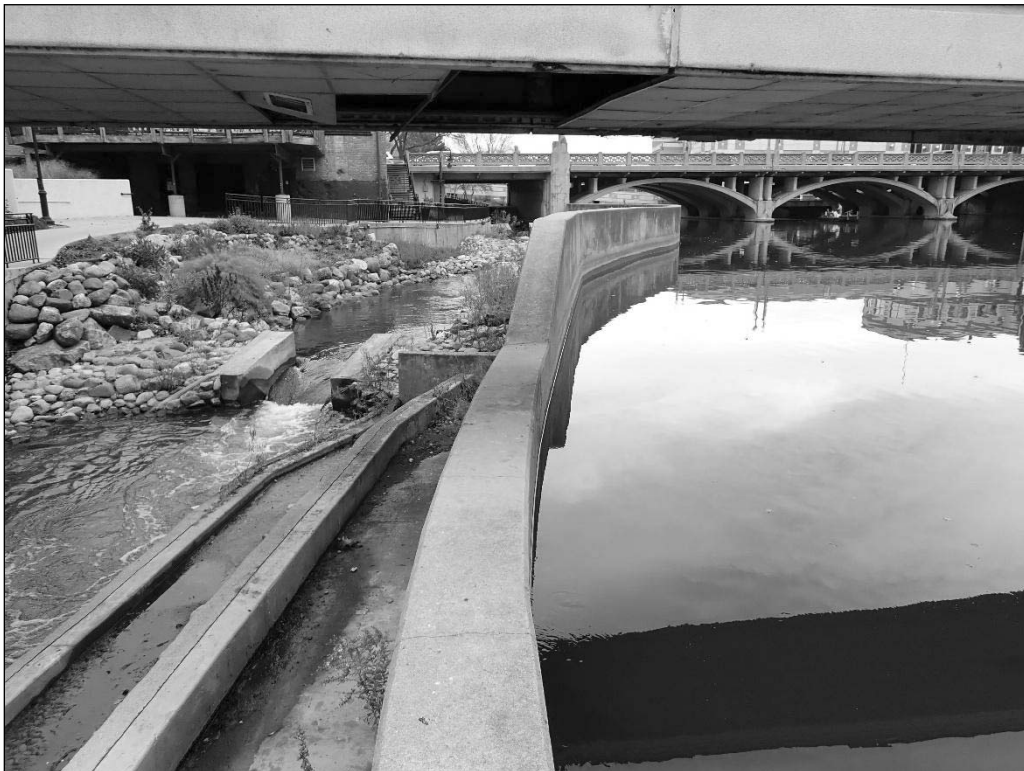
The Canoe Chute East Wall was generally in satisfactory condition. The wall exhibited hairline to 1/16-inch-wide vertical cracks extending the full height of both wall faces and across the top at 18 locations along the wall. No water seepage was observed at any of these cracks. An active water discharge was observed at the base of the Canoe Chute East Wall on the west side near the construction joint at Station 1+80. A void measuring approximately 1.5 feet in length by 2 inches in height was observed at the river bottom along the outboard side of the wall at this location. The water discharge has resulted in minor bank erosion and localized loss of stone along the west side of the wall. The east wall downstream of the dam was undermined by up to 3 feet vertically, exposing one steel caisson supporting the wall. The caisson did not exhibit any defects. The Canoe Chute pool adjacent to the east wall is constructed of a concrete apron floor and did not exhibit any defects. Refer to Figures 2 and 3 in Appendix A for detailed inspection notes and Photographs 5 through 16 for views of the Canoe Chute Pool and the East Wall.

Photograph 6. View of the Canoe Chute East Wall, Looking North.

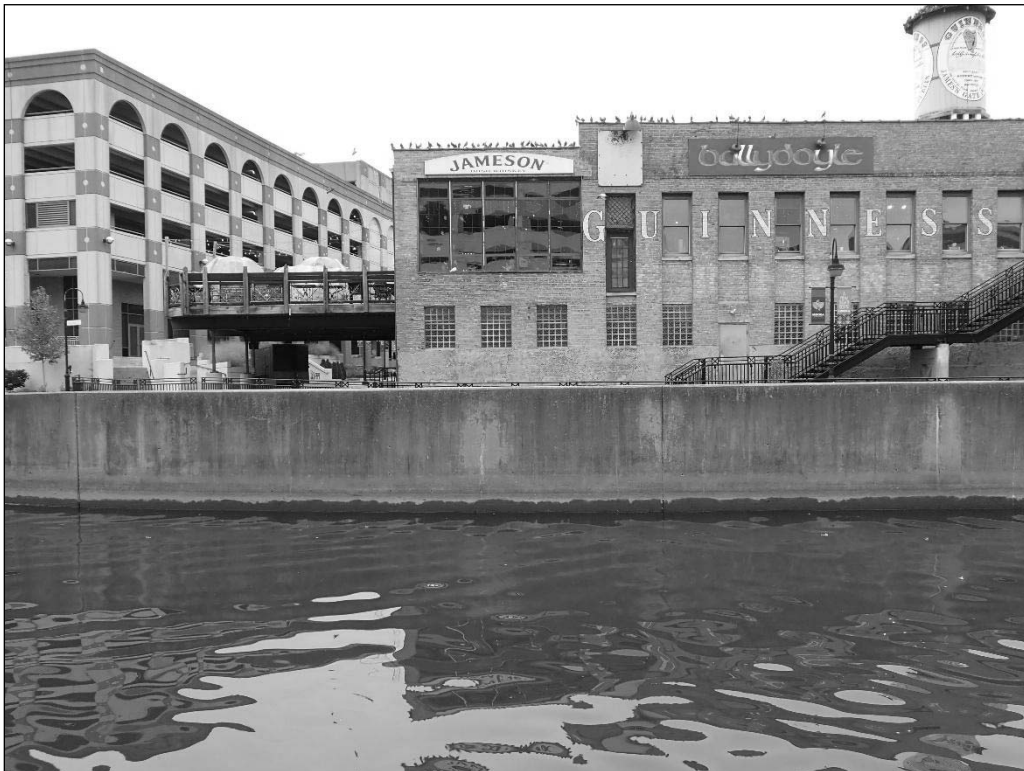
Photograph 8. View of the Canoe Chute East Wall from Station 0+50 to Station 0+75, Looking West.

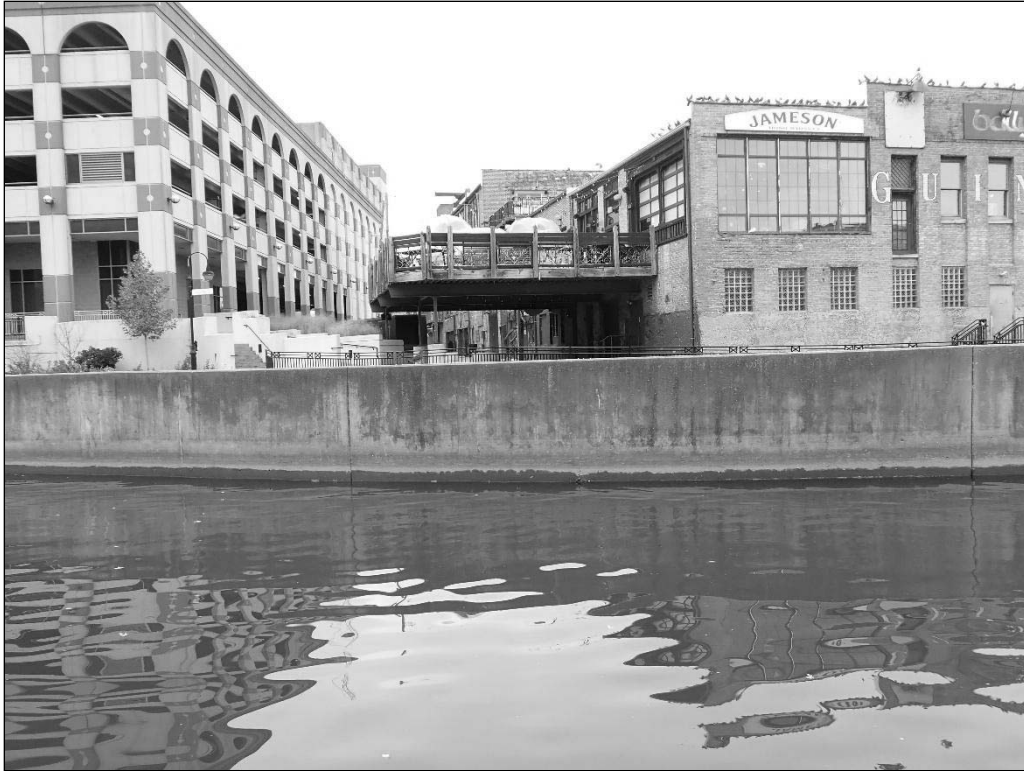
Photograph 9. View of the Canoe Chute East Wall from Station 0+75 to Station 1+25, Looking West.

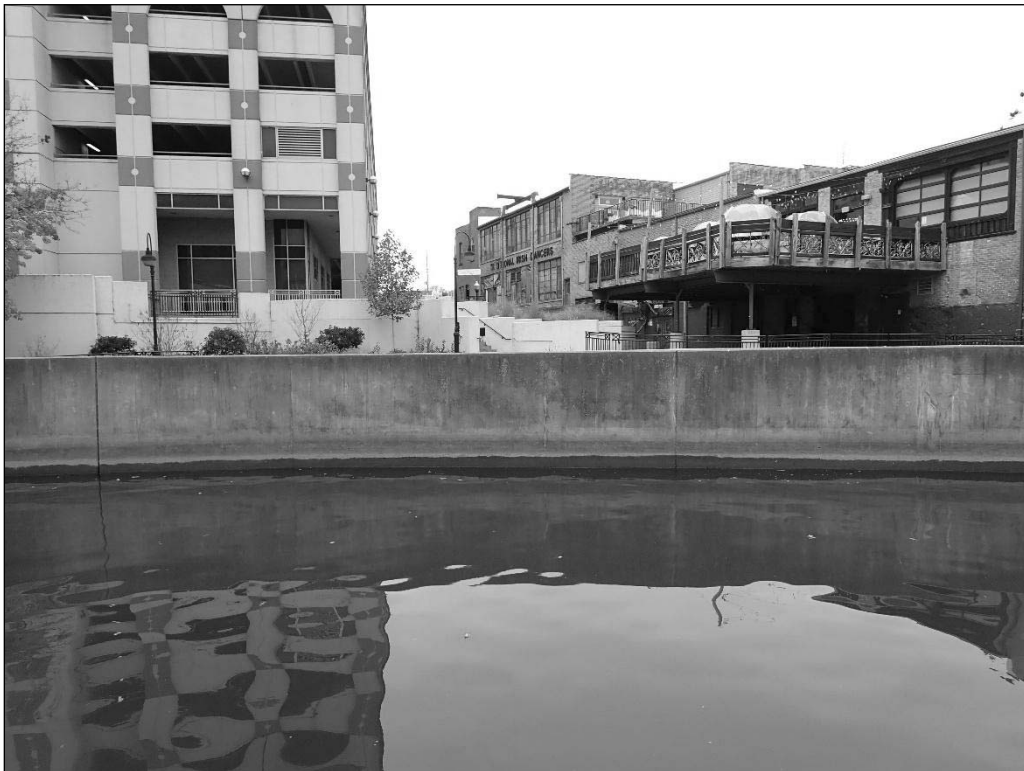
Photograph 10. View of the Canoe Chute East Wall from Station 1+25 to Station 1+75, Looking West.

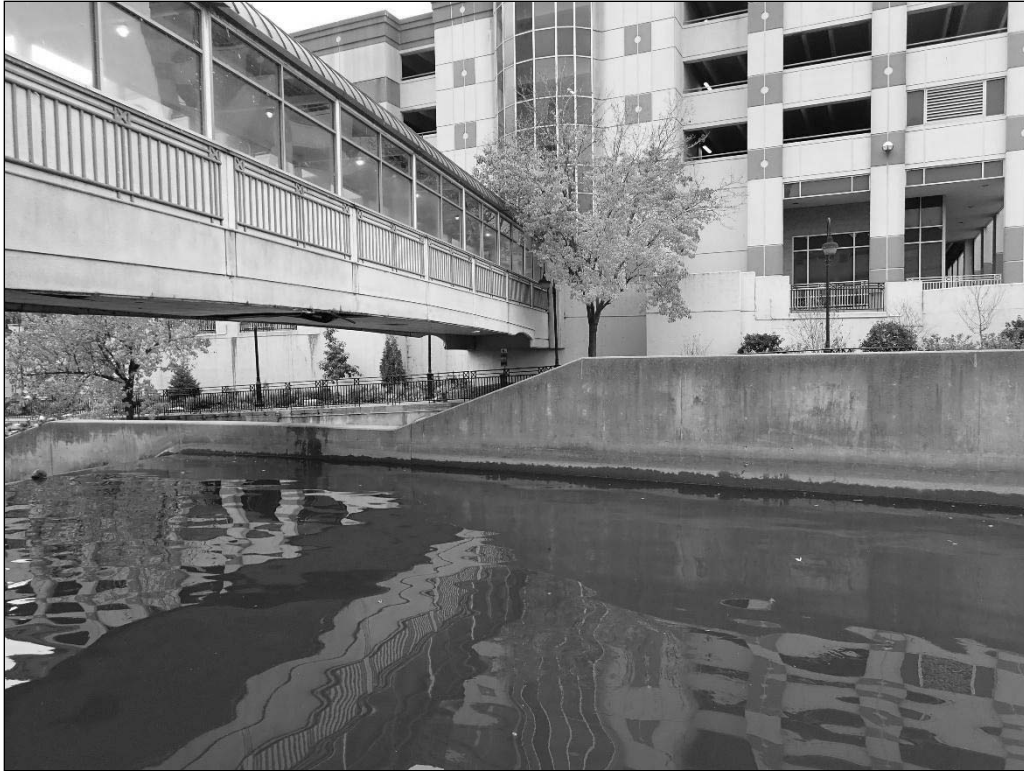
Photograph 11. View of the Canoe Chute East Wall from Station 1+75 to Station 2+35, Looking Southwest.

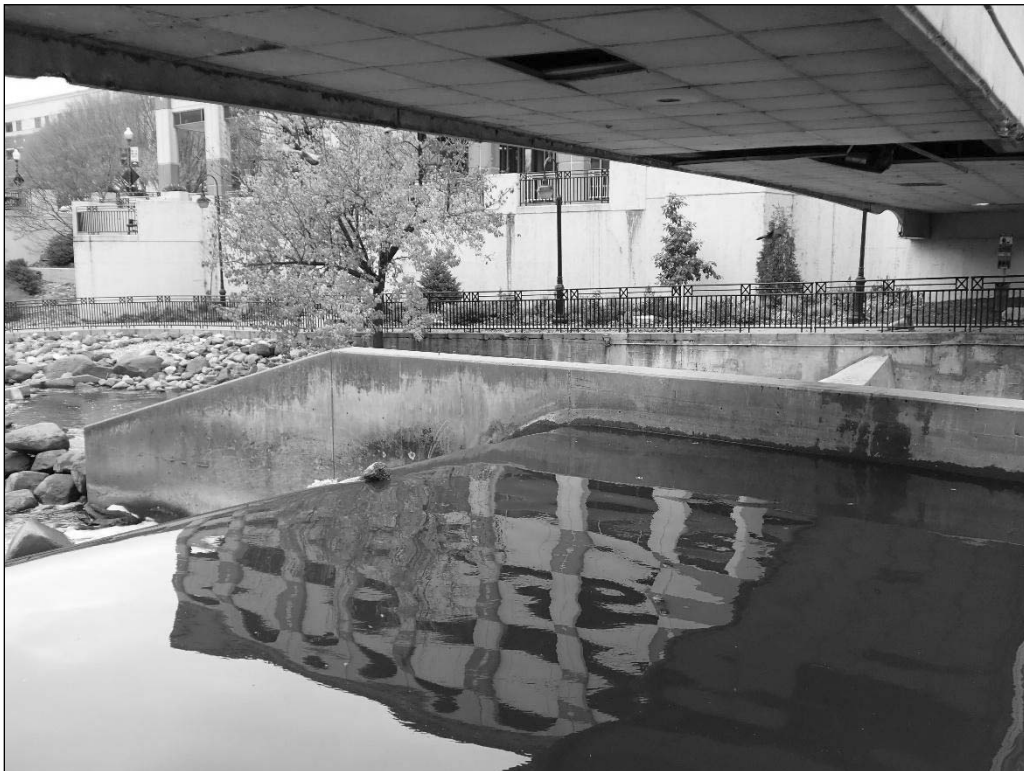
Photograph 12. View of the Canoe Chute East Wall from Station 2+20 to Station 2+62, Looking Southwest.

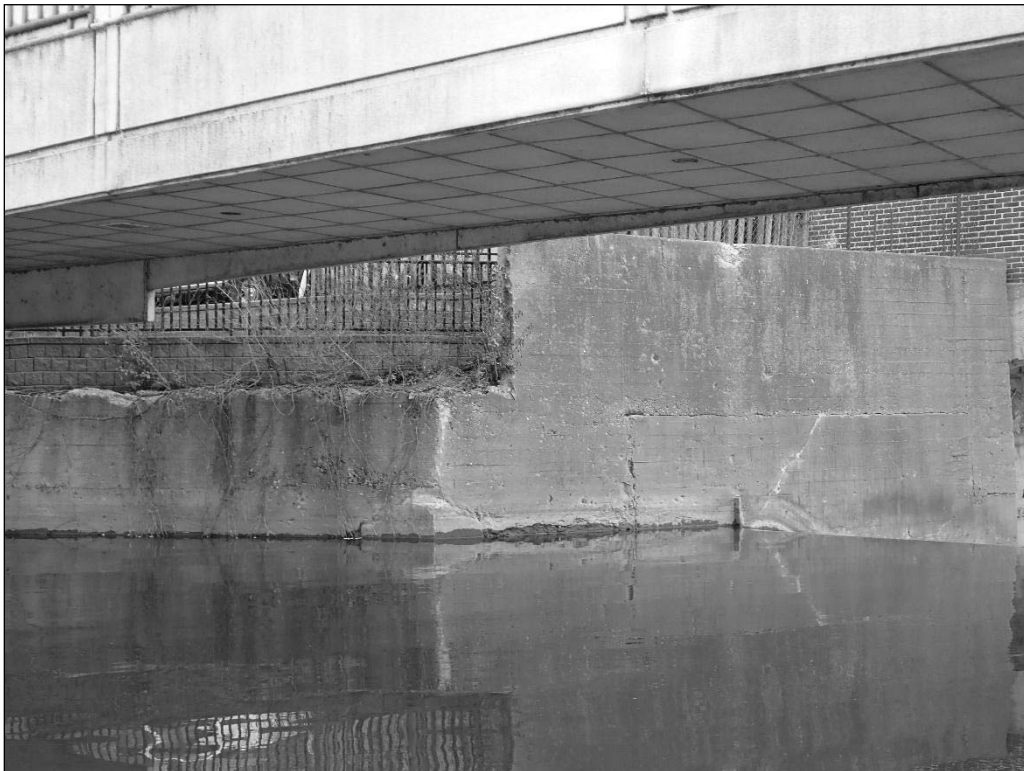
Photograph 18. View of the East Abutment, Looking East.
