City of Aurora

2019 Bridge Condition Report

Rotary Plaza Pedestrian Walkway

Benesch Project No. 10483.03

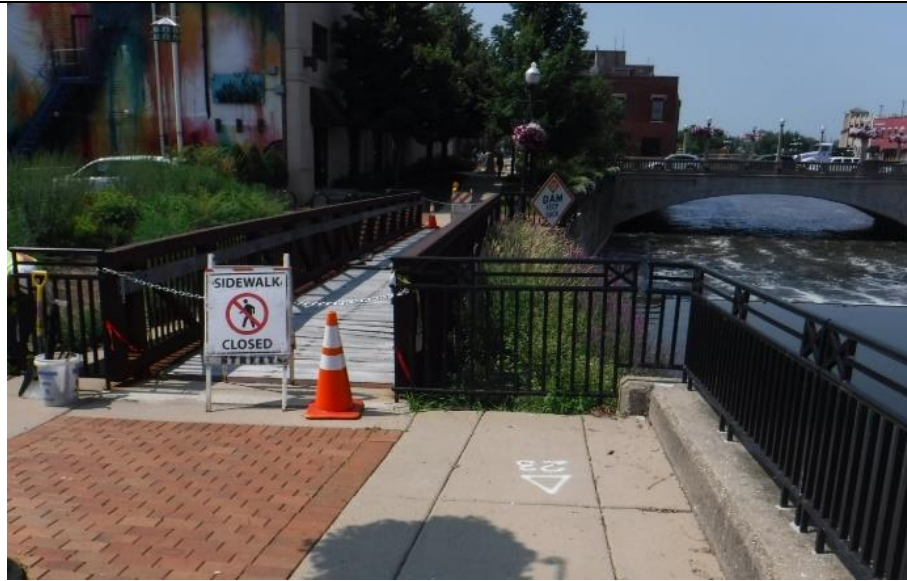
Aurora Riverwalk - Existing View Looking South at Pedestrian Walkway Bridge

Upon evaluating the project's needs, desires, constraints and per concurrence with the City, Alternative 3, constructing a retaining wall, is recommended. Below are two options to consider concerning the overall riverwalk aesthetics and path alignment preference. The final wall location will be dictated by the findings of the geotechnical, environmental and hydraulic investigations.
