M.E. SIMPSON COMPANY, INC.

LEAK LOCATION REPORT

Client: Aurora, Illinois **Time:** 9:30 AM
Date: December 22, 2025 **Tech:** Sandison P. & Juan M.
Address: Ohio Street & Indian Avenue (N. of)

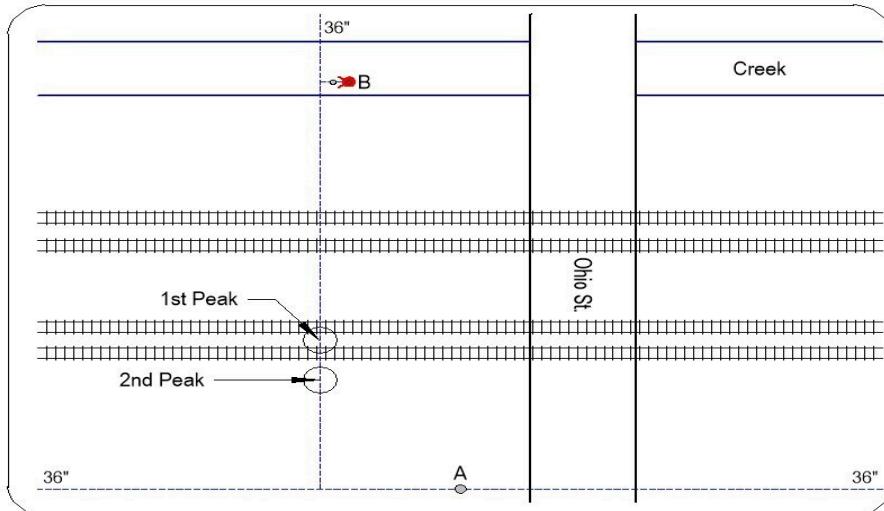
Below is a diagram of the area surveyed for a suspect leak.

This drawing is not to scale.

Distance: 380' from A to B
Connection point: A= Main Line Valve **Connection point:** B= Hydrant
Leak Location: 240' from A
Comments: This is a leak on a 36" main. We came up with two peaks. The first was 240' from "A", and the second was 210' from "A". The first peak was the strongest. "B" is missing its head and is in the creek.
