# *AURORA WEST DAM AND CANOE CHUTE INSPECTION REPORT*

December 30, 2025  
City of Aurora,  
Kane County,  
Illinois

Purchase Order:  
311184  
RS&H No.:  
1056-0079-000

Prepared by RS&H, Inc. at the  
direction of The City of Aurora, Illinois

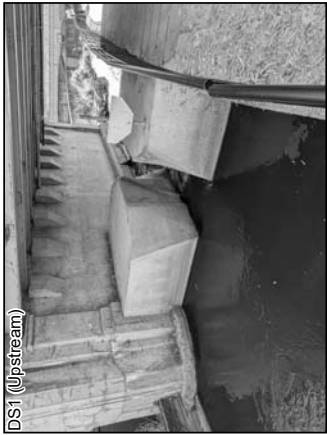
DS1 was observed to be in good shape overall. The depth of flow through the structure was at a higher velocity, but no erosion was observed through the structure or downstream channel. The Obermeyer Pneumatic Crest Gate is situated on the downstream side of this structure, was repaired after the 2020 inspection report, and is assumed to be operational. See Photos **DS1-1** to **DS1-4**.

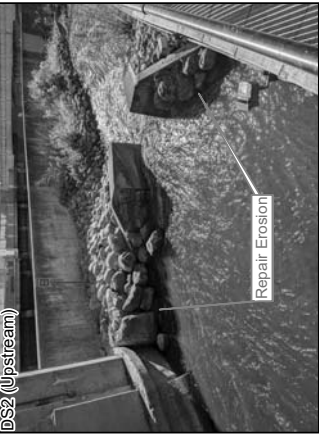
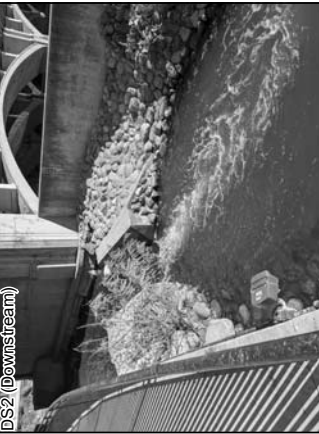
DS2 was observed to have damaged riprap and erosion along the upstream flares of the drop structure. There is a void between the south side of the New York Street bridge pier and the chute bank on the upstream side of DS2 (see Photo **DS2-2**) and erosion-related damage to riprap upstream and downstream of DS2. Shrubbery downstream of the drop structure is recommended to be managed. Some erosion was observed along the west sidewalk wall. Overall, the condition of the structure itself appears satisfactory. See Photos **DS2-1** to **DS2-4**.

2. The drop structures were observed to have erosion and scour mostly along the concrete flares which included undercutting and riprap pop outs. It is recommended that void areas be filled with grout, and that riprap be reset along the concrete flares, in areas of undercutting, and along the pool walls. At the time of the inspections, pockets of branch and stone debris were noted, and these should be removed during regular Canoe Chute maintenance to keep continuous flow and prevent additional buildup in the chute. The West Dam also had two tree trunks trapped against the dam crest that should be removed.

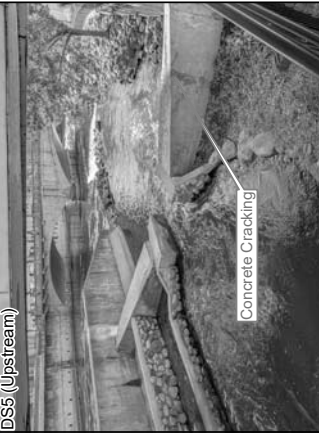
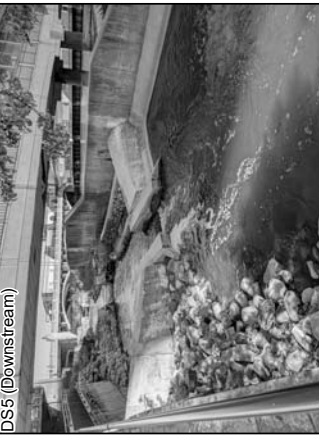
DS5 has some minor erosion issues on the downstream side. The west side of the structure and the west sidewalk wall show concrete cracking. Seepage was observed upstream of the structure along the west Fox River wall. The downstream pool connects to the chute outfall and there is a spillway along the east side of the chute to the Fox River. This spillway appeared functional; however, the grading of the top of the spillway was irregular. See Photos **DS5-1** to **DS5-4**.

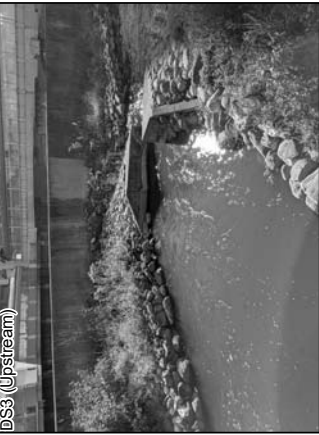
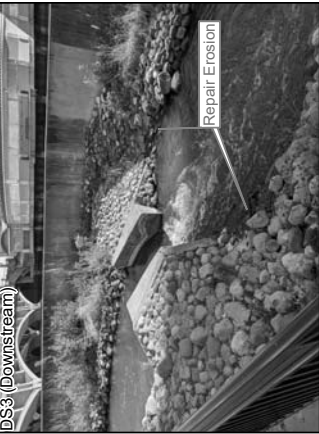
DS3 was observed to have some minor erosion issues on the upstream and downstream sides but was in good shape overall. Erosion has dislodged riprap as noted at other drop structure locations, creating voids in riprap. Shrubbery upstream and downstream of the drop structure is recommended to be managed. Cracking was observed along the west

sidewalk and wall. Overall, the condition of the structure itself appears satisfactory. See Photos **DS3-1** to **DS3-4**.
